# MIFACE Investigation Report #14MI122

## Subject: Truck Driver Struck by Rear Tractor Tires When Semi Tractor Driven Forward

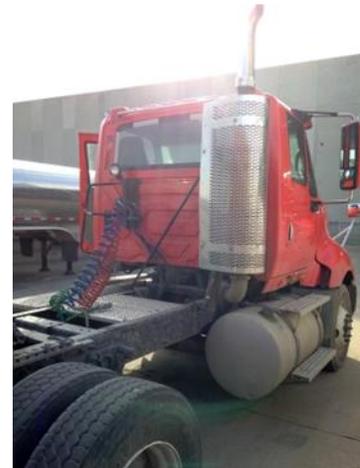
In late fall 2014, a truck driver in his 50s died when he was struck and run over by the passenger side tires of a 2011 International semi-tractor while positioned in a blind spot on the passenger side of the cab. The incident occurred at night. The incident occurred in a staging area lit by four lights attached to the building. Several of the decedent's coworkers were on site, working together to quickly move trucks and associated tankers in and out of a designated staging area at a dairy due to a procedural change imposed on the company by the dairy. One of the decedent's coworkers (Coworker 1) was assisting the 2011 International truck driver. Coworker 1 was positioned on the driver's side of the tractor cab unhooking the trailer. He also acted as a spotter during both the backing and forward movement of the tractor-tanker unit. The decedent was positioned on the passenger side of the semi-tractor and was lowering the landing gear down while the Coworker 1 unhooked the hoses, electrical and other connections from the tractor and tanker. When the trailer was unhooked and landing gear lowered, Coworker 1 saw the decedent standing away from the tractor and signaled the semi-tractor driver to back the tractor to disconnect from the tanker. The driver backed the tractor and felt the tanker shift and come off the truck. Coworker 1 did not see the decedent prior to signaling the tractor driver to drive forward. The semi-tractor driver checked his mirrors and looked out his windows. He drove forward to disengage the trailer. As the driver drove forward, the Coworker 1 walked around to the rear of the tractor and saw the decedent lying on the ground. Subsequent investigation showed that the decedent was standing between the passenger side cab, behind the muffler unit and in front of the rear dual tires. As the driver moved forward to disengage the tractor from the tanker, the decedent was struck and run over by the passenger side rear tires.

*Photo 1. Rear view, passenger side of similar truck*

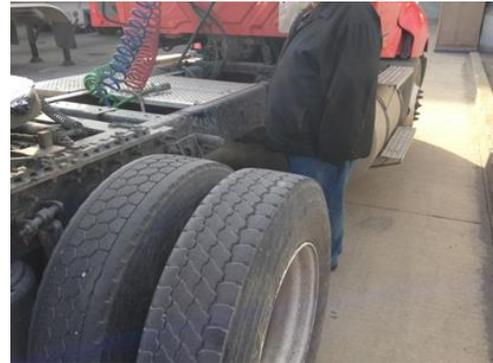
The decedent and one of his coworkers (Coworker 1) unhitched the newly arrived tanker from the incident tractor. Standing on the north (driver) side of the tractor/tanker, Coworker 1 unhooked the hoses and electric pigtail while the decedent, standing on the south (passenger) side, lowered the landing dolly legs. The decedent was wearing a black coat, black sweatshirt and black baseball cap, and blue pants.

*Photo 2. Location of decedent when truck driver drove forward*

Coworker 1 stated that he observed the decedent positioned away from the tractor/tanker unit. He stepped forward to inform the tractor driver it was all clear and to pull ahead. At this time, his view was blocked from seeing the decedent. The tractor driver stated he looked out his windows and checked his mirrors prior to pulling forward. For reasons unknown, the decedent had entered a blind spot on the passenger side; he was positioned behind the cab and its muffler system and in front of the rear tandem wheels of the tractor (See Photo 2). Another truck driver observed the positioning of the decedent and honked his horn to warn the driver and decedent but it was too late. As the tractor pulled ahead, the tractor ran over him. Emergency response was called and the decedent was pronounced dead at the scene.

- Blind spot training should include hazards associated with their role as a driver and as a pedestrian, including pedestrians acting as a spotter. As a driver, emphasis should be placed on the need to determine pedestrian location for both forward and backward movement and as a pedestrian, the need to be seen and acknowledged by the truck driver.

- Stop the driver if any hazards are observed or if you are uncertain of the direction that the driver is maneuvering.
- Always wear a high visibility vest/clothing when a pedestrian around moving vehicles, especially at night and/or in dimly lit areas.

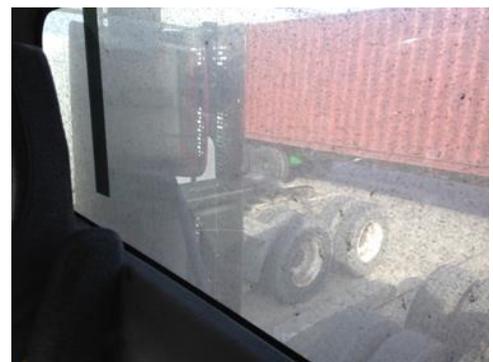
*Photo 3. View from driver's seat in truck cab*

The MIFACE researcher sat in the driver's seat of a similar unit at the firm's headquarters. The researcher observed that while in the driver's seat there was a large blind spot created by the large muffler system, which was mounted on the right (passenger) side of the truck tractor and blocked view of this area. Figure 3 is a picture taken by the MIOSHA compliance officer seated in the cab of the incident tractor and shows the driver's view out of the back window and the blind spot created by both the height of the cab above the ground and the muffler unit.

- Window rolled down.
- Radio off.
- No cell phone or similar distraction while backing.
- Foot on brake.
- If you lose sight of the spotter or pedestrian in your mirror, STOP.
- If any individual on foot is not acknowledged and eye contact is not made, the driver should not move the truck until visual contact is re-established.
