MIFACE Investigation Report #14MI200

Subject: Farmer Crushed Under Free Standing Grain Bin Struck by Horses and/or Manure Spreader

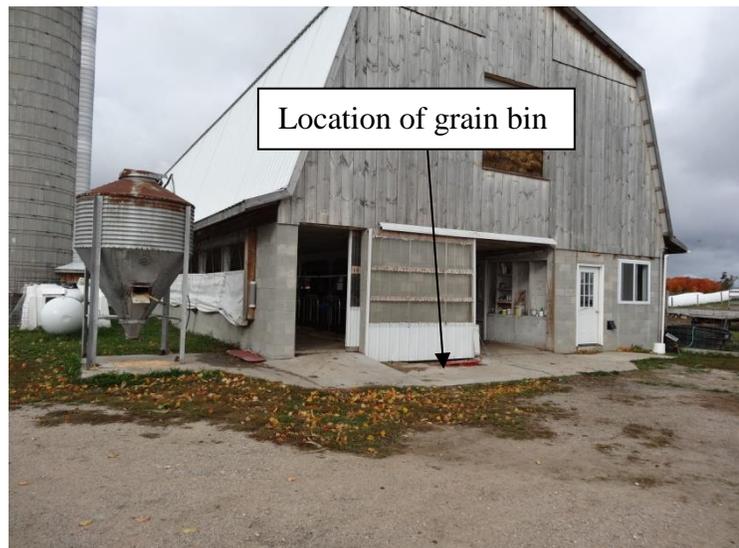
Figure 2. View of barn looking west

The decedent had been at this location for three years (Figure 2). He had been raised on a dairy farm. He currently raised 31 dairy cows. The decedent had attended some general farm safety meetings held by his community, but the safety meetings dealt primarily with sawmill safety.

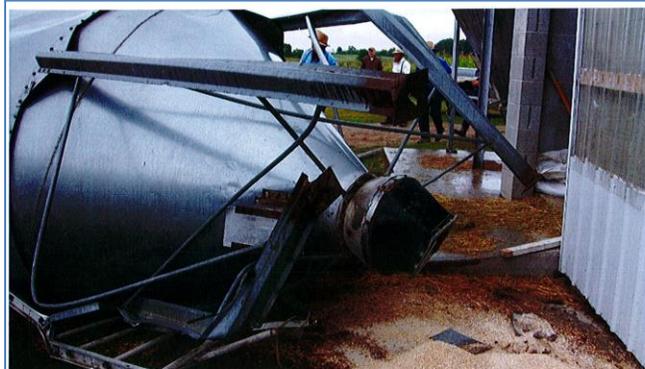
The decedent bought the grain bin involved in the incident second-hand; the age of the bin was unknown. The smooth walled steel hopper bottom grain bin had a capacity of 8 tons. The day prior to the incident, 6 tons of grain was delivered. Each of the grain bin's legs was positioned on a fairly level concrete pad, which was positioned next to the east side of the barn, between two access points for the cows. The grain bin was free standing – none of the legs were anchored to the pad.

Figure 5. Overturned grain bin

The decedent bought the bin second hand. There were no full pictures of the bin from the police report to determine the condition of the legs and bracing for the bin and if the bin had all of the necessary cross-bracing for stability. MIFACE recommends that bin owners conduct a structural inspection of the bin on a regular basis. Elevated storage structures are typically designed for “vertical” loads, check manufacturer’s installation guidance for leveling requirements.

- Ensure grain bins are anchored/tied down to the ground to minimize potential for overturn.

All grain bins should be anchored to the ground to minimize overturn caused by high winds or other outside forces, such as being struck by machinery or, as in this case, a horse and/or manure spreader. It is important to anchor every leg of a hopper bottom bin. To do so, when the bin is placed on a concrete pad, use a leg anchor or similar mechanism for each leg. Leg anchors attach to the bin leg and have anchor bolts drilled into the concrete pad to provide stability. If the bin is not on a concrete pad, clear away any gravel or rock, and use a tie down/anchoring system that is installed in firm soil.

- Inspect bins regularly for rust and deterioration to ensure the legs and braces are strong enough to maintain the weight on the bin.

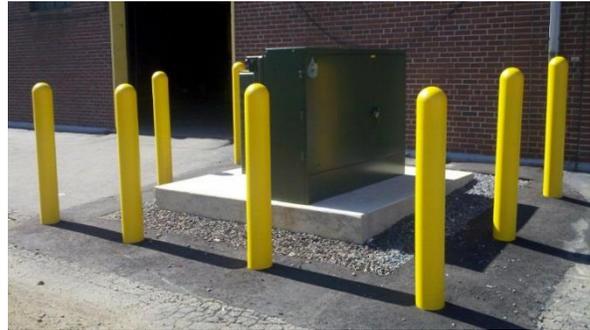
MIFACE recommends that farm operations identify “lanes of travel” and install barriers to protect vital assets, such as buildings, storage units, etc. from damage. One low cost method of barrier protection is a bollard, which is a sturdy, short, vertical steel post that creates a protective perimeter to what is being protected (See Figure 6).

Figure 6. Example of bollard use. Picture courtesy of Xavier Development. <http://www.xavierdevelopment.com/bollards/>

Bollards can be anchored to concrete, cored into a hard surface, buried in the ground or secured on a self-locking taper or impact recovery system to protect the surrounding foundations when a bollard is struck.
