Teen Laborer Rides on Side of Forklift, Falls While Jumping, and is Run Over by Rear Tire

CASE SUMMARY

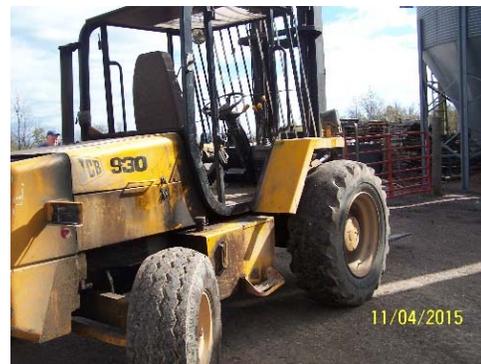
Figure 1. Rough Terrain JCB 930 forklift.

The equipment used at the job site was a JCB930 rough terrain forklift. This forklift is designed with a lift capacity of 6,000 to 10,000 pounds and a lift height of 15-22 feet. The lift was used to load and unload equipment purchased by customers and delivered by suppliers, and was equipped with one seat for a single operator. The forklift was not loaded at the time of the incident. A review of the user manual revealed that the JCB 930 was not designed to allow passengers, and that doing so could cause injury.

Recommendation No. 1: Do not allow passenger(s) to ride on a forklift unless the forklift is specifically designed to accommodate passengers.

OSHA regulations prohibit a passenger from riding on a forklift unless there is a passenger seat available for safe transport. The JCB 930 operator’s manual specifically stated that the forklift truck was not designed to accommodate passengers safely.

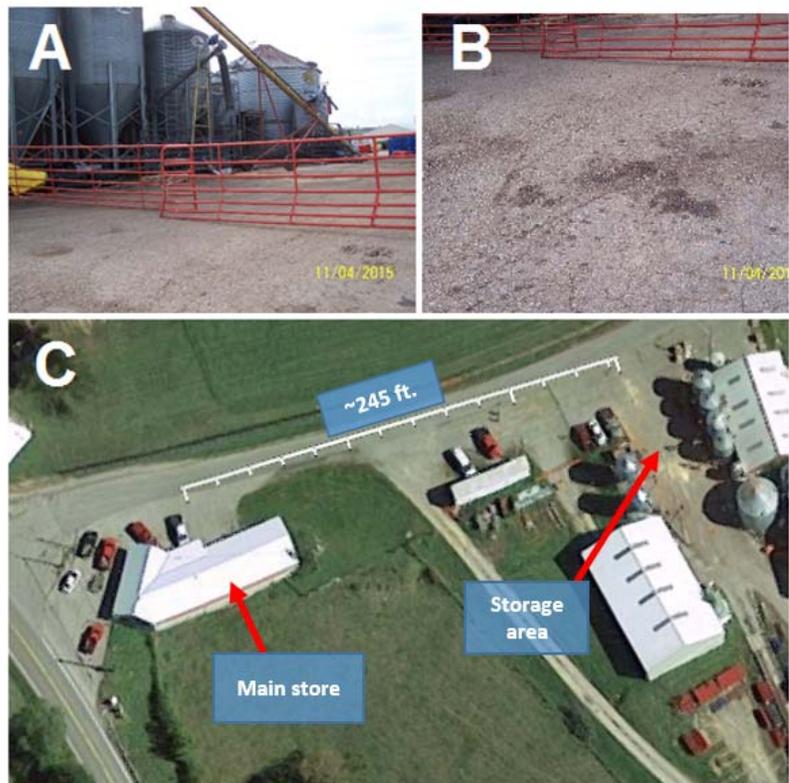
The storage area was positioned uphill behind the main store. A weathered, paved entrance led into a gated area where equipment and supplies were routinely stored. Assessment of the area surrounding the incident scene did not reveal any significant drops or potholes. The distance that the two laborers travelled on the forklift between the main store and the storage area measured approximately 245 feet.

Figure 2. A) Area where the forklift was to be stored. B) Area of the ground where the victim was struck by the forklift. C) Aerial view showing the distance the two laborers travelled on the forklift between the main store and the storage area.

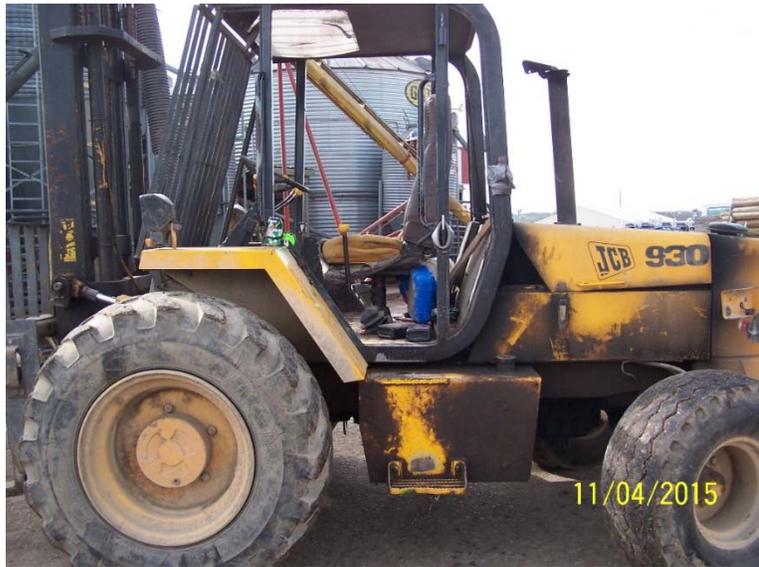
Figure 3. The JCB 930 rough terrain forklift at the scene of the incident.

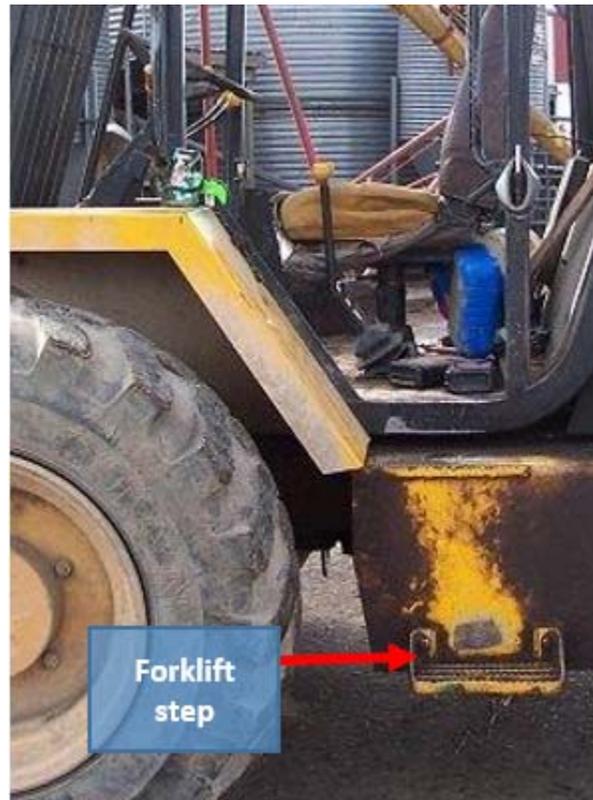
The victim shadowed a 19-year-old laborer who had been employed for one month, assisting him with various tasks. At approximately 4:50 pm, the 19-year-old laborer announced that he needed to lock the rough terrain forklift up for the night, and offered the victim a ride back to the storage area. The victim climbed onto the side of the forklift, standing on the side step and holding onto the frame of the forklift as they rode approximately 245 feet to the gated storage area (Figure 4). Moments later, as they approached the storage area, the victim volunteered to open the gate to the storage area. The victim jumped off the moving forklift, caught his foot under the forklift's wheel well, and fell face first to the dirt ground below. Unaware the victim had fallen, the young forklift driver proceeded forward until he sensed something beneath the wheel and stopped. The rear tire had run over the victim's chest, rib, and abdominal area. The forklift driver immediately backed the forklift off of the victim. A nearby customer, who happened to be a physician, heard the forklift driver screaming for help and rushed over to assist, instructing the employees not to move the victim. After experiencing a seizure, the victim regained consciousness and complained that he was experiencing severe pain. The physician stated the tire had ridden up the side of the victim's abdomen, right shoulder and the side of his head. Emergency medical services were immediately contacted at approximately 5:00 pm and arrived within 15 minutes. After assessing the extent of the victim's injuries, the EMS called for air transport. The victim was flown to a major trauma center where he arrived at 6:15 pm and died at 6:52 pm from his injuries.

Figure 4. The victim was riding on the forklift's side step at the time of the incident.

29 CFR 1910.178(m)(3): “Unauthorized personnel shall not be permitted to ride on powered industrial trucks (forklifts). A safe place to ride shall be provided where riding of trucks is authorized.”²
