Commercial Roofer Falls 30 Feet Through a Skylight While Installing Roof Insulation

CASE SUMMARY

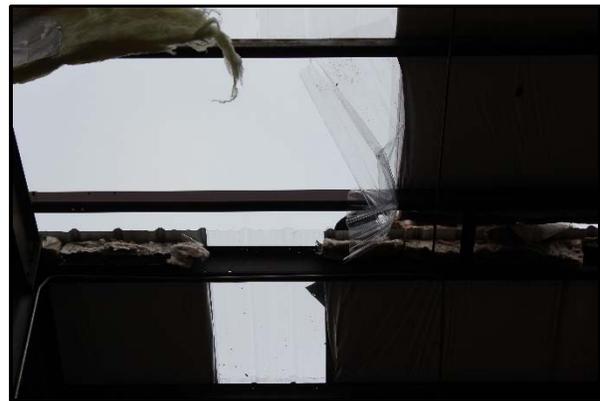
Figure 1. Location on roof where roofer fell.

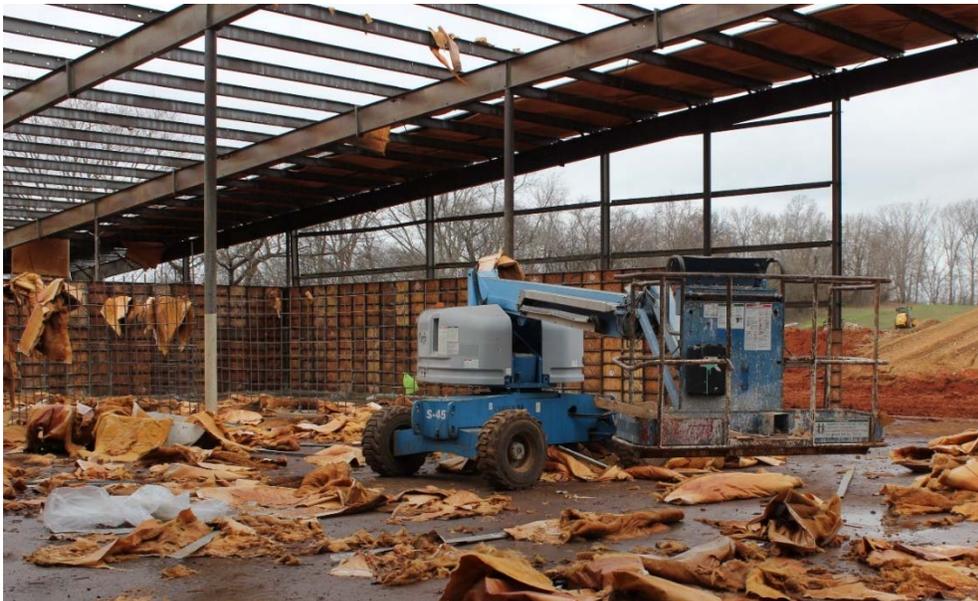
The equipment used was a Genie model S-45 boom lift to access the rooftop and to deliver materials as needed. Also, rolled fiberglass insulation was being installed.

Figure 2. Genie model S-45 boom lift used to transfer roofers and materials to roof.

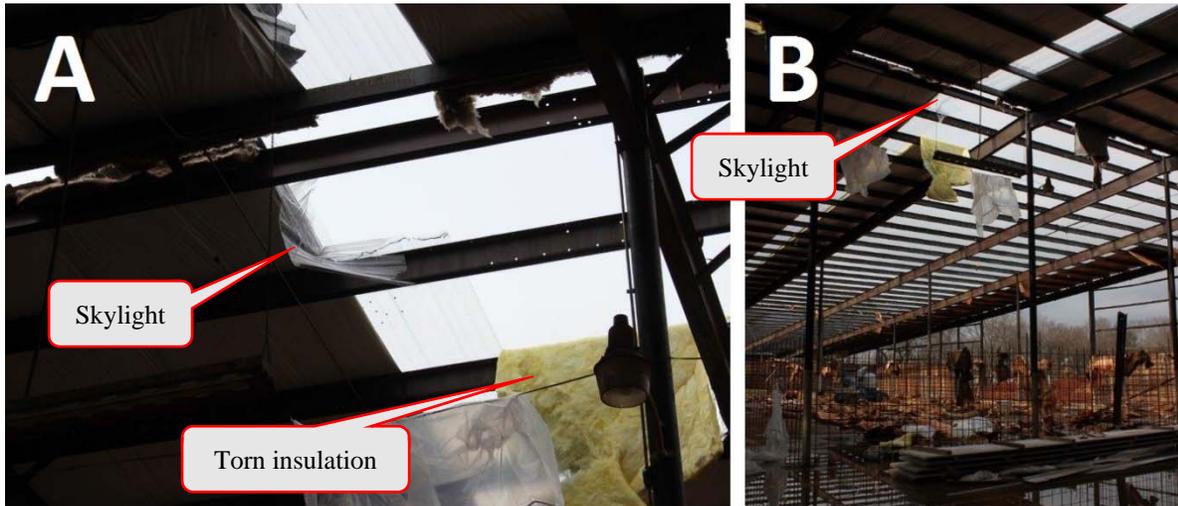
Figure 3. Skylight through which the victim fell with torn insulation (A); interior of the building (B).

The incident took place inside a former tobacco warehouse. The floor was littered with old insulation that had been removed and new rolls of fiberglass insulation were to be installed. The 1:12 pitch roof was being constructed of corrugated sheets of metal and had corrugated fiberglass skylights running through. There was a tractor and van stored inside the building. The victim was 30 feet above on the roof installing insulation when the incident occurred. When he fell, he landed on the concrete surface below in a large puddle of water. The foreman witnessed the victim falling and called for emergency medical services.

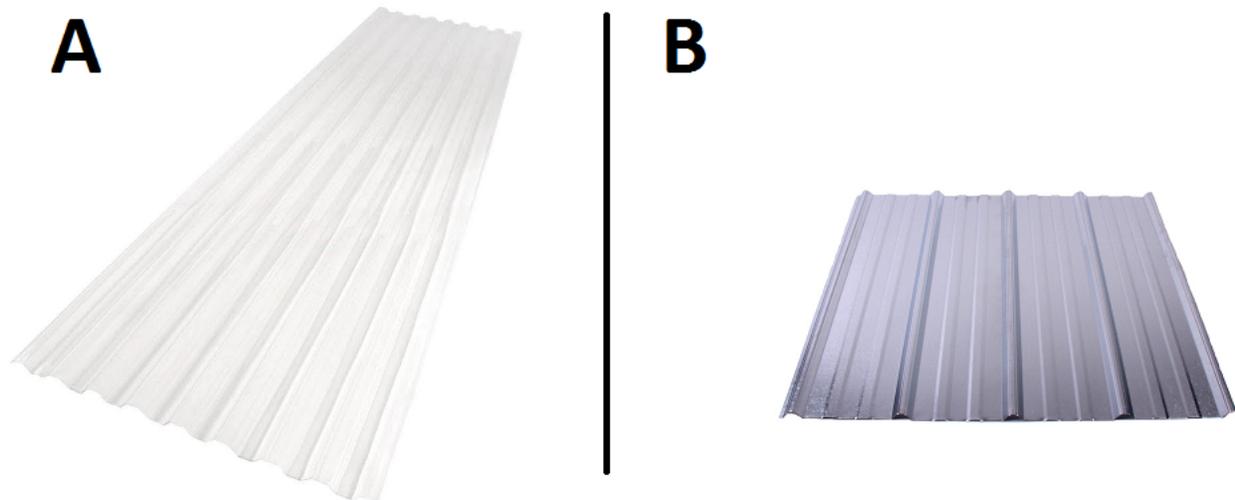
Figure 4. Fiberglass corrugated skylight panels, similar to those on the roof (A); corrugated metal roofing panels, similar to those on the roof (B).

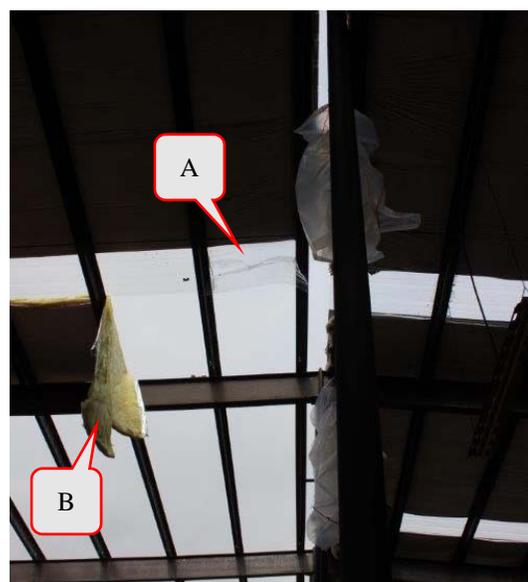
Figure 5. Skylight that collapsed under the roofer (A); insulation that tore (B).

near the roof's peak, while the other two were positioned elsewhere on the roof. The foreman was located at the ground level. None of the roofers were wearing fall protection, and the nearby skylights were not guarded. The victim pulled the insulation tight in an attempt to fully stretch it out. As he was doing this, the insulation tore (Figure 5B), causing him to lose his balance. Trying to recover his balance, he staggered forward and stepped onto an unguarded skylight panel (Figure 5A) that was attached to the purlins. The skylight broke from the weight of the victim, causing the victim to fall thirty feet to the ground below, striking his head on the water covered concrete. The victim was pronounced dead at the scene at 12:23 pm by the coroner.

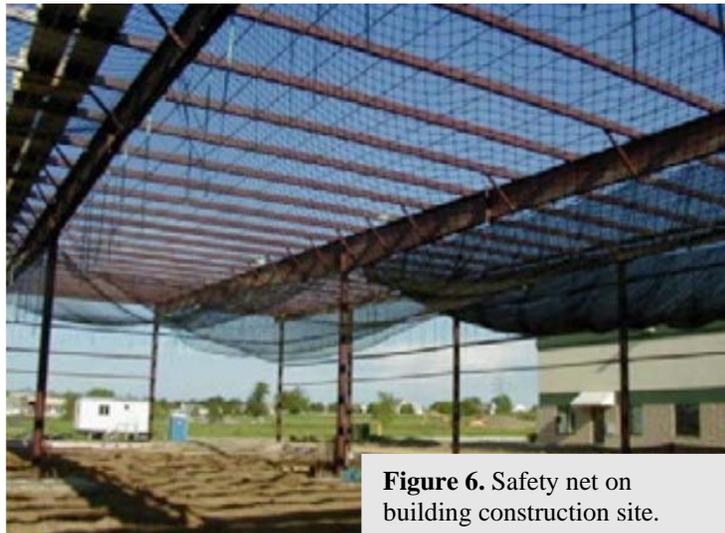
Figure 6. Safety net on building construction site.

Personal fall arrest systems (PFAS) were available, but neither the victim nor the other roofers were using personal fall protection of any kind. The use of a drop-tested safety net (Figure 6A) or a PSAF may have prevented the outcome of this fatal incident. A competent person should always be on the worksite who is capable of identifying hazards and has the authority to eliminate or reduce them. In this case, the foreman should have been trained in the role of a competent person and should have enforced the use of fall protection by all roofers exposed to the fall hazard, both on the roof and in the boom lift.
