# A 19-Year-Old Landscape Laborer Dies When Entangled in Auger after Entering the Hopper of a Bark Blower Truck

Investigation: # 15WA02901

Release Date: October 20, 2017

SHARP Report: 52-41-2017

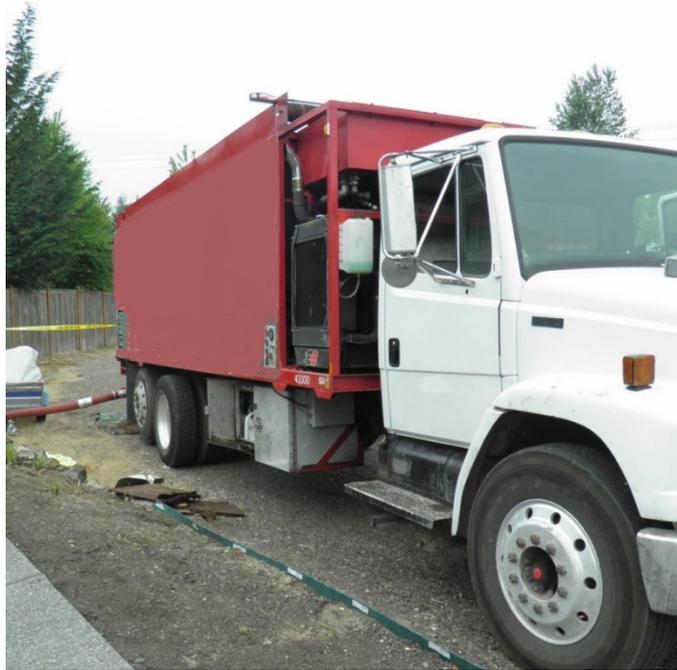
**Photo 1:** Bark blower truck at the incident site. The victim was working inside the cargo hopper near the rear of the truck. The delivery hose can be seen extending from the rear of the truck.

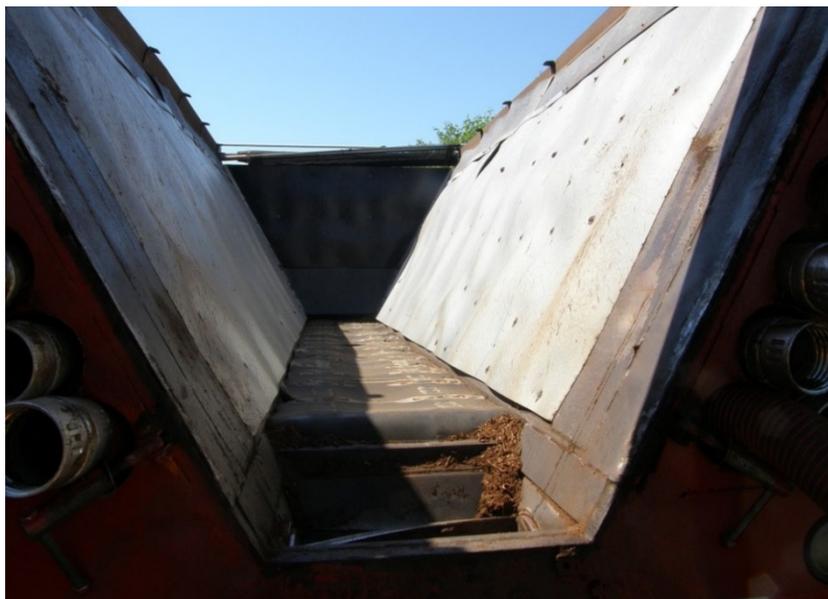
The truck's open top cargo hopper is approximately 20 feet long and 6 feet high, and holds approximately 20 cubic yards of bulk material (photo 2). It has walls that slope inward at a 60-degree angle toward the bottom. The top of the hopper is approximately 8 feet wide and narrows to approximately 2 feet at the bottom.

**Photo 2:** The empty cargo hopper of the bark blower truck. The material conveyor belt and feeder mechanism can be seen on the hopper bed.

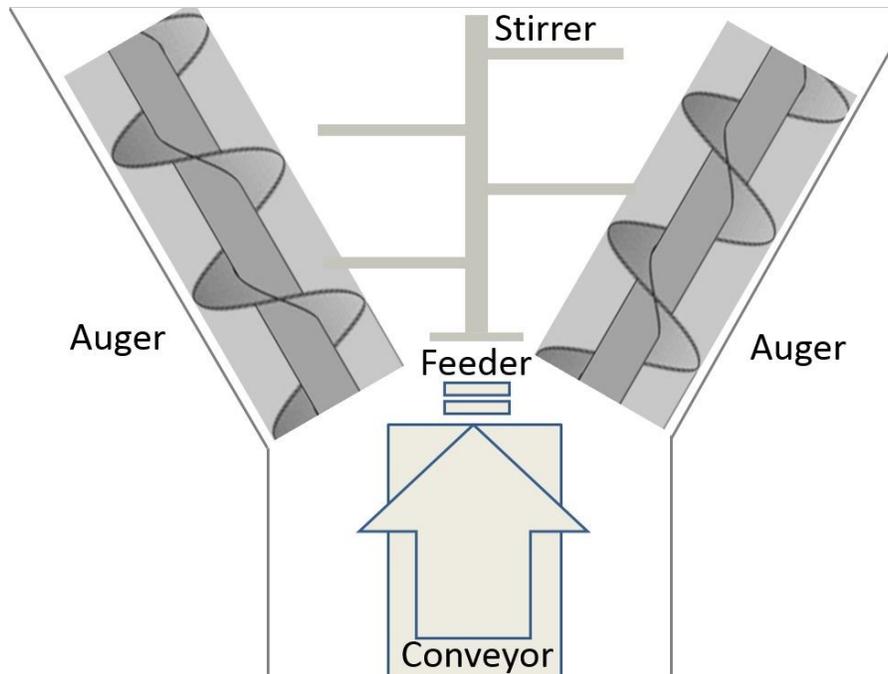
A conveyor belt mounted on the frame of the truck is located on the bottom of the hopper and runs intermittently to carry material toward the rear of the hopper where two diagonally positioned augers (screw conveyors) and a vertically positioned stir rod (mixer or stirrer) are situated in close proximity to each other (photo 3 and figure 1). Hydraulic motors drive the augers and stir rod. The augers and stir rod, located on the hopper's rear door, rotate to drive bark down into a rotating feeder mechanism at the end of the conveyor. The augers and stir rod rotate in a circle around 4-foot shafts. The blades on the augers extend out from the shaft approximately 8 inches. The stir rod has 4 projections extending outward 6 to 12 inches from the shaft, and rotates at a higher rate of speed than the augers. The purpose of the stir rod is to break up the bark. The feeder, which has rotating blades to cut up the bark, collects the material where it becomes caught up in an air flow created by the air blower and is transported through a discharge hose for placement on a site.

**Figure 1:** Illustration of how bulk material is delivered into the feeder mechanism on the cargo hopper bed.

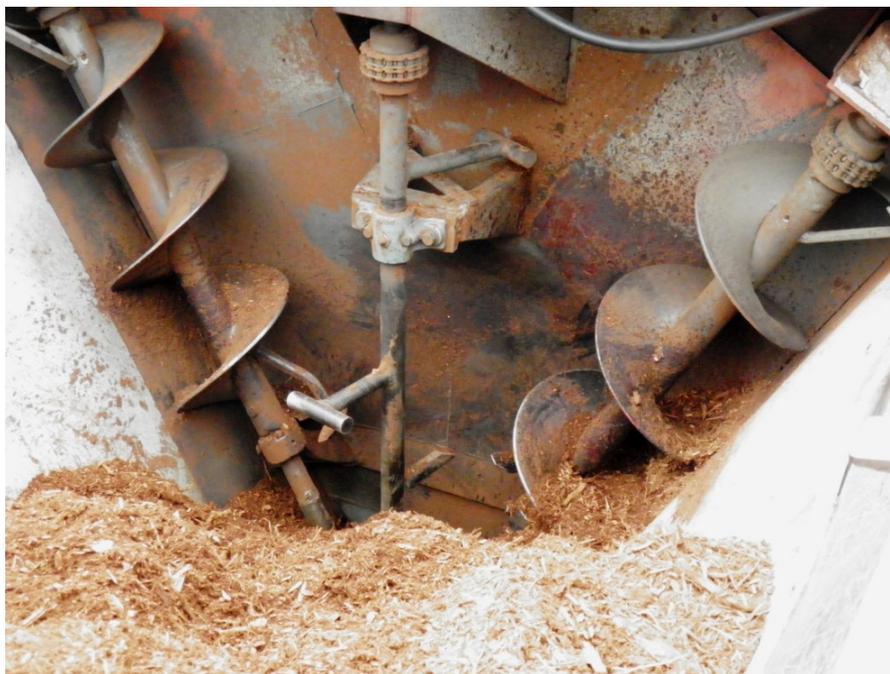
Access to the inside of the hopper is gained by climbing a ladder mounted on the hopper's rear exterior (photo 4). As there is no ladder on the hopper interior, employees would climb down the stationary augers (photo 3). The hopper was not intended for

**Photo 3:** The auger system consisting of two augers and a stir rod used to deliver bulk material into the feeder mechanism located on the cargo hopper bed. The auger system is located on the rear interior of the bark blower truck.

The bark blower truck's hopper had an auger system consisting of two angled rotating augers and a stir rod. These were unguarded, as the manufacturer did not intend for workers to be inside the hopper when the auger system was active. The victim became entangled in the stir rod of the auger system and crushed between the hopper wall and one of the augers.

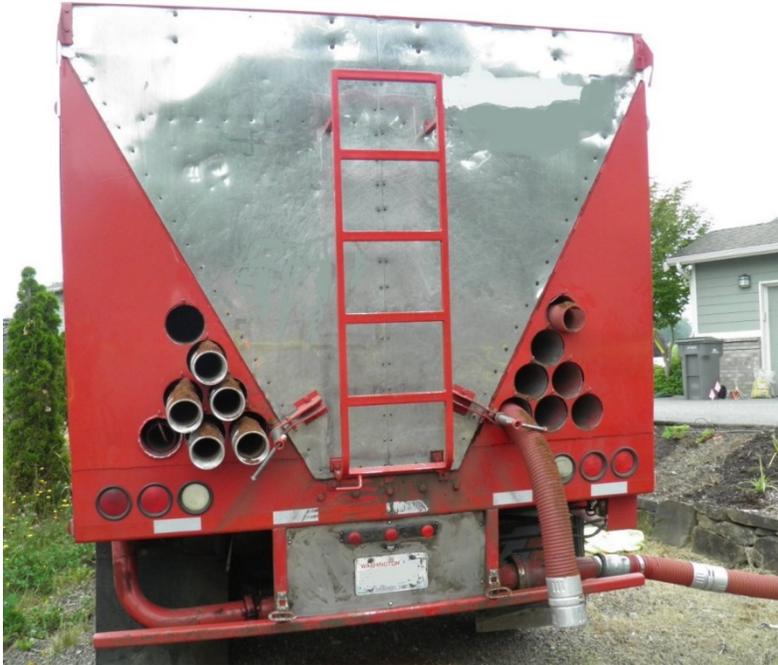
**Photo 4:** Rear of the bark blower truck with the hopper access ladder and hose assemblies.

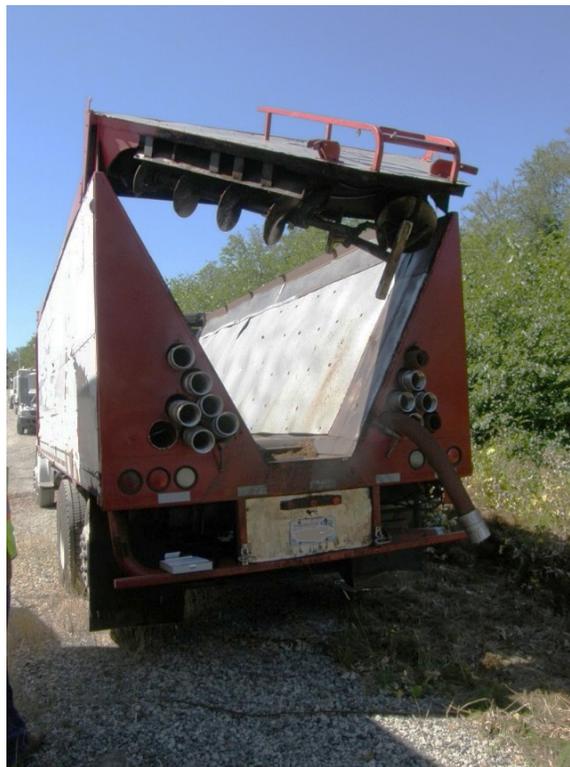
**Photo 5:** Rear of the bark blower truck in the open position showing the cargo hold and the auger system.

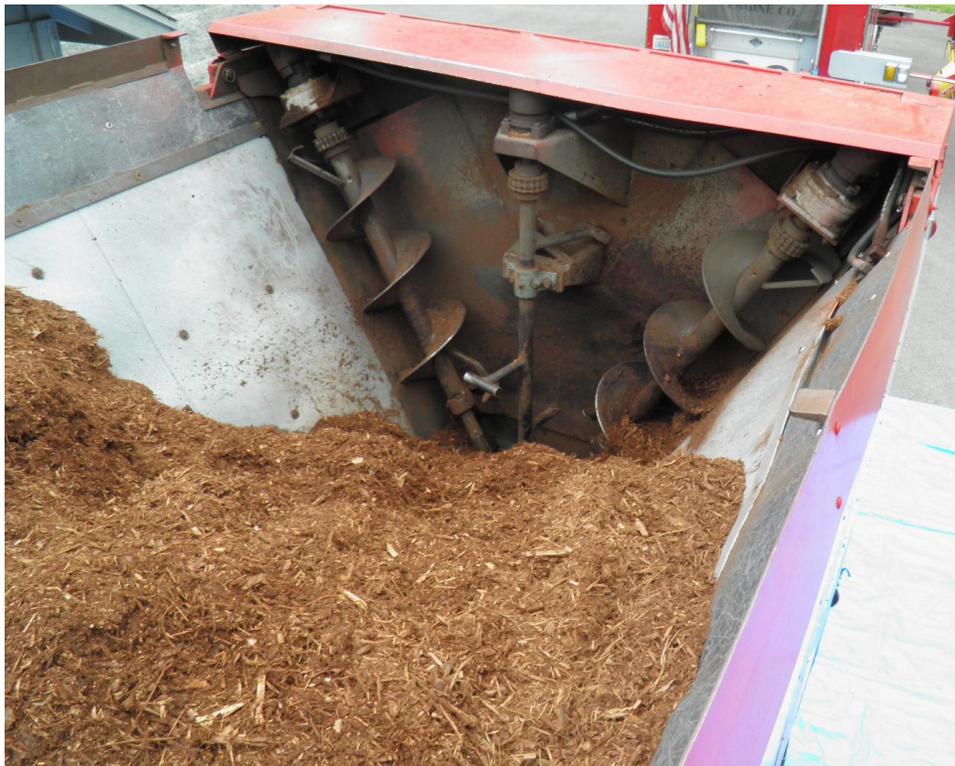
Within minutes, police and fire department emergency medical service responders arrived. A police officer looked inside the truck's hopper and found the deceased victim entangled in the stir rod of the auger system.

**Photo 6:** Inside of bark blower truck hopper at the incident scene. The victim had been standing on the bark material using a pitch fork to feed bark into the blower feeder when he became entangled in the stir rod of the auger system.

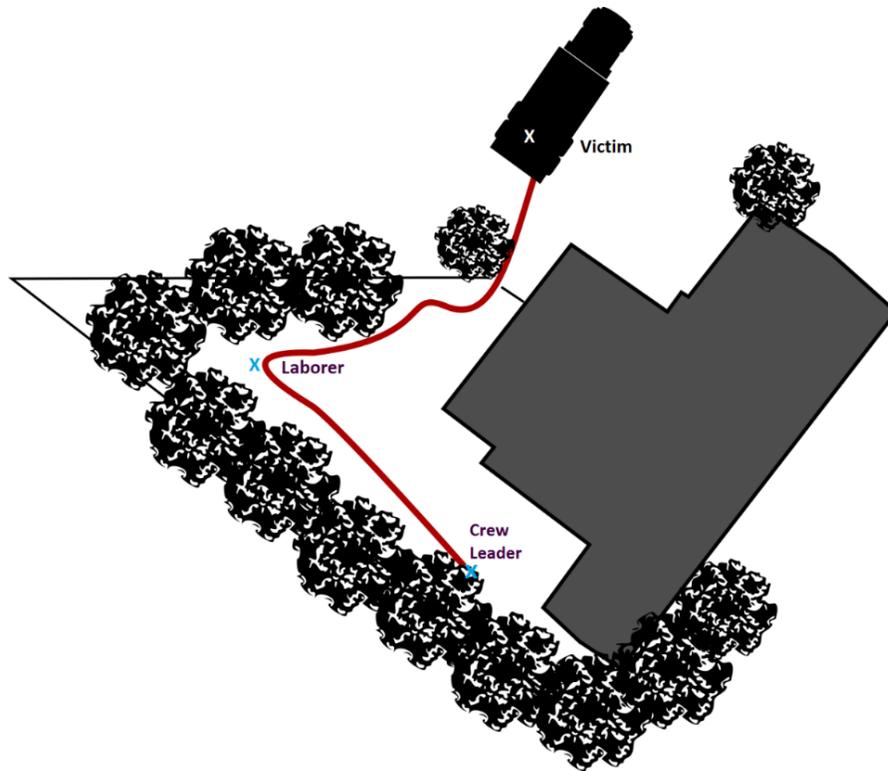
**Figure 2:** Incident scene schematic showing approximate locations of blower truck and three employees at the residential delivery site [figure not to scale].

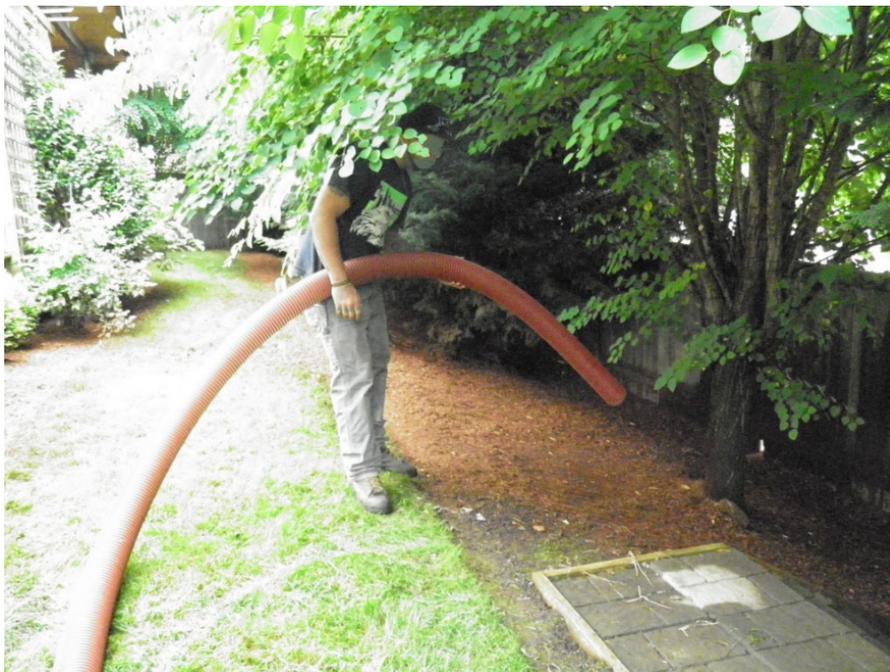
**Photo 7:** Approximate location of the crew leader with the blower delivery hose at the residential incident site.

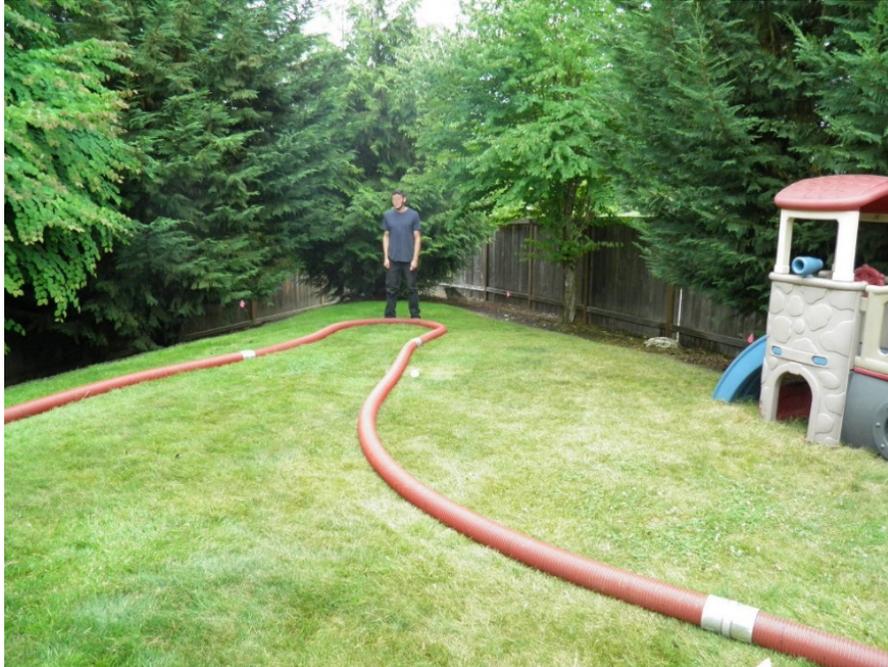
**Photo 8:** Approximate location of the laborer whose task was to move the delivery hose as the bark was being applied to the yard.

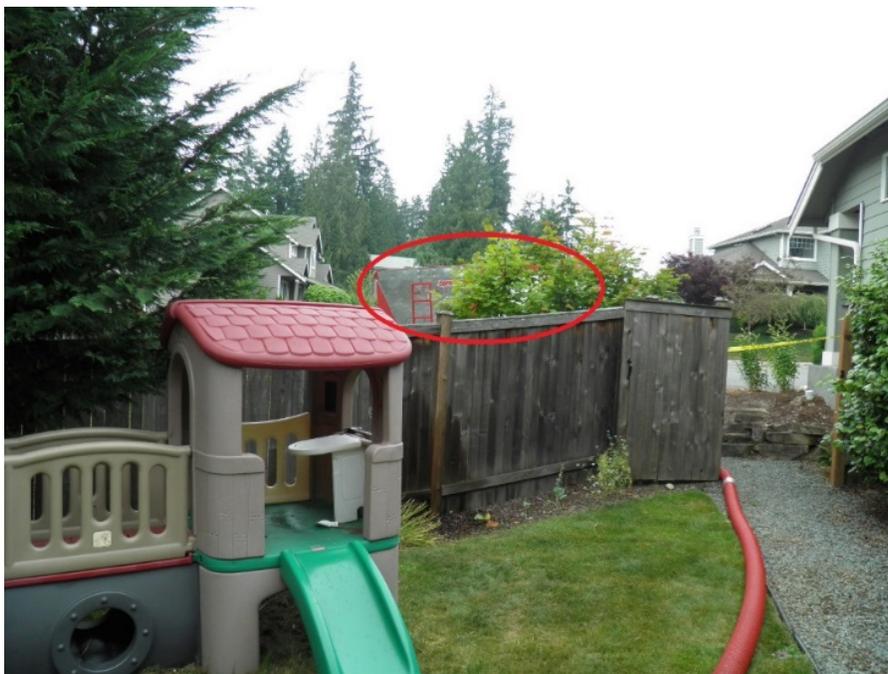
**Photo 9:** Residential yard where two employees were spreading bark while the victim was working in the hopper. The red circle indicates the blower truck's location.

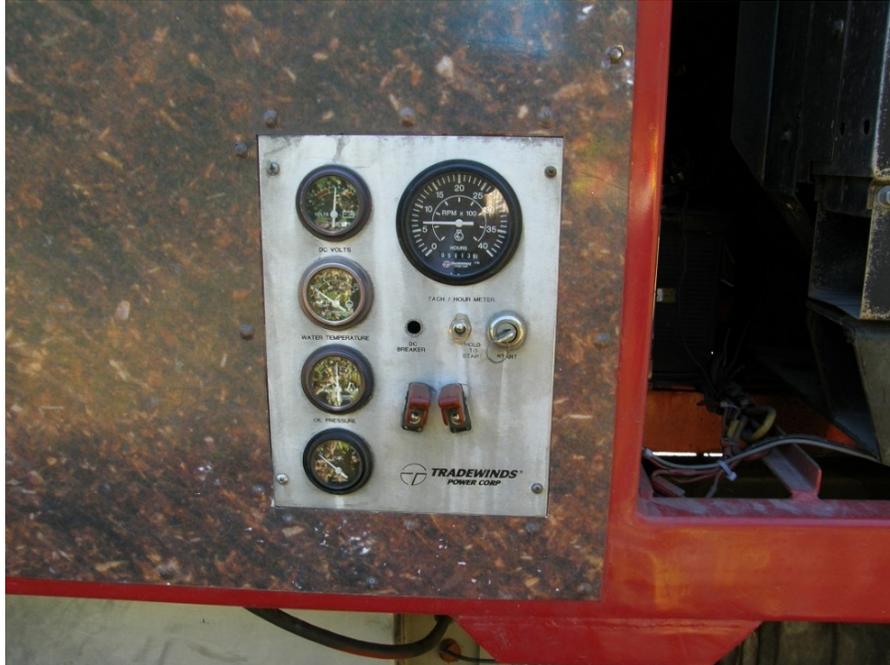
**Photo 13:** Engine controls for the blower system. The engine's power is controlled by using a key.

stir rod, feeder, and conveyor belt floor. Removing the key from the blower system engine's ignition creates a positive lockout of the Power Take Off (PTO) and the blower system's hydraulically controlled operations.

In this case, the LOTO procedures should specifically include that when an employee has to enter the blower truck's hopper to clear a jam, to perform maintenance, or for any other reason that the blower system's engine must be lockout out by de-energizing, isolating, blocking and or dissipating all forms of hazardous energy. Then the employee entering the hopper must affix a lock to secure the energy isolating device. The incident bark blower truck's self-contained blower system was run by a diesel engine. Turning off the engine shuts down all power to the all the blower system's hydraulically controlled operations. Removing the key from the ignition creates a positive lockout of the PTO and hydraulic systems.

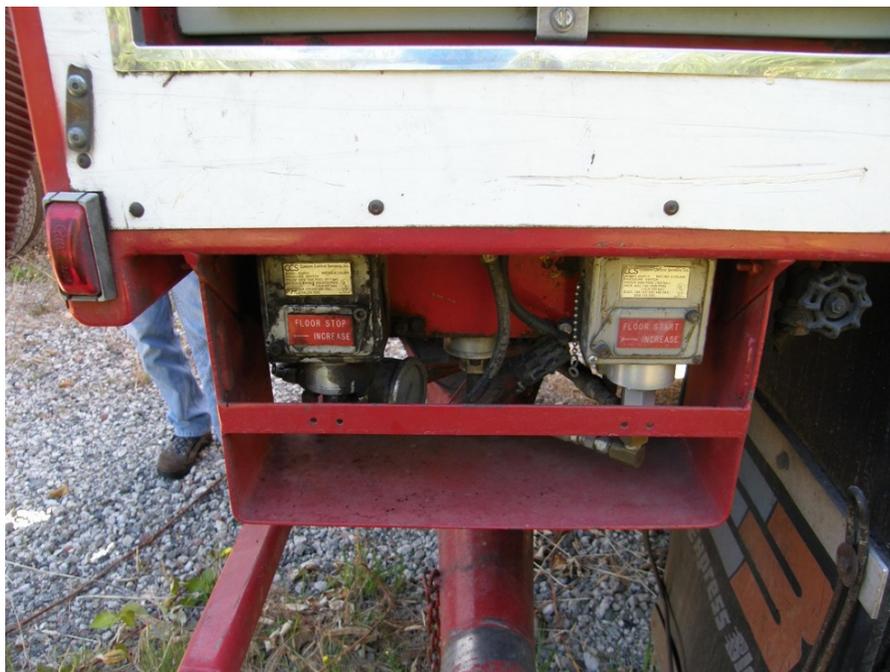
**Photo 14:** Pressure control switches on bark blower truck that were not operative and for which employer could not find replacements.

The bark blower truck's broken hydraulic pressure sensors were a significant contributing factor in this incident. These sensors would detect if there was too much pressure from bulk material in the hopper on the auger system near the feeder. If there was too much pressure on the system then the conveyor belt would be shut off. The augers and stir rod would continue to rotate, driving material into the feeder until the pressure was lessened. This would prevent bulk material from jamming the blower

The incident bark blower truck was an older model, manufactured in 1998. The employer had unsuccessfully attempted to find pressure sensors to replace the ones that were inoperative. Recommendations made by company service mechanics to take the blower truck out of service because of this issue were not heeded. Due to the tunneling of bulk material in the hopper, caused in part by the broken sensors, the employer required their employees to be in the hopper to use a pitchfork to manually feed material into the feeder. After the fatal incident the employer had the truck removed and destroyed.

**Recommendation 6: Maintain machinery and equipment in safe operating condition. Remove malfunctioning machinery and equipment from service and repair or replace.**

**Discussion:** Employers should remove machinery and equipment from service that has parts that become nonfunctional that could affect the safe operation of the equipment until they can be repaired. Employers should create a policy to ensure that machinery and equipment is regularly maintained and that they are promptly repaired or replaced so as to ensure worker safety.

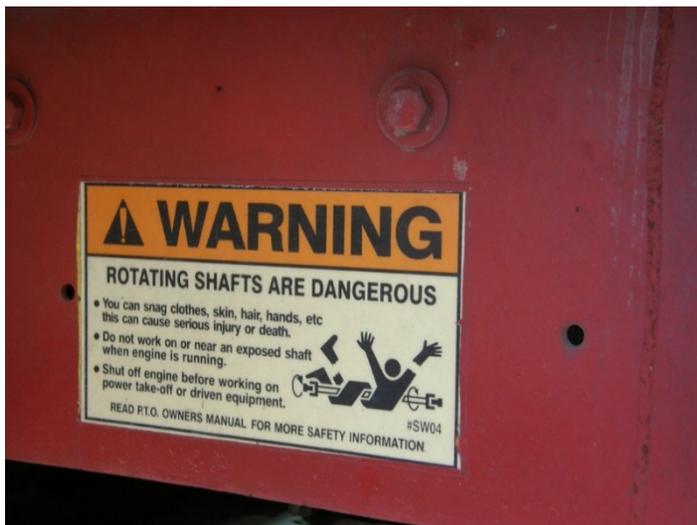
**Discussion:** The incident bark blower truck did not have safety warning labels affixed to the hopper or any part of the truck warning of the hazards associated with use of the truck and its equipment components. Ensure that manufacturer provided warning labels are placed in locations on equipment as specified by the manufacturer. If the manufacturer has not provided warning labels, then acquire American National Standard (ANSI Z535.4) compliant warning labels from a distributor.

**Photo 15:** Safety warning label affixed to an employer owned bark blower truck (not the incident truck) warning of the hazard of rotating shafts.

**Recommendation 7: Affix safety warning labels to equipment containing graphics providing hazard information and instructions for the safe use of equipment.**
