Occupational Fatality Report

Carpenter Fatally Injured after Falling from an Extension Ladder – Massachusetts

Release Date: February 24, 2017
Investigation: # 15-MA-037-01

Massachusetts Department of Public Health
Occupational Health Surveillance Program

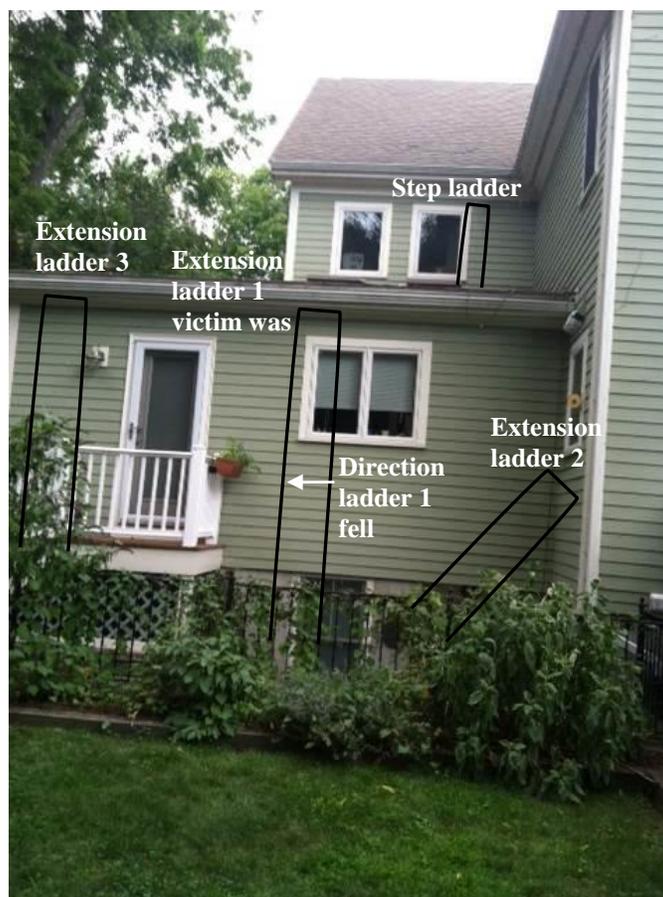
The incident occurred at a two family house within a residential neighborhood of a city. The main front section of the house was two stories with a high-pitch roof. The back part of the house, where the incident occurred, had a section that was one story in height with a low slope roof (Figure 1). At the back of the house was a sublevel stairwell and patio (Figures 2 and 3). The patio area measured approximately nine feet by 11 feet. The patio was made of two sizes of pavers; one paver was five by five inches and the other paver was eight inches by 5 inches. The top of the pavers were slightly convex and overall the patio was not level. There were gaps

A third extension ladder (ladder 3), also with an outrigger/stabilizer, was set up against the single story section of the house. The base of this ladder was positioned in the yard and extended above the roof line to access the single story section of roof. When looking at the back of the house, this ladder was the left-most positioned ladder (Figure 1). The workers brought a fourth extension ladder up to the single story roof and laid the ladder down on the roof. The step ladder was positioned on the single story roof in the closed position, leaning against the back wall of the second story portion of the house (Figure 1)

Figure 1 – Incident location. The back of the house.

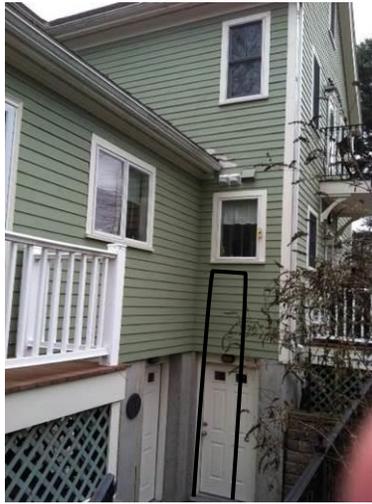
between the pavers that were filled in with stone dust. There were also retaining walls built out of stone blocks and stairs leading up to the backyard space. A metal fence was installed at the top edge of one of the retaining walls and a metal gate was located at the top of the stairs. In this sublevel patio area were two doors that led to the house's basement (Figure 2). The distance from the single story section of roof to the backyard level was about 10 feet and the distance from this roof to the sublevel patio floor level was about 20 feet.

Figure 2 – Incident location. The back of the house showing a part of the sublevel patio.

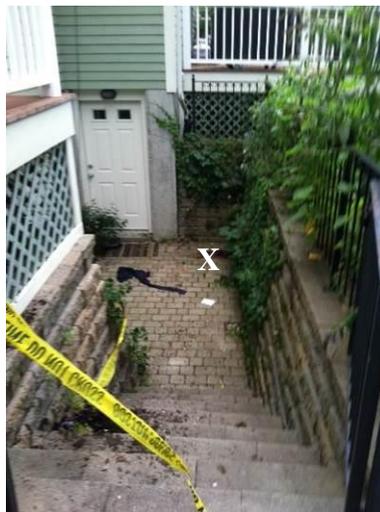
The victim started to climb ladder 1, the 28-foot aluminum extension ladder, which was not fully extended, to assist the co-worker. It was unclear if the 28-foot ladder, which was set up in the sublevel patio, was repositioned to extend above the roofline before the victim started to climb the ladder. It was reported by the employer that the victim was not carrying anything in his hands while climbing the ladder. When the victim was climbing the ladder, the base of the ladder slipped out from beneath him and then the ladder fell to the left. The victim fell approximately 20 feet at the same time. The co-worker heard a noise and realized he could not see the victim anymore. The co-worker then went to see what had happened and saw that the victim had fallen and was lying on the patio and the ladder had landed on the metal gate at the top of the stairs (Figure 3). Both the co-worker and a resident of the house placed calls for emergency medical services (EMS). EMS arrived within minutes and the victim was transported to a local hospital where he died 16 days later.

Figure 3 – Incident location. The back of the house showing sublevel patio and the location where the victim landed after falling.
