**FATALITY ASSESSMENT AND CONTROL EVALUATION PROGRAM
(CA/FACE)**

A Foreman Dies When He is Crushed in a Hay Baling Machine

Case Report: 16CA002

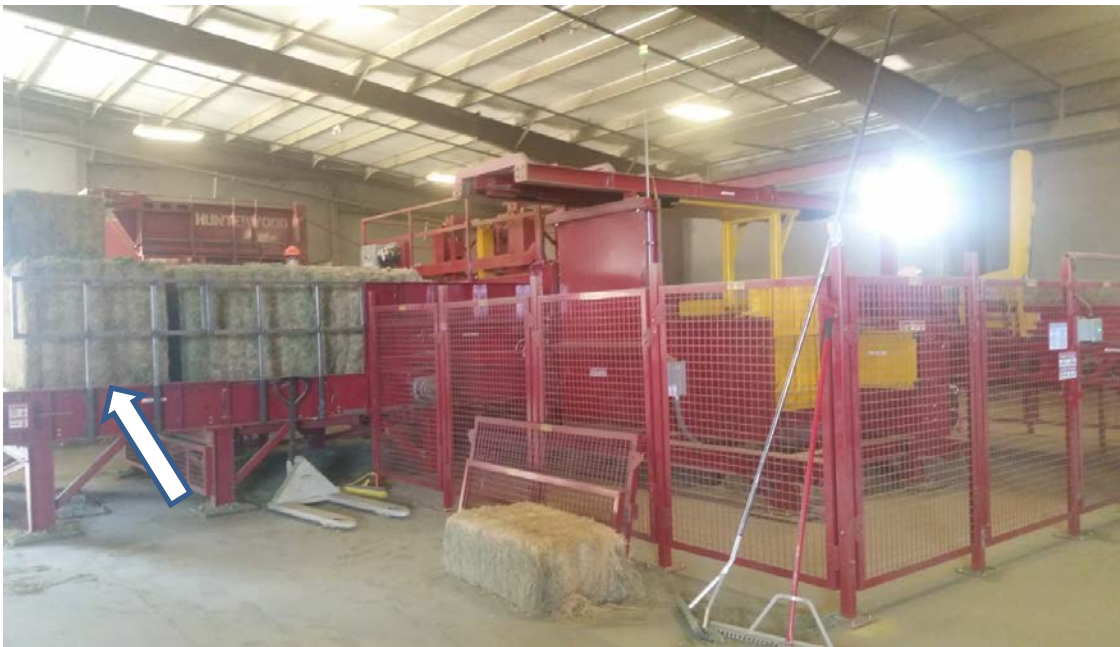
Exhibit 1. The intake portion of the hay baler.

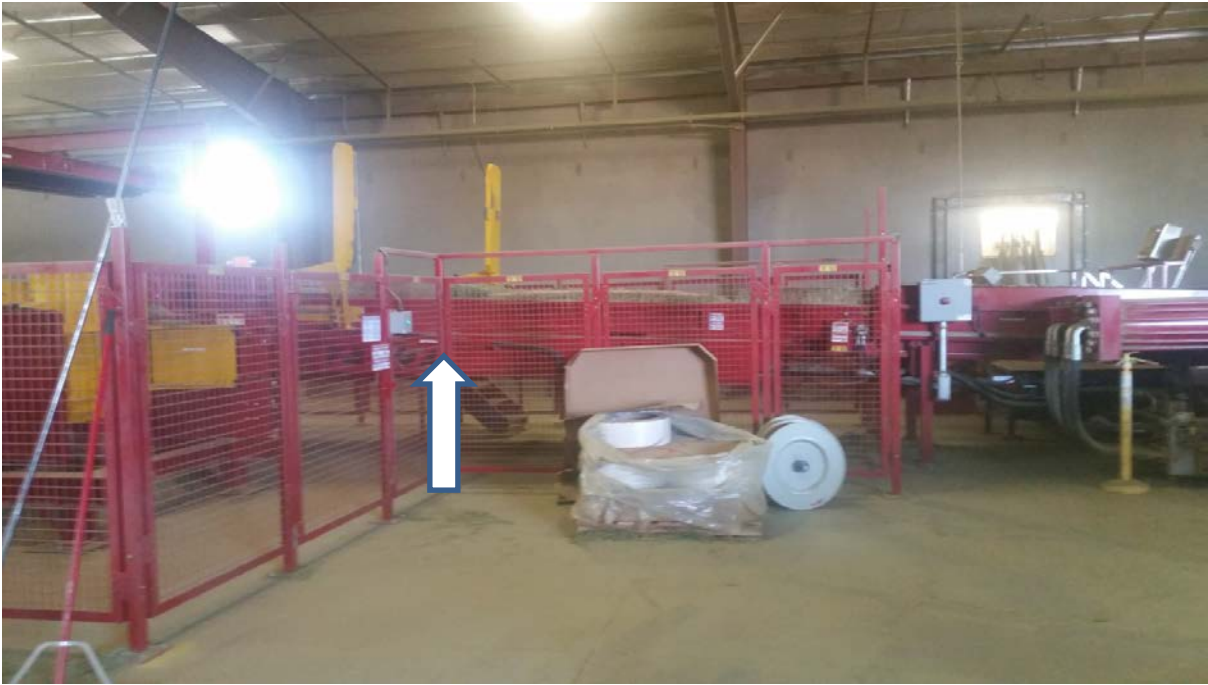
Exhibit 2. The hay baler's slicer box.

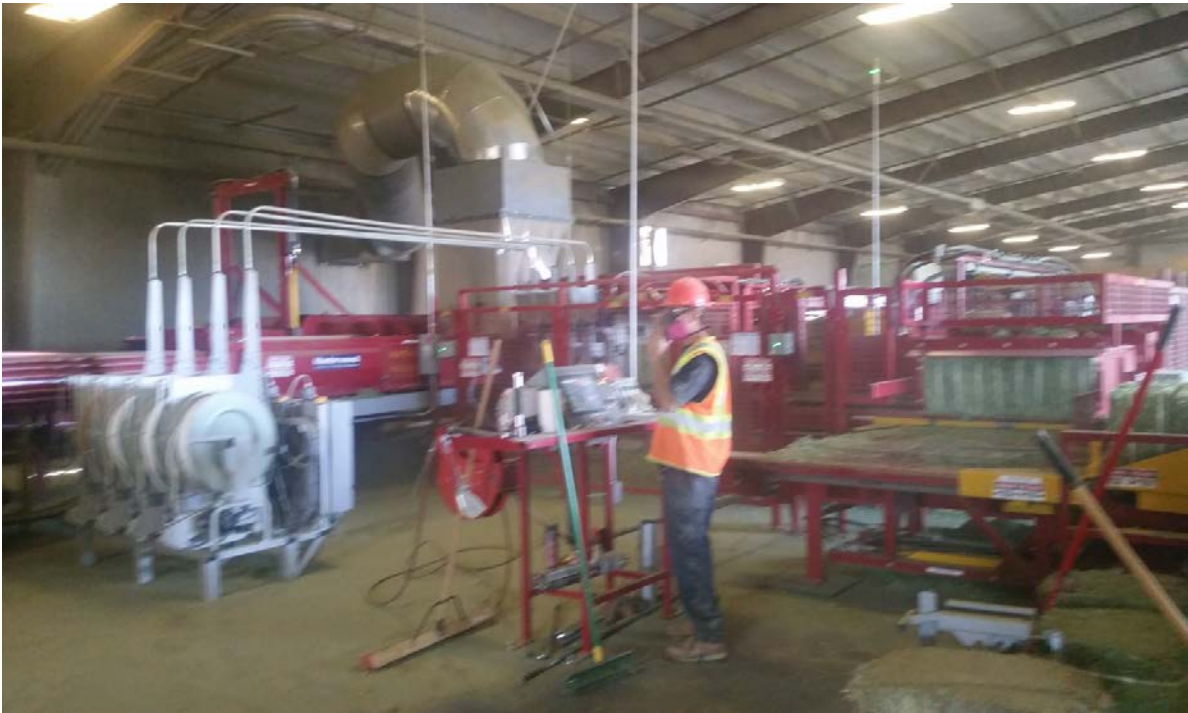
Exhibit 3. The hay baler operator's station.

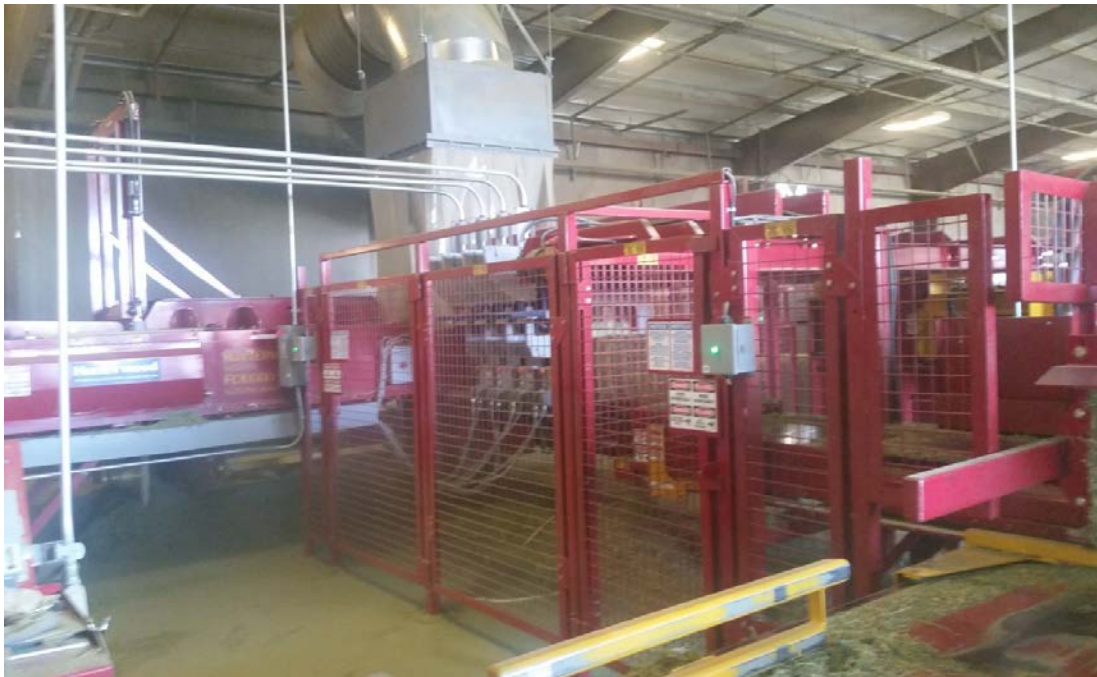
Exhibit 4. The hay baler compression, strap chamber, output scale and cutter box.

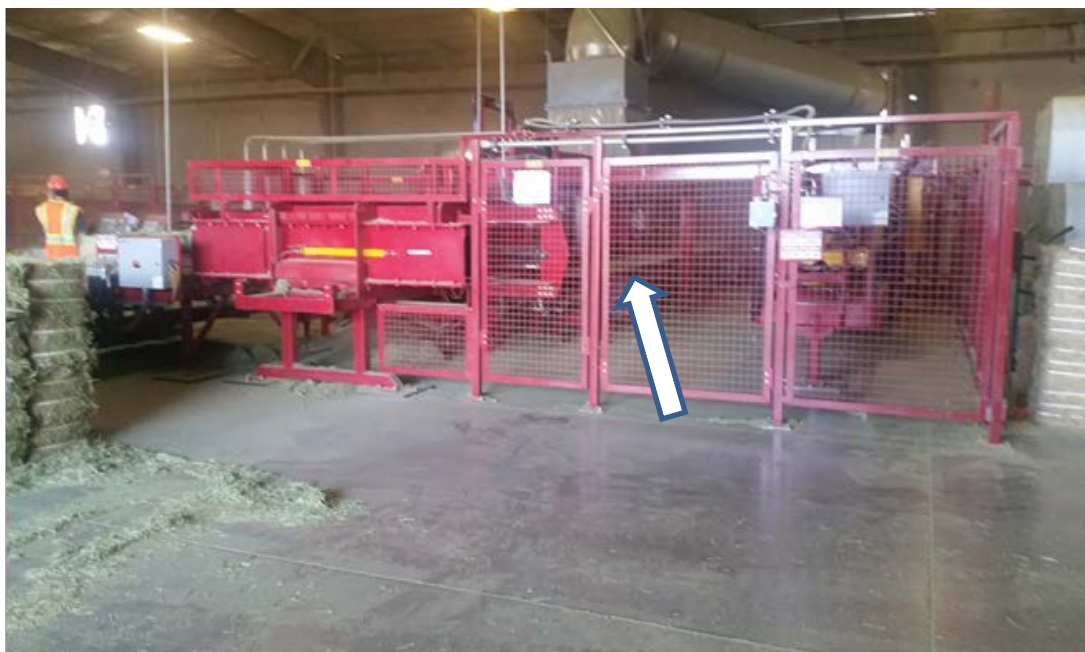
incident. At approximately 5:15 p.m., a forklift operator noticed the victim in the magazine area between the kicker arm and the magazine frame. The forklift operator yelled to the machine operator to shut the hay compactor off. The kicker arm was manually operated to release the victim. Emergency services were called and the victim was transported to a local hospital where he later died from his injuries.

Exhibit 5. The splay table and shuttle (area where the incident occurred).

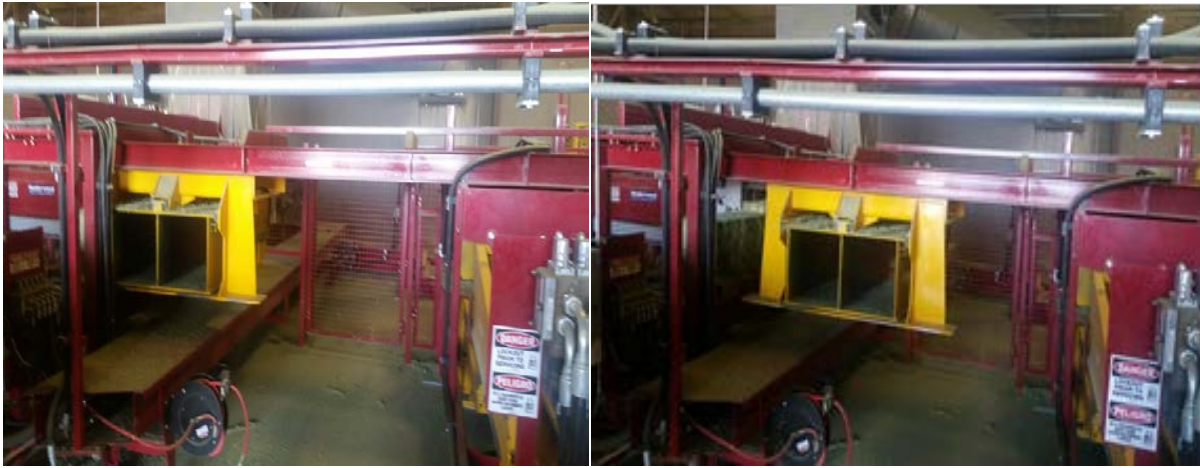
Exhibit 6. The moving part (in yellow) that crushed the victim.

Employers also need to be sure that affected workers have a clear understanding of when hazardous energy control procedures apply, and provide worker training in their primary language on how to properly apply the procedures. Employers need to ensure that lockout/tagout procedures are specific to each machine. In this incident, if lockout/tagout procedures had been in place, the hay baler would have been de-energized and the victim would not have been crushed.

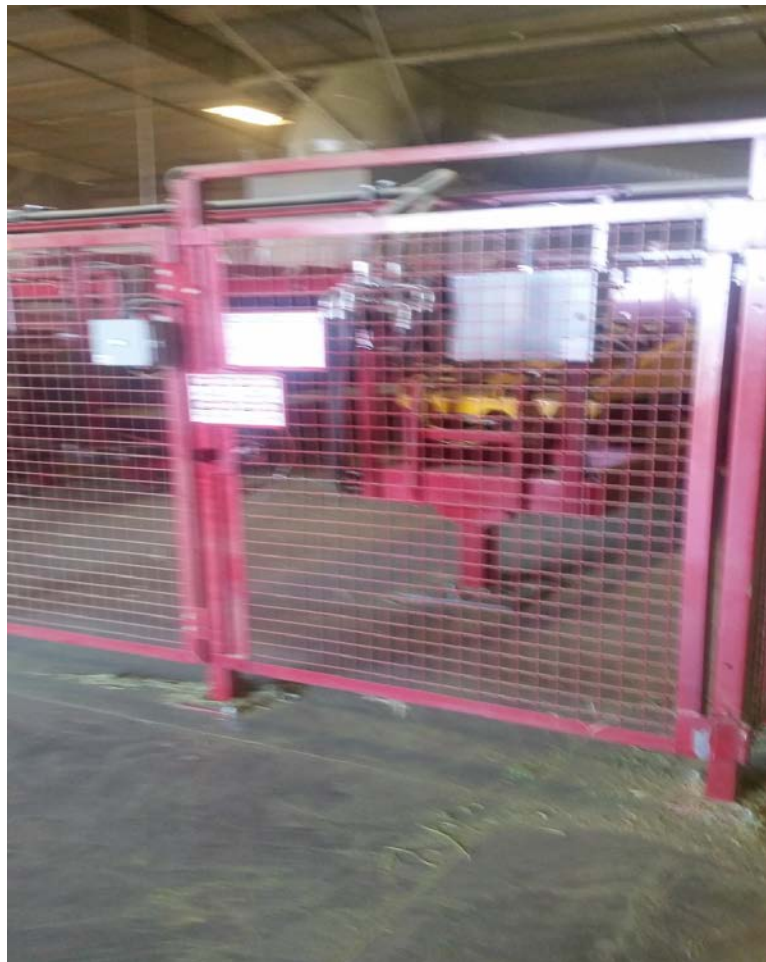
On the day of the incident, the victim was the foreman overseeing the workers feeding hay into the hay baler and removing the finished product. At approximately 5:00 p.m., the victim told the machine operator that he was going to clean the baler with compressed air. The victim likely entered the magazine area through the access gate. It is not known if the victim disabled the interlock sensor so the machine would not shut off when he opened the gate. The machine operator stated that he was at the control panel at the time of the incident, was not aware that the victim was in the magazine area, and that the machine did not shut down at the time of the

Exhibit 7. The gate the victim most likely accessed to gain entry into the restricted area.

Discussion: In this incident, the victim entered a restricted area of the machine while it was in operation. A restricted area is any place in or around a machine or piece of equipment where an employee may be struck or caught between moving parts, or caught between moving and stationary objects or parts of a machine. In this incident, the victim entered through an access gate that is designed to shut the machine off when opened. However, this gate was not designed as, and should not be considered part of a lockout/tagout program. It is possible that the victim bypassed the gate sensor and the machine started spontaneously, or the machine operator did not see the victim and restarted the hay baler at the computer controls. In any event, the access gate should not be construed as the sole means to prevent employees from injury from the hay baler's moving parts.

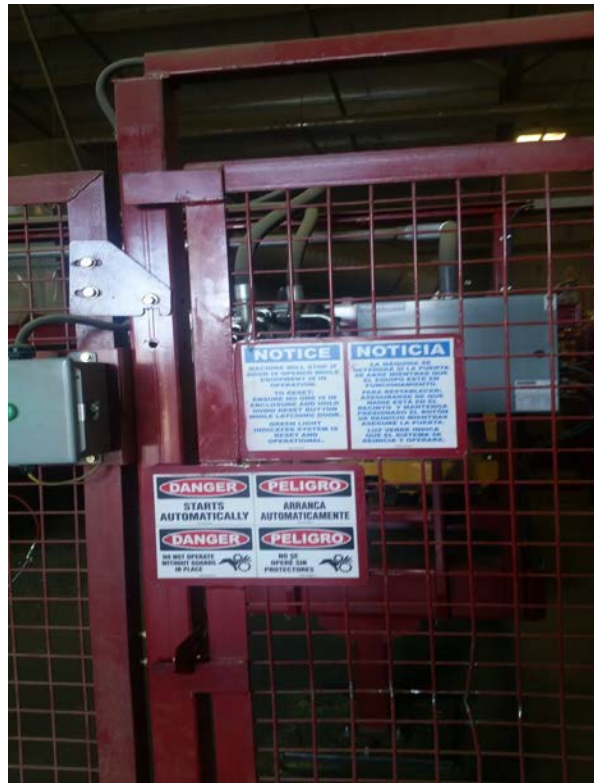
Exhibit 8. The safety signs on the gate.

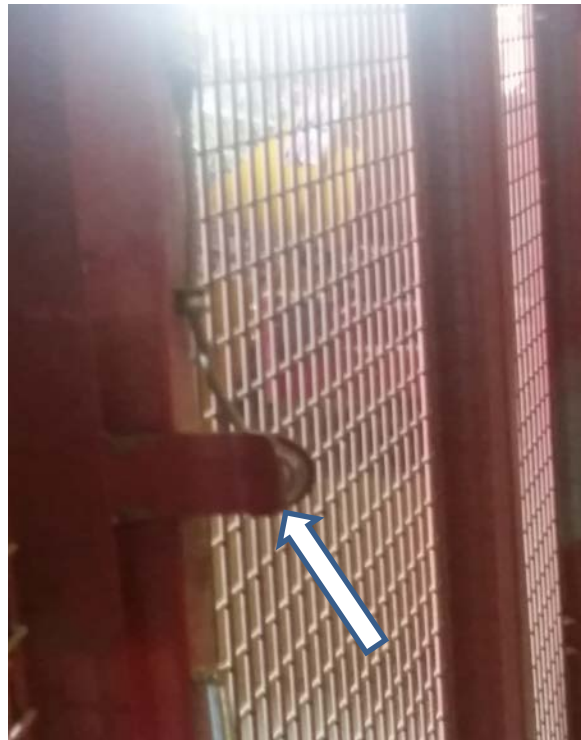
The scene of the incident was a warehouse that houses a hay baler - an automated machine that is designed to take large bales of hay and cut and resize them into a variety of bale sizes and weights. The hay baler is run by an operator who can control the operation of the machine at a computerized panel. A bale of hay is automatically loaded onto the hay baler, where it is resized to customer specifications. The bales are compressed, tied, weighed, and removed for storage and shipment. A magazine kicker arm moves the hay bale to an area for pickup after it has been compressed and tied. All moving parts of the hay compactor, including the kicker arm, were painted yellow to warn of a hazard. Portions of the machine with moving parts, including the magazine area, were enclosed by a six-foot metal enclosure with access gates. The access gates were equipped with an interlock sensor so that the machine would shut off when the gates were opened. The hay baler was installed at the company by the manufacturer.

Exhibit 9. The safety sensor on the gate.
