Tow Truck Driver Struck and Killed by Passenger Vehicle While Securing Disabled Vehicle onto Flatbed Tow Truck

CASE SUMMARY

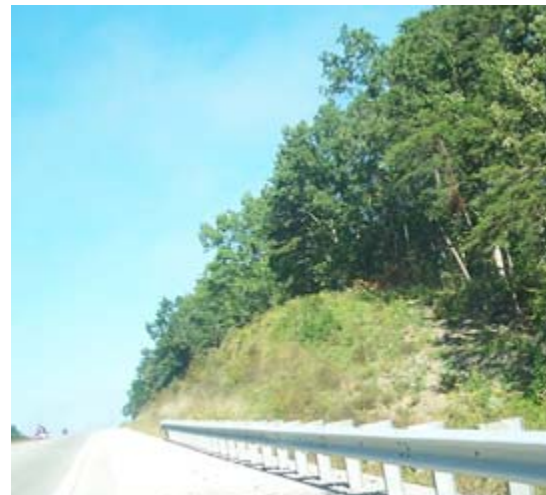
Figure 1. Highway shoulder; approximate location of the collision.

The incident took place on the westbound shoulder of a 4-lane controlled access highway. The highway was divided by a grassy median. The incident occurred on a slight incline. A straight, curve-free stretch of road approximately 1,800 feet in the westbound lane led up to the point of impact. The posted speed limit was 70 mph. It was 10:15 pm and dark outside, and there were no light poles located in the incident area.

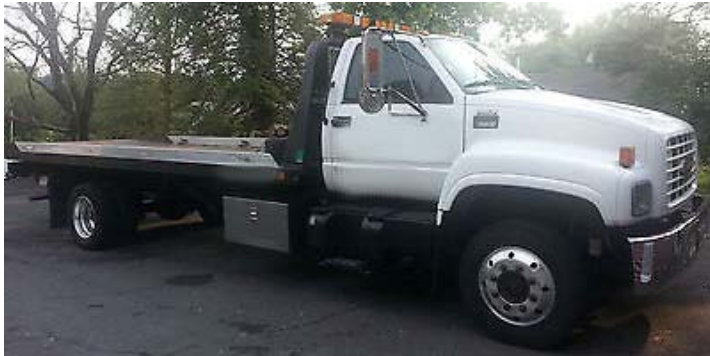
Figure 2. Stock image of flatbed tow truck, a similar model to that which was involved in this case.

The tow truck involved was a 2000 Chevrolet C6500 C Series model flatbed tow truck, commonly known as a “rollback wrecker”.

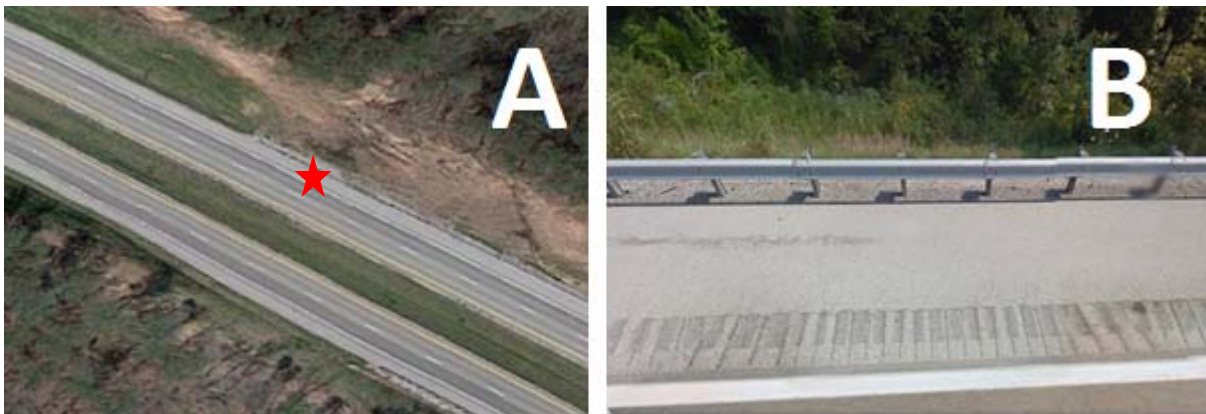
Figure 3: Aerial view of incident scene with a star indicating the approximate location of the incident (A); view of shoulder where the tow truck was parked (B).

- The Dodge Durango driver did not move over as state law requires.
- The highway shoulder was too narrow for tow work to be completed.

At a minimum, law enforcement officers should leave their light bar engaged during the entire duration of the loading procedures. In instances where the tow truck driver is lacking shoulder space to safely work on the traffic-facing side of the tow truck, law enforcement officers should position their police cruisers to temporarily block the adjacent travel lane until towing procedures are finished.
