## Tow Truck Driver Struck and Killed by Van While Entering His Tow Truck

### CASE SUMMARY

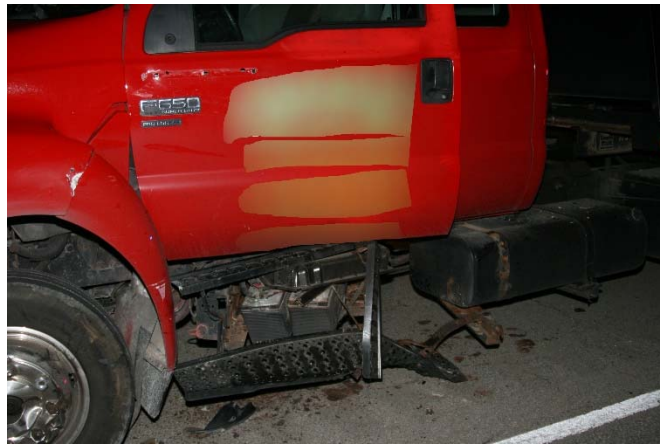
**Figure 1.** Point of impact, driver's side door of tow truck.

### ***Recommendation No. 1: Tow truck drivers should limit the amount of time spent on the traffic-facing side of the truck.***

To reduce the risk of being directly struck by passing vehicles, tow truck drivers should limit their time spent on the traffic-facing side of the truck. There was sufficient room to enter the cab on the non-traffic-facing side of the truck. To further prevent injury, tow truck operators should use the winch controls on the non-traffic-facing side when the tow truck is equipped with dual winch controls. When tow truck drivers must be on the traffic facing side, they should keep an eye on the adjacent lane and any approaching traffic as often as possible.

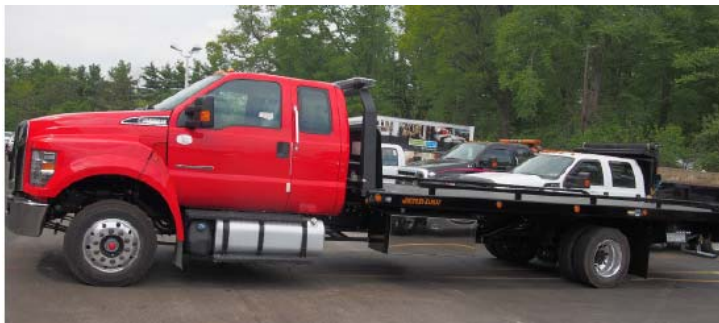
**Figure 2.** Stock image of a Ford F-650 Super Duty Pro Loader tow truck, similar to the one operated by the victim.

The tow truck operated by the victim was a Ford F-650 Super Duty Pro Loader with a rollback design for loading. The light bar was positioned on top of the truck bed, on the side nearest the cab. According to manufacturer's specifications, the rollback wrecker's front-wheel fender-to-fender width measured approximately 8 feet.<sup>1</sup>

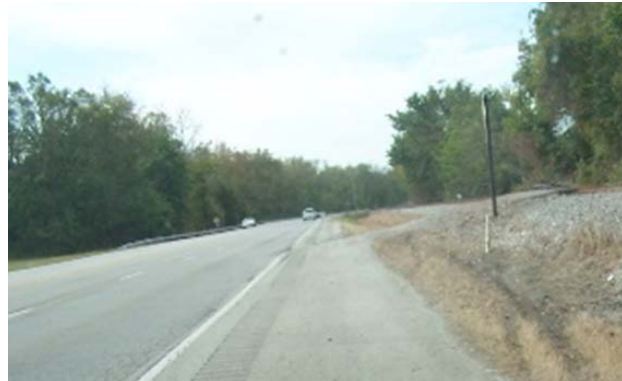
The incident took place on the southbound lane shoulder of an undivided highway (no median). The highway had two lanes in each direction, with a double yellow line separating the two directional sides of traffic. On the outside perimeter of each side of the highway was a shoulder measuring approximately 8.5 feet wide. Running parallel to the southbound lane was a railroad track, which measured approximately 21 feet from the outside edge of the shoulder. Approximately 15-20 feet ahead of the parked tow truck was the entry to a single-lane side-road. The highway was flat and straight for approximately two-thirds of a mile leading up to the incident location. There were no forms of artificial lighting provided in proximity to the incident scene and it was dark at 10:00 pm. The posted speed limit was 55 mph, but witnesses stated they observed vehicles driving approximately 70 mph prior to the incident.

**Figure 3.** Shoulder where the incident occurred.

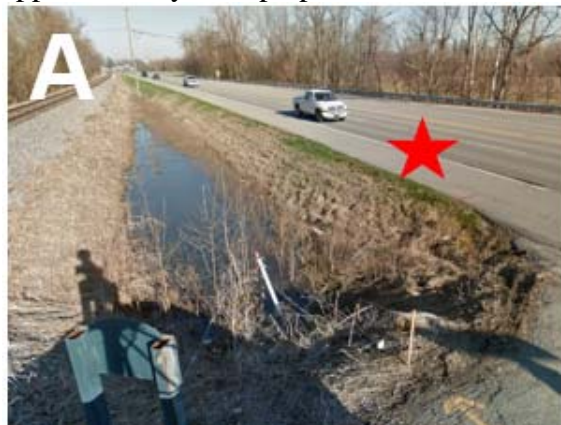
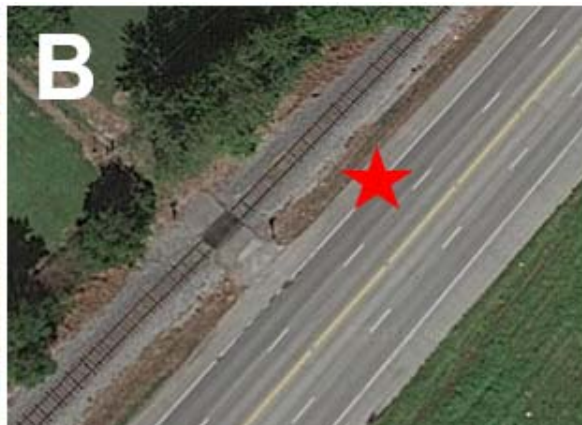
**Figure 4.** A) View of the incident scene from the single-lane side-road entry. B) Aerial view of the incident scene. The red star denotes approximately where the victim was positioned when struck.

On a late fall evening, a tow truck driver (the victim) received a phone call from a stranded driver requesting vehicle towing assistance on the shoulder of a four-lane undivided highway (Figure 4B). Arriving at approximately 10:05 pm, the tow truck driver parked his rollback wrecker on the shoulder directly in front of the disabled vehicle, exited his cab, spoke with the customer, and began loading the vehicle onto the tow truck. It was dark outside, and there were no light poles in the incident area to illuminate the work area. Although it is not required, it is notable that no law enforcement officer was present upon arrival of the tow truck driver, and none was contacted to assist with traffic control. While the light bars on top of the rollback wrecker were engaged, no emergency cones, triangles, or other warning devices were set up to alert approaching motorists of the roadside work being performed. The tow truck driver was wearing an ANSI class 2 reflective shirt and class 3 orange reflective vest—a combination that was compliant at the time with the Manual on Uniform Traffic Control Devices (MUTCD) nighttime visibility standards.

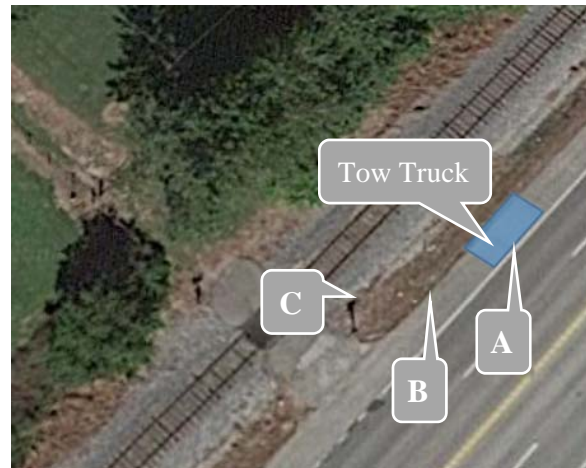
**Figure 5.** Diagram of scene following the incident. A) location victim was standing when struck, B) final resting place of victim, C) final resting place of approaching vehicle.

After securing the disabled vehicle to the bed of the tow truck, the victim, walking on the traffic-facing side of the tow truck, approached the driver-side door and began to enter the cab. Meanwhile, a van, which had been observed weaving back and forth across lanes, approached the victim's location. As the driver was climbing into the cab, the van drifted across the shoulder edge line, and struck both the tow truck driver and the tow truck (Figure 5, point A). The victim came to rest in front of the tow truck on the edge of the shoulder's pavement (Figure 5B), and the van came to rest on in the ditch next to the shoulder (Figure 5C).
