Fatality Investigation Report

OR 2016-16-1

Construction worker killed when trench collapsed

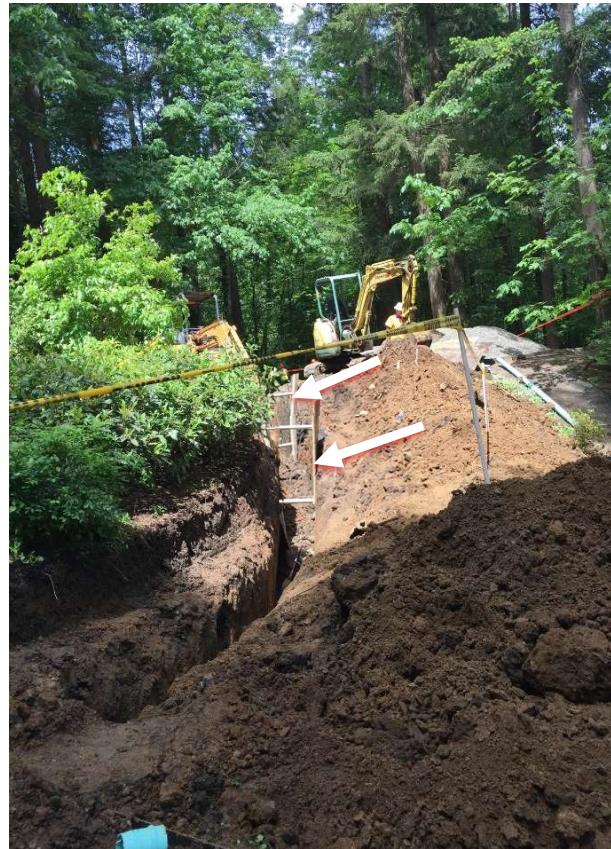
On May 5, 2016, a 29-year-old construction worker employed by a small excavation contractor was killed when the trench he was working in collapsed and buried him in approximately 6 feet of dirt. The worker was part of a crew installing a sewer pipe at a residential property. The trench was 10 feet deep and approximately 3 feet wide in the area where the collapse occurred. The collapse occurred in an unprotected area of the trench, between two pieces of shoring that were spaced 15 feet apart (see Figure 1).

Figure 1. View from front of house: area of incident showing placement of shoring; collapse occurred in between the two pieces of shoring spaced 15 feet apart (indicated by arrows)

The trench collapse occurred when decedent was working in an unprotected area of the trench between two pieces of shoring that were spaced 15 feet apart. The specific task being performed by the decedent at the time of the incident is uncertain. It was reported that he may have been checking the grading of the new sewer line. Other evidence suggests he may have been hand digging a high spot of soil or preparing to put in a pipe connector.

- Trench protective systems may include shoring, sloping, and/or shielding. When shoring is selected as the appropriate protection system, the competent person must implement proper horizontal and vertical spacing, which includes placing the shoring the proper distance apart (in this case, a maximum horizontal spacing of 6 feet for Type C soils). However, the shoring in this case was spaced 15 feet apart (too wide to adequately support the trench wall) and it failed to protect the worker in the trench.

- In this case the competent person reported defaulting to a presumed worst-case soil type (Type C, the least stable type of soil). However, performing a visual and manual test and consulting the tabulated data or the OSHA tables and charts would have provided a better understanding of soil and site conditions including any surface encumbrances and other potential hazards to be mitigated prior to starting work. Making assumptions about site conditions devalues the need for a knowledgeable competent person and increases risk of injury. Further, the maximum horizontal spacing for Type C soil is no more than 6 feet (along with a waler system). The shoring in this trench was spaced 15 feet apart and omitted a waler system.

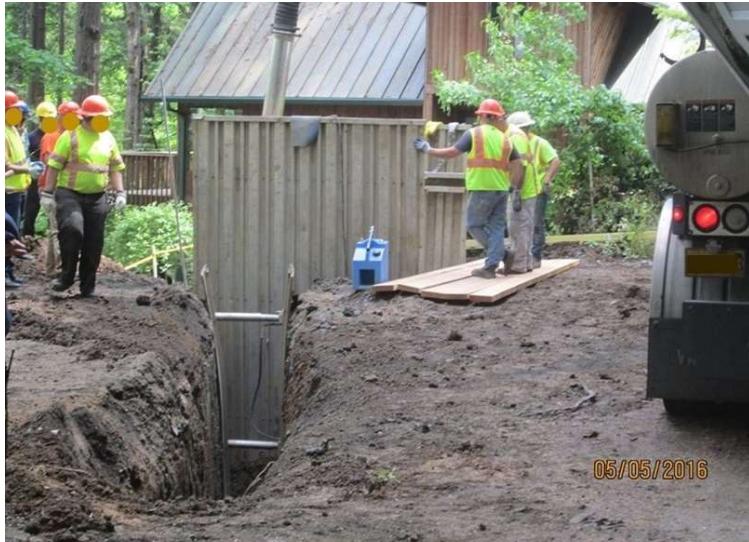
When the trench collapsed, co-workers called 911 and attempted unsuccessfully to locate and dig the worker out. When emergency responders arrived, their first task before commencing rescue and recovery efforts was to shore up the trench to prevent risk of additional collapse and injuries (see Figure 2). Emergency responders spent several hours recovering the worker's body.

Figure 2. Emergency responders preparing to install a trench box before starting rescue and recovery work, to prevent risk of additional collapse and injuries

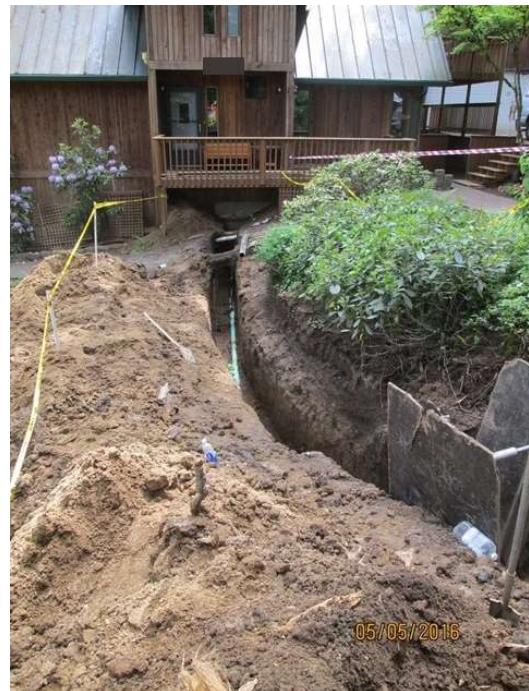
On the day of the incident, the decedent and a co-worker were working in the trench in front of the house (see Figure 3). As shown in the photos, the property was heavily wooded, and soil conditions around the property varied (see Figures 1 through 4). Two pieces of aluminum hydraulic shoring were installed in the trench. The foreman had installed the shoring. Evidence suggests that the foreman was less knowledgeable and experienced than the employer/owner (competent person) in installation of shoring systems. It was also reported that the competent person did not inspect the shoring before work started or during the work shift, as required.

Figure 3. View of trench work area in front of house

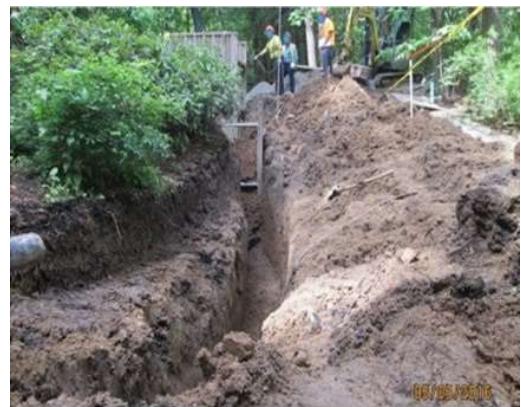
Figure 4. View from house showing trench work area and general soil conditions

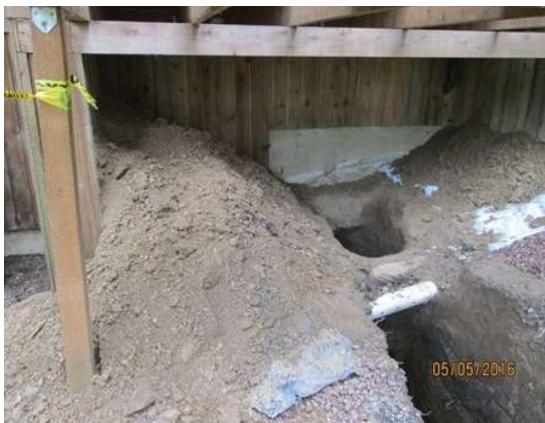
Figure 5. View of work area under deck of house where spoils had been placed at the open edge of the trench

used alternative, safer practices to reduce cave-in risk in this situation. Examples could include use of boring equipment that could eliminate the need for a worker to enter a hole that cannot be protected with shoring or other protective systems.

Another hazard identified was the placement of excavated soil (spoils) on the edge of the trench that was located underneath the deck at the front of the house (see Figure 5). The spoils pile in this location was reported to be approximately 2 to 3 feet high. Spoils piles should be placed at least 2 feet from the edge to prevent creating a surcharge (meaning that it places extra pressure on the trench wall and affects trench stability). Alternatively, retaining devices may be used to prevent material from falling into trench.

In addition, while not specifically related to the collapse, the owner was reported to have said they would have been unable to install any form of shoring in the area underneath the deck (shown in Figure 5). Investigation findings suggest that while this may be the case, the contractor could have

- Placing a load too close to the edge of the trench imposes a surcharge. This means that the spoils increase lateral pressure on the affected zone of the trench, thereby impacting the stability of the trench.
- In this case, the spoils from under the deck in front of the house were placed at the edge of the trench in that location.

- It also is important to consider any obstructions that might hamper the use of standard protective equipment, and to take the time to determine ways to abate any hazards and/or identify alternative safe measures for performing the work. Do not take shortcuts or ignore these conditions. For example, the property in this case was heavily wooded. Per discussion with an OR-OSHA investigator, a large tree root ball in one area of the trench obstructed an area where shoring would have been placed. One possible alternative for an obstructed area could be to use a trench box or shield instead of shoring.

Recommendation #5: Keep excavated soil (spoils) and other materials and tools at least 2 feet from the edge of the trench.
