FATALITY ASSESSMENT AND CONTROL EVALUATION

**A 23-Year-Old Worker Pulled into a Wood Chipper on His First Day on the Job
Case #: 16NY024**

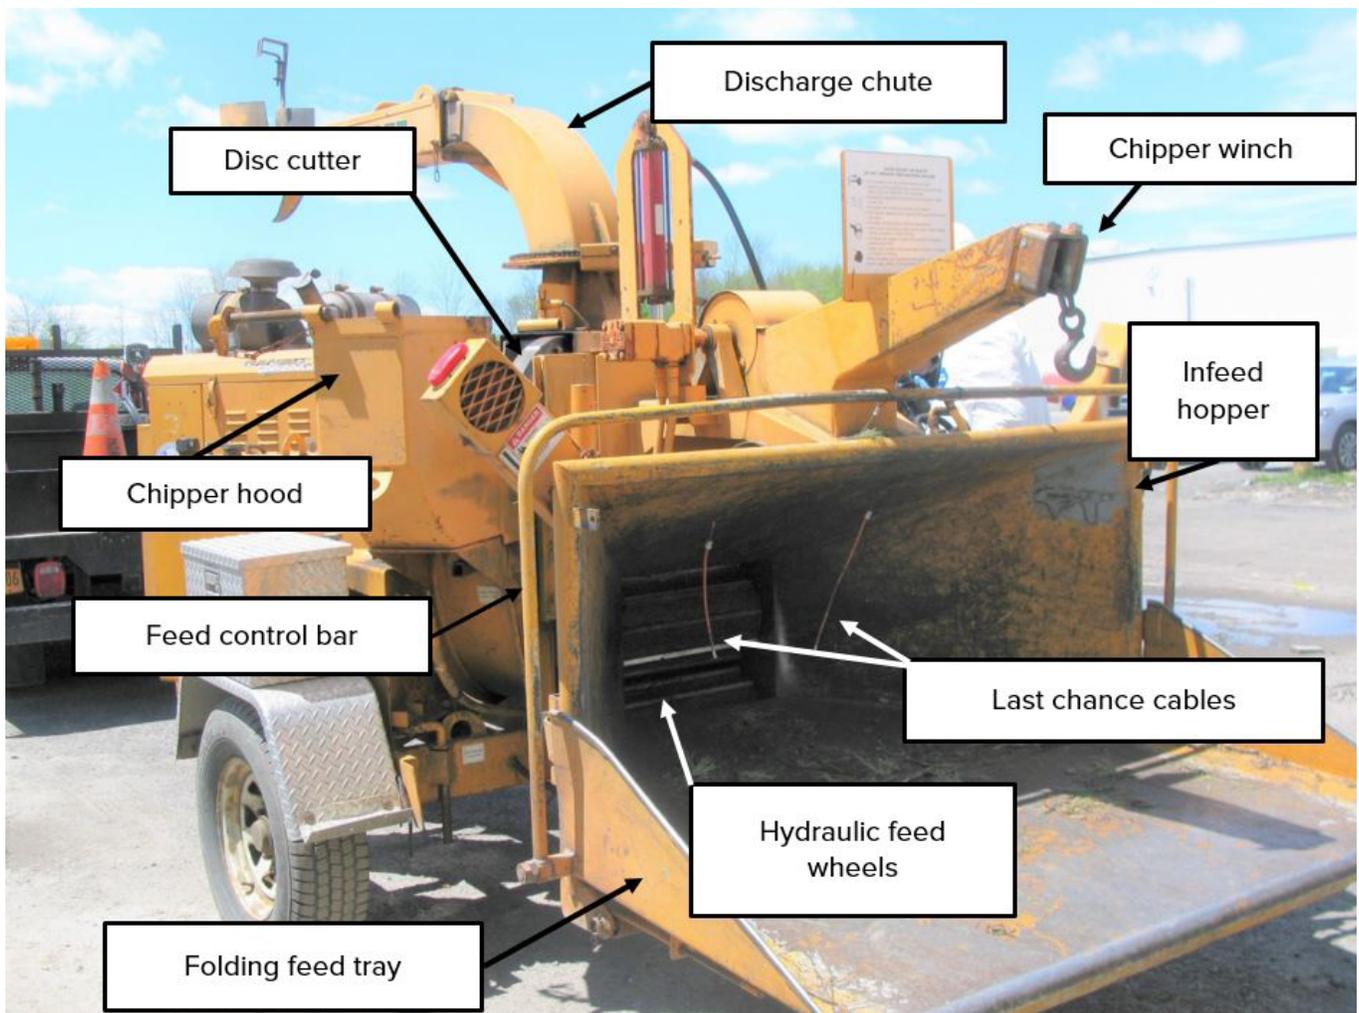
The wood chipper was a handfed disc style wood chipper (Model: Bandit 250, Photo 1) with cutting capacity up to 12 inches in diameter. The chipper consisted of a 110-HP diesel engine, a folding feed tray, a feed hopper, an automatic feed mechanism, a chipping disc, and a discharge chute. The main component of the automatic feed mechanism was a pair of hydraulic horizontal feed wheels located between the infeed hopper and the disc cutter. Tree materials were placed on the feed tray and fed into the hopper until they were caught by the rotating feed wheels. The feed wheels pulled the materials into the disc cutter at a speed of 2 feet per second. With a rotational speed between 1,000 and 2,000 rpm, the disc cutter cut and shredded the woody materials and propelled them through the discharge chute.

The Bandit 250 was equipped with two safety features to control the feed wheels: a feed control bar and two “last chance cables”. The feed control bar was mounted across the top and along the sides of the infeed chute (Photo 1). It had three positions: feed, neutral (off), and reverse feed. A worker could use the control bar to stop or reverse the rotation of the feed wheels during an emergency.

Photo 1. Bandit 250 Brush Chipper that was involved in the incident.

The “last chance cables” were located inside the infeed hopper and pulling them could reverse the feed wheels (Photo 1). The folding feed tray was 19 inches above ground, 30 inches deep, and 60 inches wide (Figure 1). The infeed hopper opening was approximately 36 inches long, 60 inches wide, and 36 inches deep. The last chance cables were 18 inches from the feed wheels.

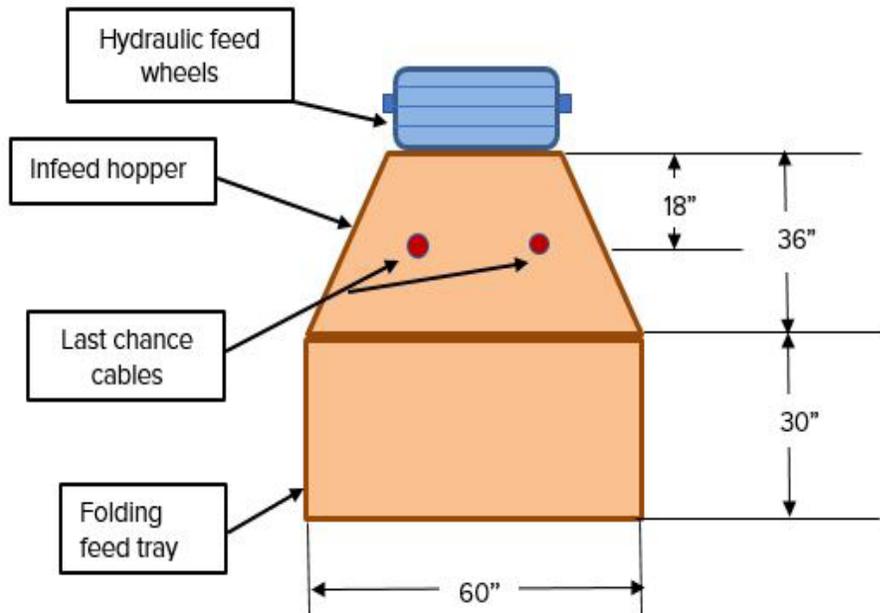
Figure 1. Location of the last chance cables on Bandit 250.

If a worker fed the chipper from the end of the feed tray, the distance between the worker and the feed wheels would be 66 inches. Based on the chipper’s feed speed of 2 feet per second, the time for a worker to be pulled into the feed wheels was approximately 2.75 seconds. When the worker reached the last chance cables, he would have less than a second, 0.75 seconds to be precise, to pull the cables.

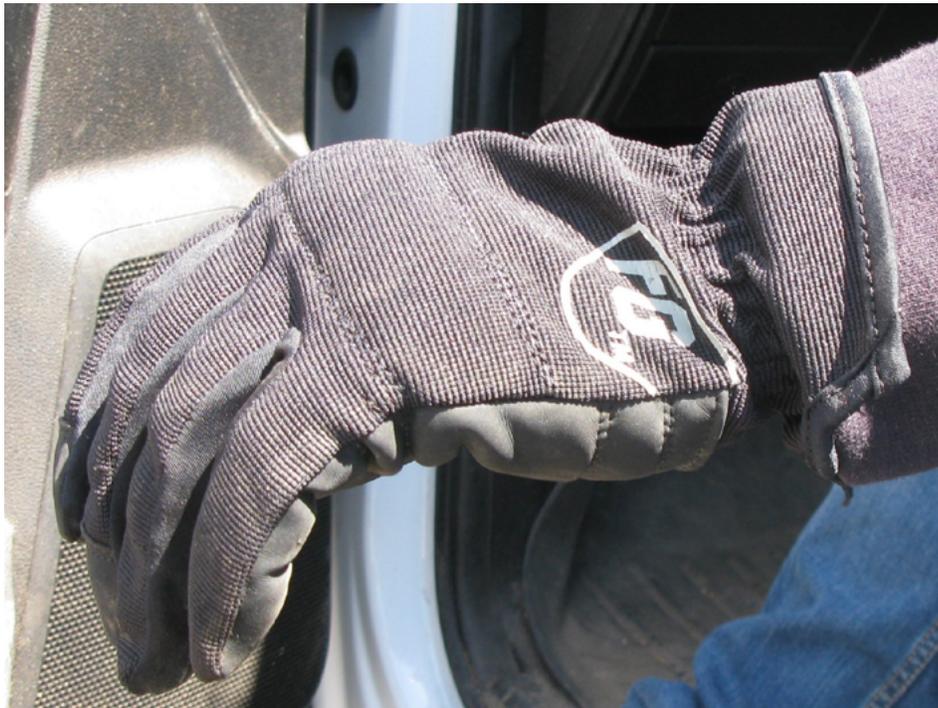
The employer and the four workers along with the crane contractor started working at the first job site around 8 am. The workers were not required to wear any personal protective equipment (PPE), although the employer had hard hats and gloves in his truck that workers could use. The type of gloves that the employer carried were Firm Grip (FG) Utility gloves with loose-fitting short cuffs (Photo 2). The victim was wearing a sweat shirt, jeans,

Photo 2. Gloves provided by the employer with loose-fitting cuffs that may catch branches.

and a pair of FG gloves. He did not wear a hard hat, nor did he wear hearing protection or eye protection.

Discussion: To prevent entanglement hazards, workers should wear close-fitting clothing, gloves and trousers without cuffs, and skid resistant foot wear. Employers should ensure that workers wear the proper clothing and personal protective equipment including hard hats and eye and hearing protection. The gloves that the employer provided in this case had loose-fitting cuffs that could catch branches, although it was unknown whether the victim's gloves were caught.

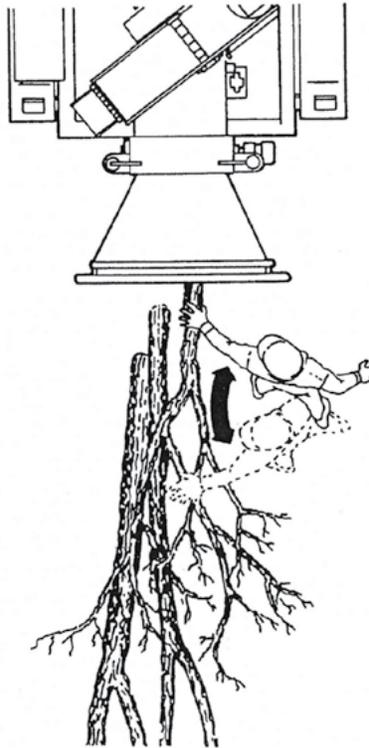
- Feed from the curbside to avoid being struck by road vehicles;
- Stay at the side of the machine when feeding to allow quick access to the emergency shut-off device and minimize risk of entanglement in branches (Figure 2);

Figure 2. Safe feeding pathway: material fed from side, operator walks away immediately following feeding. (Courtesy of Michigan Occupational Safety and Health Administration, Pub OSC-6125).
