FATALITY ASSESSMENT AND CONTROL EVALUATION

Worker Crushed Unloading Steel Waste Container Case Report 16NY066

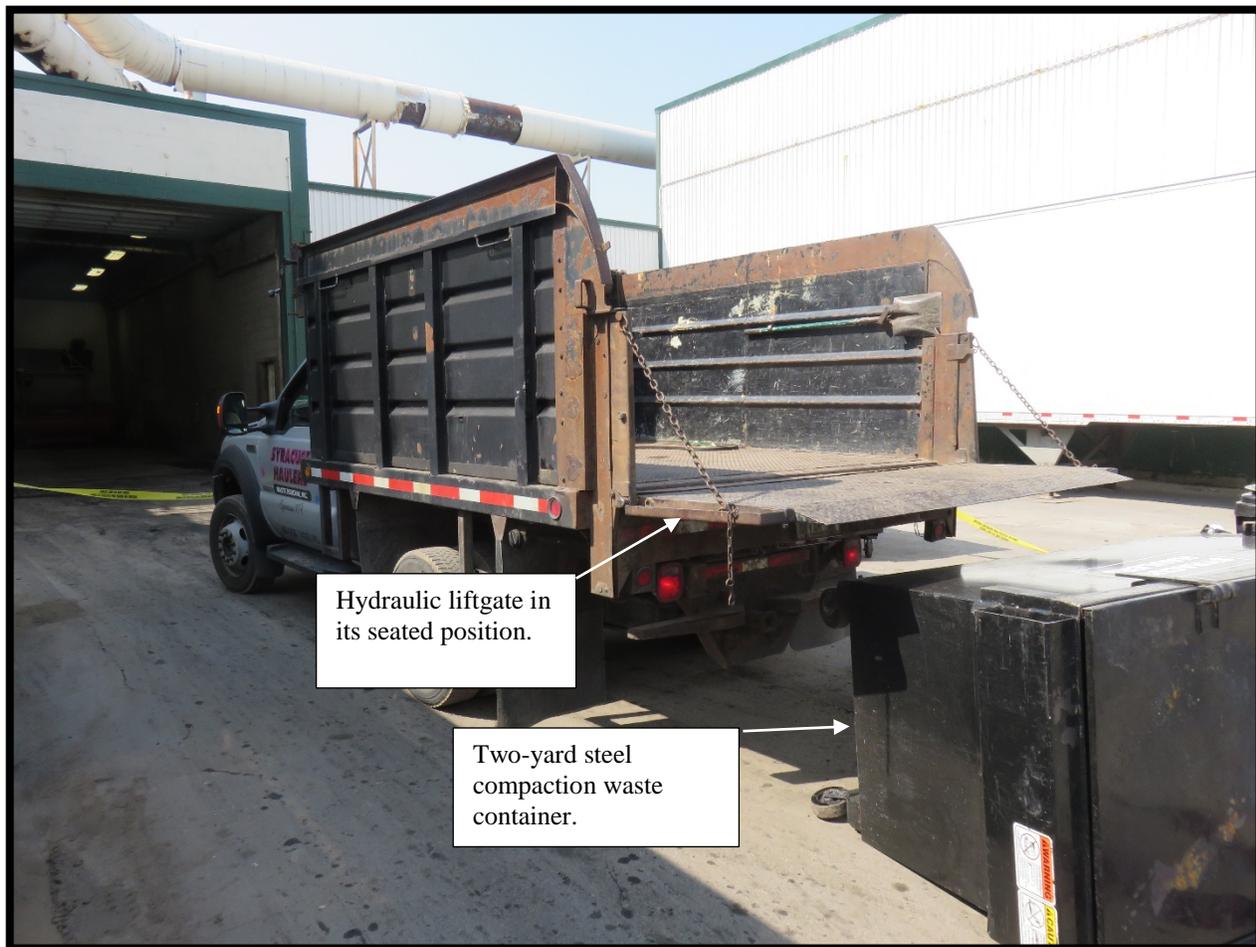
Photo 1. The truck with hydraulic liftgate being used to load and unload containers and the container after falling from the liftgate. (Photo courtesy of OSHA)

On the day of the incident, the driver was bringing the empty container to the wash bay in the back of a Ford 550 dump truck that was equipped with a Tommy Gate hydraulic liftgate attached to the rear of the vehicle (Photo 1). The weight capacity of the liftgate was not available for the investigation, but it is not believed to be a factor in the incident. The width of the liftgate allowed for 12 inches of space on either side of the container if centered. The liftgate was 28 inches deep to the beginning of the bevel which was an additional six inches. The center point of the casters on the container came to the edge of

Since a forklift was not available, the driver proceeded to have the victim to assist him in unloading the container manually. The driver rolled the container and positioned it on the liftgate. From inside the bed of the truck, the driver used one hand to hold the container while using his other hand to operate the toggle switch on the side of the truck that controlled the liftgate. Meanwhile the victim positioned himself on the ground directly below the container to steady it during descent. The driver felt the container begin to move and shouted to alert the victim below to get out of the way. Surveillance video shows that the victim attempted to stop the container from rolling off the liftgate as it fell and crushed the victim. The container fell from a height of approximately 42 inches. The driver moved the container off the victim and ran inside to alert coworkers and call 911. EMS arrived on site and the victim was transported to an area hospital where he was pronounced dead as a result of his injuries.

Discussion: The 900 Lb. waste container with casters was neither strapped nor chocked in this case. Employers should ensure that large, heavy, and unstable containers are restrained and strapped securely to the liftgate. Wheeled containers such as the one in this case should be both strapped and chocked to prevent them from tipping and rolling of the liftgate platform causing worker injury and death.

Discussion: Manufacturers have developed features and mechanisms that make a liftgate safer to operate. A remote control allows a worker to operate the liftgate outside the cargo falling zone. Self-leveling liftgates can keep the platform level and liftgate cart-stops can prevent cargo from rolling off the platform. Employers should consider installing and utilizing these liftgate safety features to enhance the equipment safety so that workers can be better protected.
