REPORT#: 17MI075

Sole Proprietor Falls Eight Feet from Flat Roof While Installing Siding

State **FACE** Program

Fatality Assessment & Control Evaluation

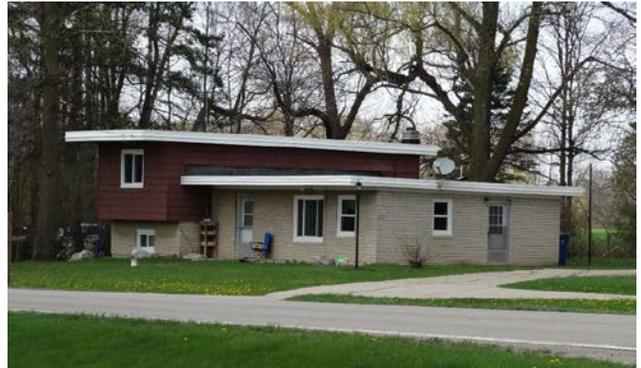
Photo 1. Picture of home where decedent was siding. Decedent working on lower level flat roof.

Firm 1 had been contracted by the homeowner to: remove old aluminum siding from home and install new cedar shake siding to all walls where siding was removed, remove and install 15 Ultimate 2000 windows, and white trim around the windows and on the fascia. The home had two flat roofs, one roof was approximately eight feet high and the second roof was approximately 13-14 feet high. (Photo 1)

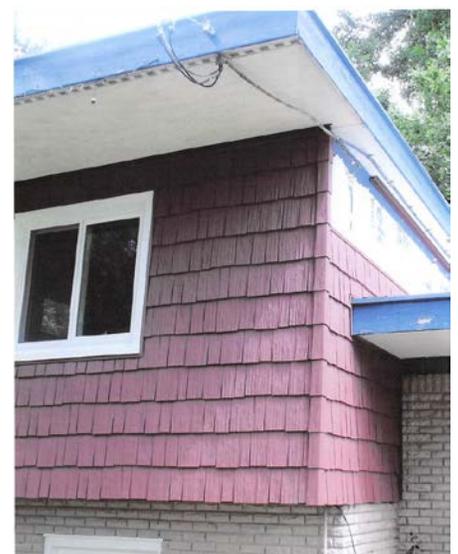
The decedent climbed a ladder to access the lower roof. There was also a ladder on top of the lower roof to provide the decedent access to strip siding and fascia. At the time of the incident, it is believed the decedent was installing siding on the dormer, working on the street side (front) of the roof. (Photo 2)

Photo 2. Lower level and upper level roof. Area of home where siding was to be installed and where decedent was working.

Recommendation #1: Protect workers against falling while working six feet or more above a lower level. This includes, but is not limited to, providing appropriate fall protection utilizing conventional fall protection systems (guardrail systems, safety net systems, or personal fall arrest systems), a fall restraint system, or a written site-specific fall protection plan when conventional fall protection systems are deemed infeasible or pose a greater hazard.
