**REPORT#: 17MI142**

## Farm Laborer Run Over by Tractor With Broken Parking Brake

State **FACE** Program

**Fatality Assessment & Control Evaluation**

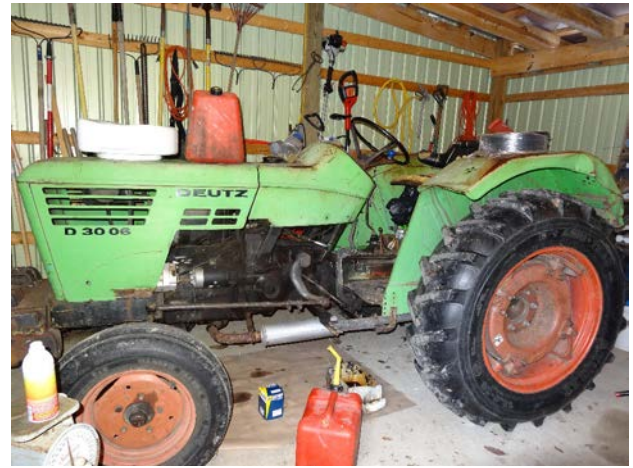
The 4,120-pound tractor involved in the incident was a Deutz tractor, Model D 30 06 (See Photo 1). The year of manufacture was unknown. The owner bought the tractor at a farm auction – year unknown. The farm owner indicated to the MIFACE researcher that the tractor had an emergency brake, but it was non-functional (See Photo 2).

Photo 1. Picture of Deutz tractor operated by decedent. Tractor in storage barn.

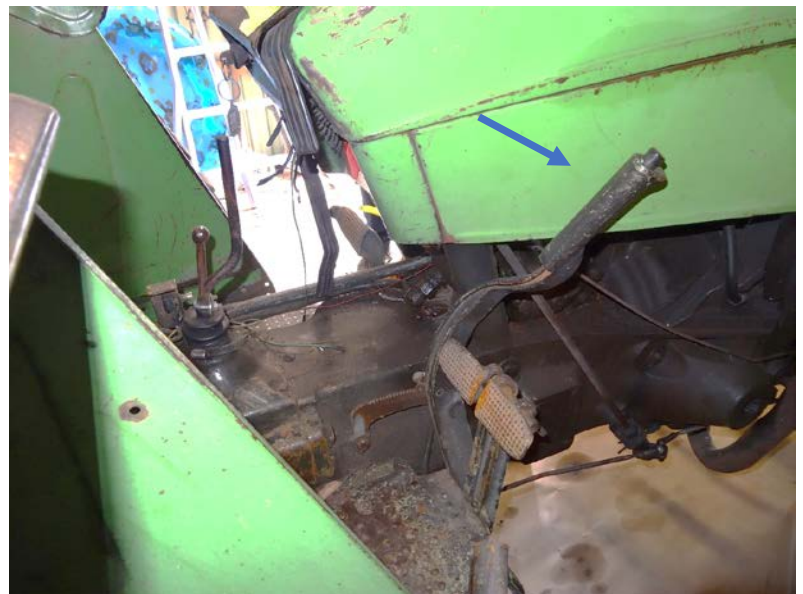
Photo 2. Arrow points to emergency brake identified by owner as non-functional

***Recommendation #1: Owners/operators should inspect and maintain equipment to ensure it is in good operating condition.***

Discussion: Like many farmers, the farm owner used the tractor “because it still worked”. The tractor, although operable, had at least one major safety issue - a non-functional emergency brake. Additionally, the tractor was difficult to start that morning. The inability of the decedent to use the emergency brake to prevent the tractor from rolling was and his presumed reticence for shutting the tractor off prior to dismount were factors in this incident.

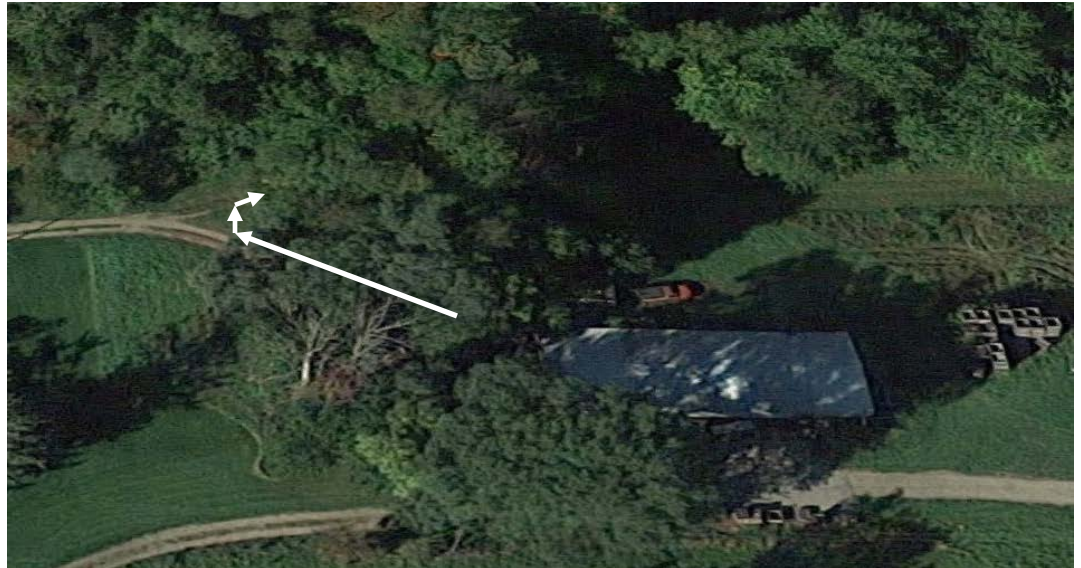
was in neutral gear. Tractor tire tracks indicated the tractor had traveled approximately 12 feet west off the two-track and into the foliage. There were no skid marks in the dirt.

*Photo 3. Google map. Probable path of decedent per farm owner based on tire marks at time of incident.*
