**FATALITY ASSESSMENT AND CONTROL EVALUATION  
PROGRAM (CA/FACE)**

**Laborer Dies of Carbon Monoxide Poisoning  
When He Operates a Gasoline-Powered Concrete Saw Indoors  
Case Report: 17CA001**

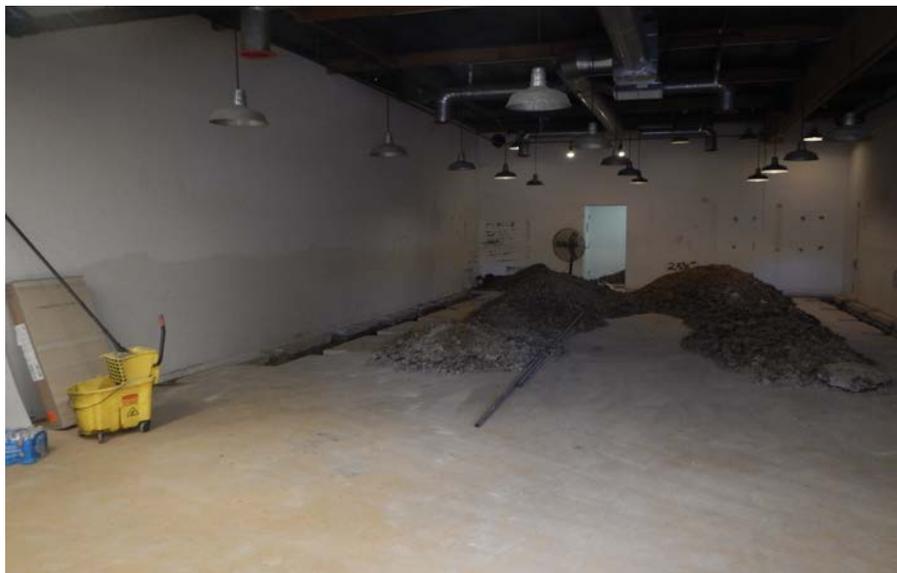
At 4:15 pm an employee of the general contractor arrived at the worksite to pick up the victim. He opened the door and found the victim lying face up in the rear left corner of the store (Exhibit 2). He was wearing his respirator and had fallen backwards while operating the vacuum. The vacuum was running, but the concrete saw had been turned off. The employee called 911.

Exhibit 2: The rear left corner of the store space where the victim died.  
Note: The trenches were dug after the fatality.

The fire department paramedics pronounced the victim dead at 5 pm. The coroner's office later reported that the victim's carboxyhemoglobin level was 69% -- a very elevated level which confirmed carbon monoxide poisoning as the cause of death.
