REPORT#: 18MI037

Tow Truck Driver Died When School Bus Was Struck by SUV

Michigan Fatality Assessment and Control Evaluation (FACE) Program

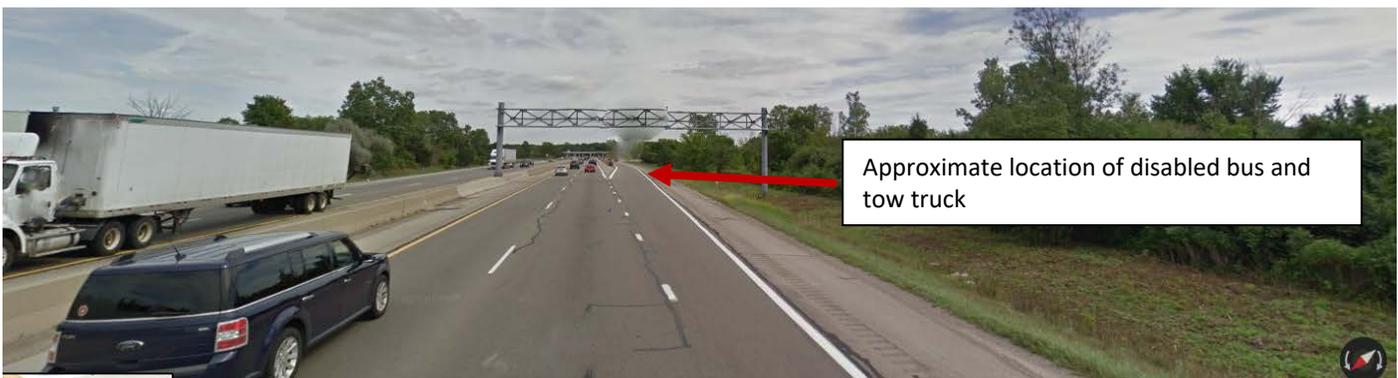
Photo 1. Incident scene. Driving eastbound in right travel lane. Photo courtesy of Google Maps

The incident scene was an eastbound, 3-lane, dry expressway with a posted speed limit of 70 mph. Two expressway lanes were eastbound travel lanes and the far-right lane was the exit lane associated with an exit ramp providing access to another expressway (Photos 1 and 2). The incident occurred mid-morning.

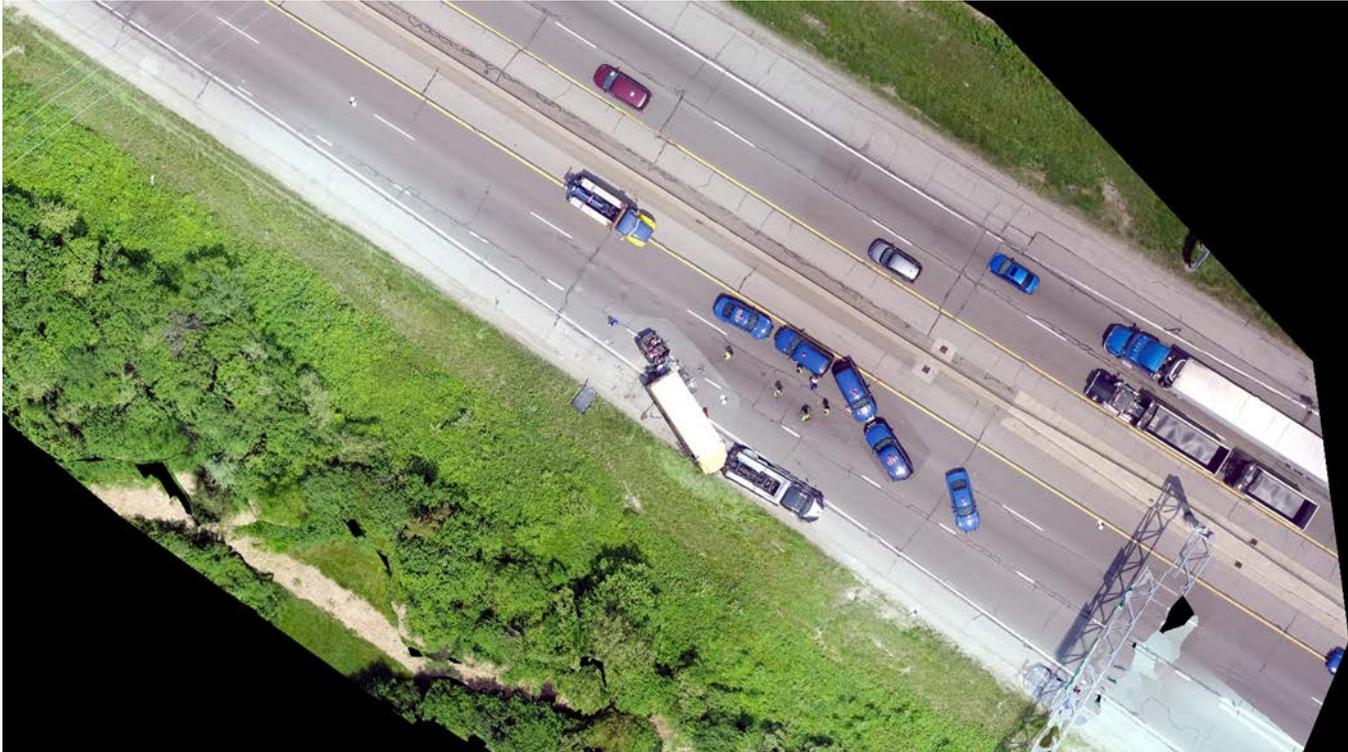
Photo 2. Overhead drone view of incident site showing location of tow truck, bus and SUV. Note tire tracks on outside of shoulder.

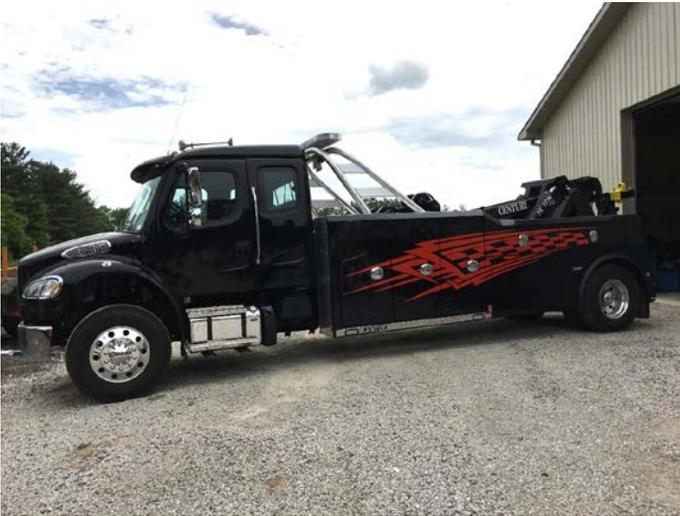
Photo 3. Tow truck driven to disabled bus

The decedent drove the heavy-duty 2018 Freightliner tow truck to the incident site. The tow truck had a 25-ton Century lifting hoist in the back of the truck with a lifting fork that had a 128-inch under-lift. The controls for the lift forks could be operated by remote control or from compartments on the back-right side or left side of the truck (Photo 3). The truck was purchased three weeks prior to the incident. All truck components, including the horn, hoist, tires, cables and hooks, etc., were in good working order and functioned as intended.

When the decedent arrived, he was dressed in a gray t-shirt with logo of tow business, a pair of black safety pants with bright green reflector tape, a pair of black high-top shoes, black socks and boxer shorts. He parked the tow truck approximately 8-10 feet in front (east) of the disabled bus and activated the tow truck's lights, flashers, and emergency lights.

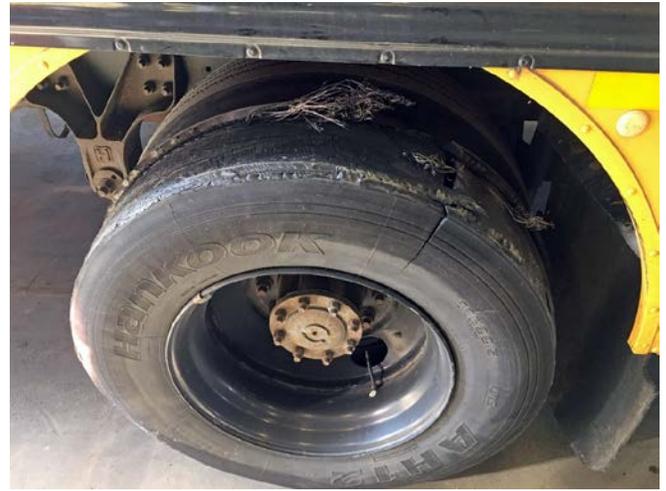
Photo 4. Driver's side outside dual rear tire of school bus causing driver to exit expressway

A school district had eliminated school bus service and had contracted with an outside transportation firm to provide student bus service. The contract bus driver and an aide were returning to the district from another elementary school district when the bus had a blowout of the outside driver's side rear dual tire (Photo 4). The bus driver continued to drive the empty bus for approximately 3 miles before pulling off and parking the bus onto an exit ramp shoulder. The bus was parked completely on the shoulder. The driver set the emergency brake, which was only active on the rear wheels, and activated the flashers. The bus driver called the school district for assistance. The school district called the decedent's employer to tow the bus.

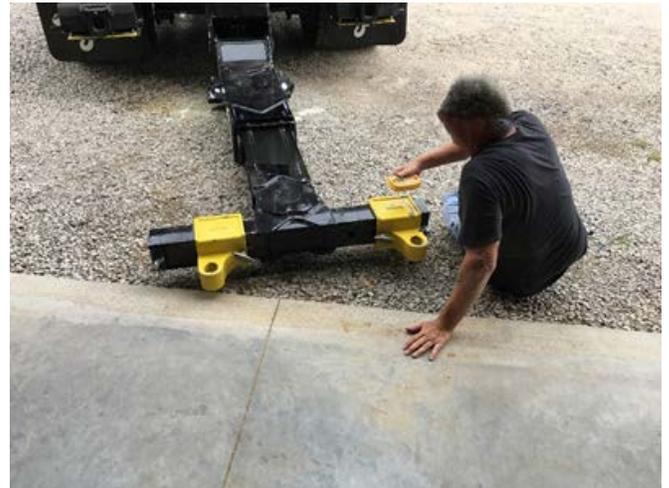
Photo 5. Use of remote to position lift forks

The decedent was lying on the ground under the bus with the remote in his hand when the incident occurred.

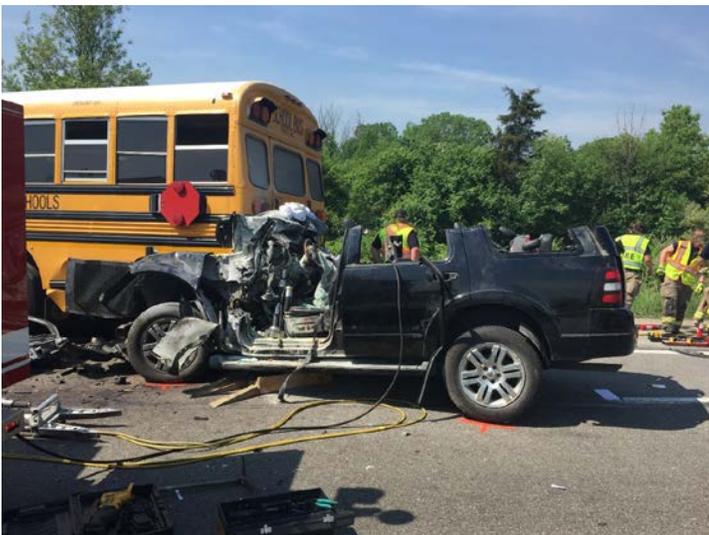
Photo 6. SUV under the school bus, driver's side.

The SUV driver was traveling eastbound in the left lane at a high rate of speed (at least 77 mph). It was hypothesized by witnesses that the driver wanted to exit but was in the wrong lane. Witnesses stated the driver veered abruptly to the right crossing over the two right lanes, and onto the shoulder. The vehicle traveled 4-5 feet off the shoulder onto the gravel and it looked like the SUV was going to go to the right of the school bus, but the driver attempted to correct and re-enter the expressway. The SUV struck and went under the school bus (driver's side) and burst into flames (Photo 6).

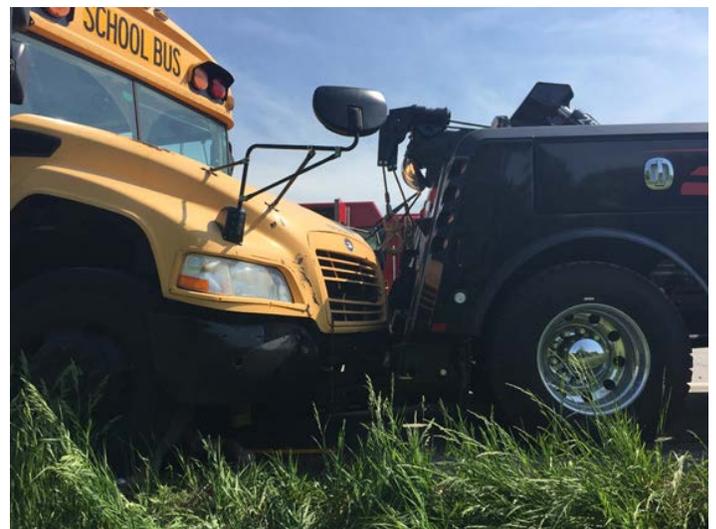
Photo 7. Front of school bus pushed 10-12 feet forward into rear of tow truck.

The force of the impact moved the back of the bus out into traffic and caused the back tires to lift off the ground, which disabled the bus's emergency brake, permitting the bus to be pushed forward 10-12 feet into the wrecker (Photos 7-9). As the bus was pushed forward, it pinned the decedent against the lift fork of the wrecker and the ground. The front passenger bus tire ran over the decedent and the front right spring shackle bolts struck him in the back.

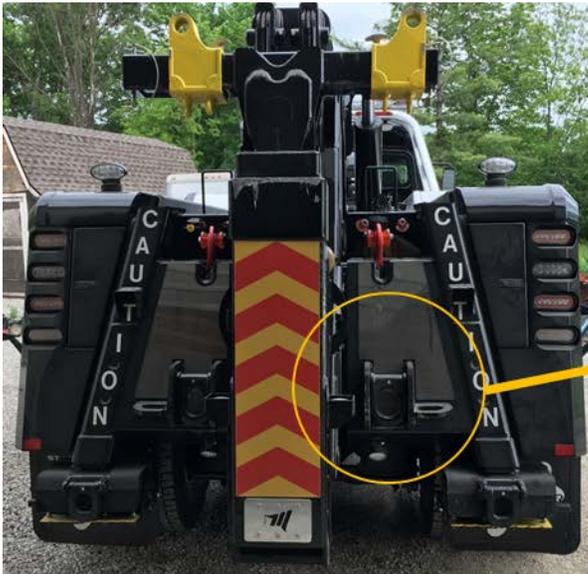
Photo 8. Yellow paint transfer from school bus on rear of tow truck

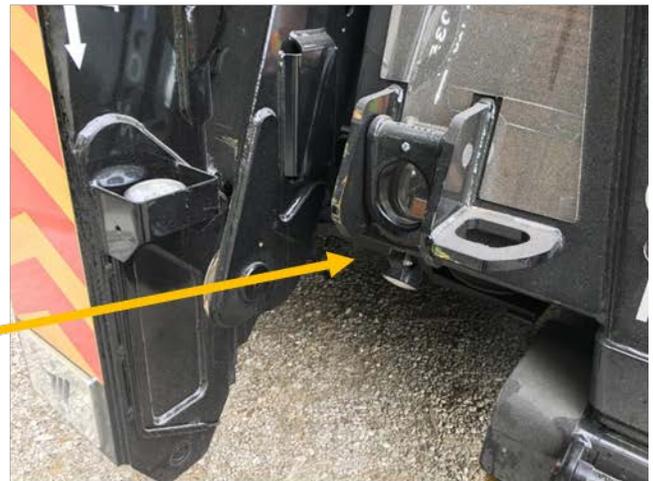
Photo 9. Yellow paint transfer from school bus (Expanded view)

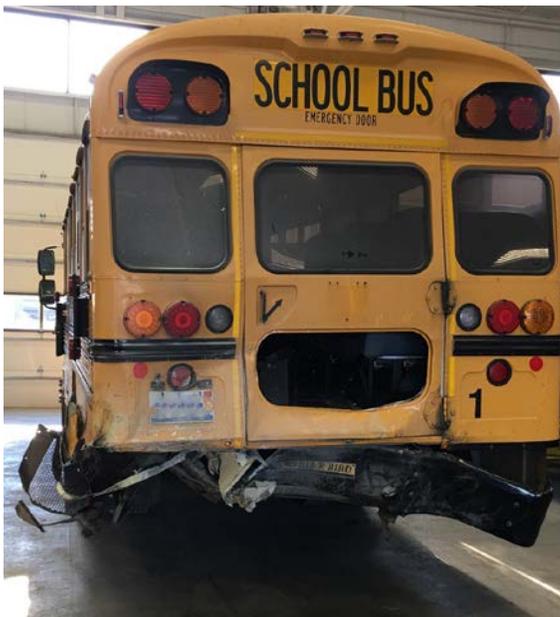
Photo 10. Damage to rear of school bus

The resulting damage to the bus from the collision can be seen in Photos 10-11.

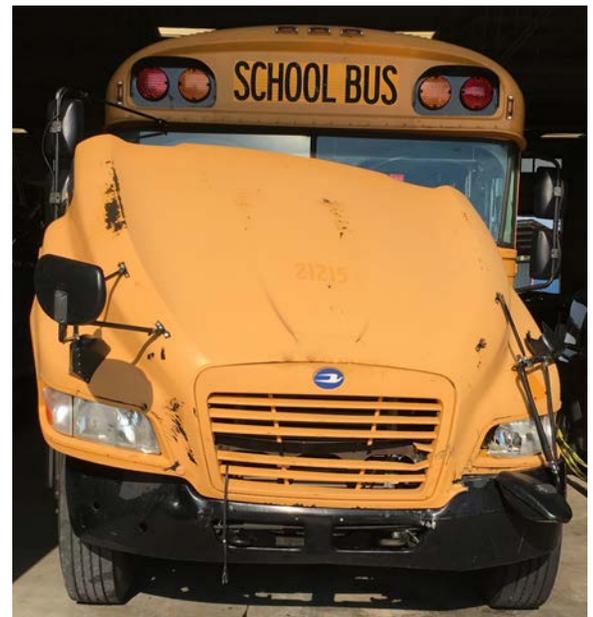
Photo 11. Damage to front of school bus
