**REPORT#:** 18MA022

## Land clearing and forest product company owner overcome by carbon monoxide in hopper of wood chip burning boiler—Massachusetts

## Fatality Assessment and Control Evaluation (FACE) Program

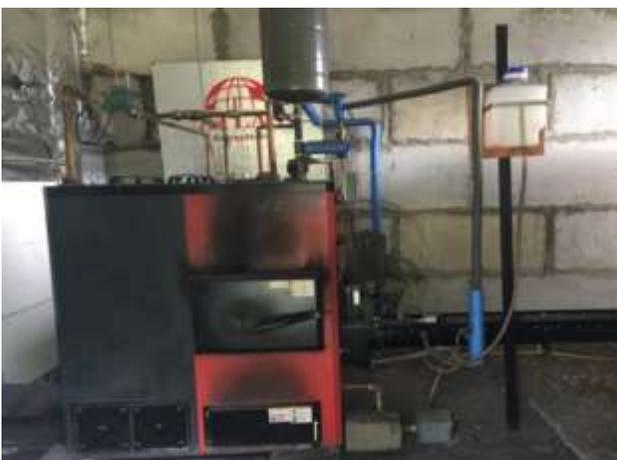
Figure 1 - The boiler/furnace and the auger/conveyor

The equipment involved in the incident was an electrically controlled solid fuel boiler system (Figures 1 and 2). The unit was purchased from a Finland manufacturer through a distributor in Massachusetts and was installed by the victim himself, 18 months prior to the incident, despite cautions about the need for professional installation. It had been used through almost two winter heating seasons. Prior to installing this unit, the company had used an outdoor furnace that could burn large pieces of waste wood such as stumps, roots, and trunks. Because that unit had trouble burning wet wood and needed to be refueled daily, the owner had worked with the equipment distributor to find a better system.

The unit consisted of a solid fuel fired boiler and a computer-controlled fuel delivery system that monitored the burner status and moved fuel from a five cubic yard fuel hopper using an auger/conveyor (Figure 2). The unit was designed to burn manufactured wood pellets, briquettes, or wood chips of limited dimensions of 10-30 mm (<1.2 inches branchless wood). The employer made wood chips on site by processing trees, which were then used for fuel in the system. The fuel hopper was sized to allow for two days of continuous operation. Reportedly the unit routinely was not able to run unattended for two days, did not provide enough heat to adequately warm the workspace it was installed to heat, and had trouble burning chips that were large, irregularly shaped, or dirty.

The wood burning system selected for this company was limited in its capacity, and was installed by the owner, instead by an "authorized professional installer," as directed in the manual. In practice, the system required emptying ash twice a day, rather than once a week, and entry into the fuel hopper to remove oversized wood pieces, every two to three

days, rather than thorough cleaning every six months. The system was too small for the heating desired and was running “harder” than expected. The flue was loose when inspected and the numerous occasions soot was found on the floor may have indicated it was installed incorrectly. The manual advises the connection between the boiler and chimney must be airtight, the combustion chamber must be under-pressured, and chimney sweeping may be necessary. It is possible the flue exhaust was not maintained well, nor operating correctly, and not inspected to ensure it remained open and operational.

According to the installation specifications, the shed building housing the unit was supposed to have a “compensation air hole” sized 1.5 times the chimney size, which would have allowed outside air into the building and apparently was not included in the design of the building.

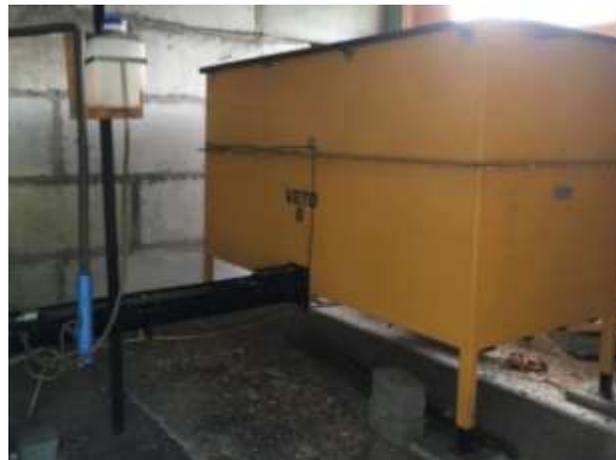
Figure 2 - The hopper and wood chip auger/conveyor

According to the manufacturers' manual the fuel hopper was 7'9" tall and the auger axis was located at the bottom of the hopper. Temperature sensors along the auger and an automated fire suppression system helped to ensure fire did not spread out of the burner and back to the fuel source. The fuel hopper was also sealed tight to help ensure the wood within the bin would not combust.

The auger that advanced the wood chips ran from the bottom of the hopper to the burner. Two metal agitators or stirrer disks were mounted on the floor of the hopper and would help the wood chips flow into the trough and be pushed by the auger (Figure 3). The manufacturer's instruction manual indicates that the fuel hopper should be cleared of possible obstacles weekly and also that these two disks should be removed every six months so debris that accumulates under the disks can be cleared.

Discussion: A decal on the fuel hopper specifically warned about carbon monoxide hazard and cautioned that work should be done in pairs, but did not specifically label the hopper a confined space. Operation routinely required entry into the hopper to clear jams caused by large wood pieces every two to three days. The manual advised cleaning every

six months, removing the agitators/stirrer disks, at the bottom, to remove debris that collects under the gears. A ladder was needed to gain access to the fuel bin which indicated restricted entry and exit.

In this case, the manufacturer was aware of the hazard of carbon monoxide accumulation in the hopper and included multiple warnings about the hazard in the user manual and on the hazard decals on both the boiler and fuel hopper. Further implementation of PtD concepts by the manufacturer may have built in local exhaust ventilation and/or air quality monitoring within the hopper that could provide protection to the users of the equipment. An operating carbon monoxide detector on the unit may have prevented this death. The additional safeguard of a detector that could activate a local ventilation system would be even more effective.

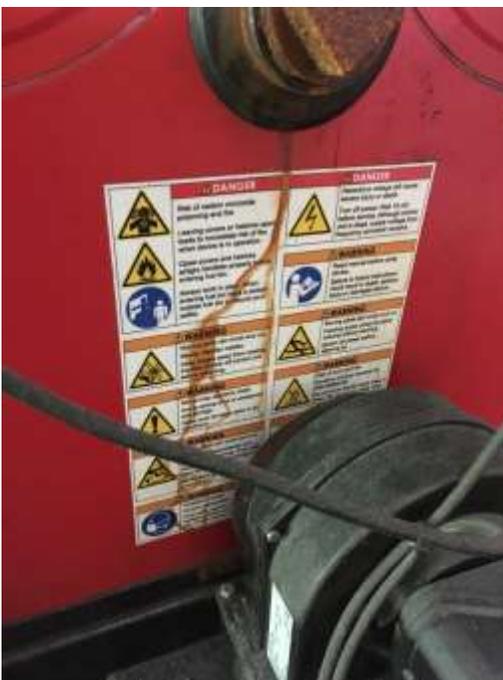
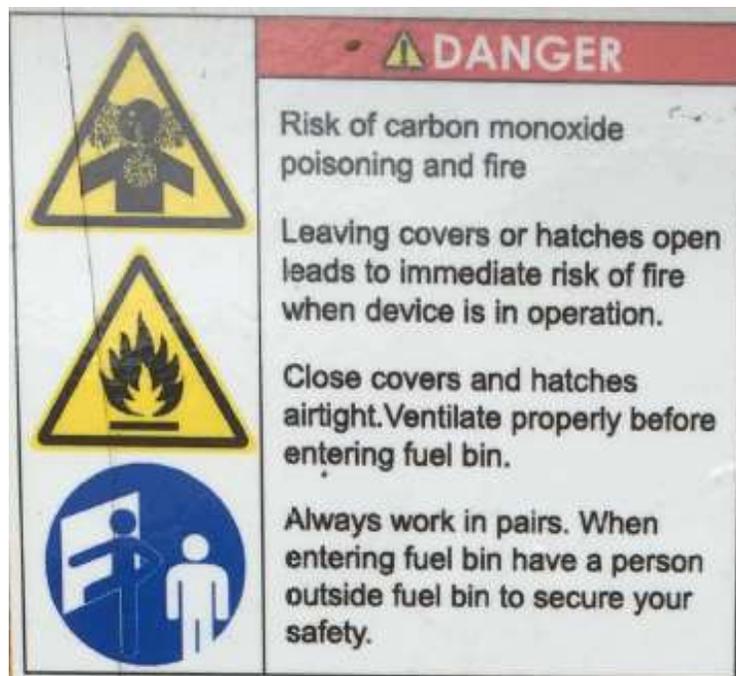
Figure 5 - Warning decal on the boiler/furnace and image of warnings listed on the decal on the boiler and on the hopper.

Discussion: OSHA recommends posting a warning sign, “DANGER – PERMIT-REQUIRED CONFINED SPACE, DO NOT ENTER.” The colors and symbols should conform to the U.S. standard ANSI Z535 which describes colors and graphic symbols to communicate hazards. The equipment was manufactured in Finland, and warning labels were present on both the boiler and the hopper, consistent with the international ISO 3864 symbols. The label on the boiler included more than a dozen warnings that were partially obscured by the auger/conveyor connection. The label distinguished between red banner danger and orange banner warnings. Despite the labels, the hazards posed by this equipment were underestimated. The listed dangers included the risks of CO, fire, high voltage and the need to work in pairs, and also highlighted closing covers for fire prevention and ventilating before entering the fuel hopper. The remaining warnings included three cautions about rotating and moving parts (blower impeller, feeding screws, and springs in the burner and fuel bin) that can crush and cut, the need to shut off the device before servicing, the risk of the lid suddenly shutting, health effects of inhaling dust particles, risk of burns and fire, waiting periods after shut-off for electrical and heat purposes and the need to read the manual prior to operating. Some of the cautions are incomplete and appear to be in contradiction with each other. This hazardous heating system required ash removal from the boiler twice daily and entry into the fuel hopper to clear wood pieces every two to three days. There were no detailed standard operating procedures developed for work with this equipment. There was no warning that specifically labeled the hopper a permit required confined space. The multiple warnings were confusing in their detail and did not provide guidance about the correct methods to use.

The fuel hopper was not explicitly labeled as a confined space by the manufacturer or the employer. This may be due to the device being designed and manufactured in Europe. But the warning decals and operator's manual described hazards and procedures consistent with confined spaces. The user manual for the boiler unit and hopper indicates that two workers should always be present when the hopper is entered for service. The label cautions that there is a risk of carbon monoxide poisoning and that work should be performed in pairs. In this situation, the victim had entered alone, using a ladder to access the interior of the fuel hopper because it had a wall height nearly eight feet off the floor, demonstrating restricted entry and exit. Also, the fuel hopper posed a risk of engulfment from the loose wood chips and a risk of a hazardous atmosphere (carbon monoxide), meeting the definition of a permit-required confined space. The employer should have recognized these hazards as meaning the hopper was a confined space, and thus developed a written permit confined space program, informed employees, and provided training. In addition, the employer should have posted a permit-required confined space sign on the hopper. Untrained rescuers are also at risk of being overcome by a hazardous atmosphere while trying to aide or rescue an affected person. The presence of permit-required confined space should include notification of all employees regarding the risks of unprepared rescue.
