REPORT#: 18MA031

Laborer Dies While Clearing Snow After a Blizzard—Massachusetts

Fatality Assessment & Control Evaluation

Massachusetts Department of Public Health

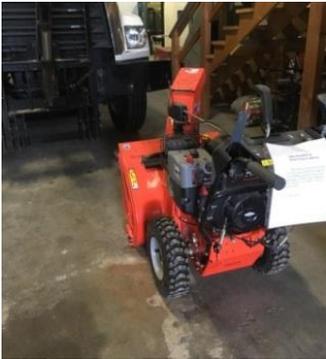
The equipment being used by the victim at the time of the incident was a snow blower (Figure 1). The snow blower was manufactured in 2015. The snow blower operator's area was equipped with multiple controls. Starting at the left side of the operator's area was a heated handle with an integrated traction drive clutch lever, a chute control, electric start, deflector control, speed selector, and the heated right handle with an integrated clutch lever. The snow blower has a 16 inch diameter steel auger, a 28 inch clearing width, four cycle gas engine, and 16 inch wheels. The overall dimensions were 61.5 inches long by 30.5 inches wide by 45 inches high and it weighed 318 pounds.

Figure 1 - Snow blower used at the time of the incident

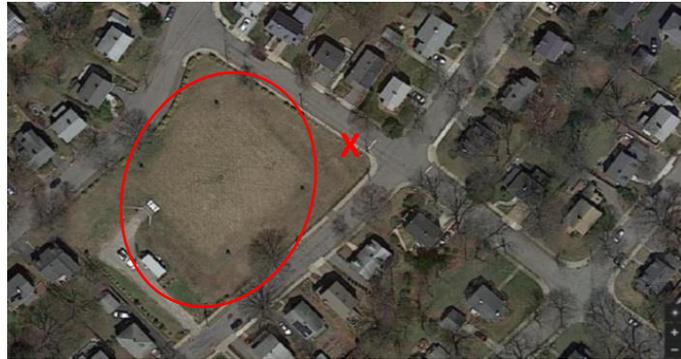
Figure 2 - Aerial view of the underground water tank location (red circle) and location where the victim was found (red X)

The incident occurred at an underground water storage tank located in a residential neighborhood (Figure 2). The area of the underground tank is owned and maintained by the authority. The tank capacity was two million gallons and the storage tank is higher than the ground level, but it is covered with grass. The property is enclosed by a chain-link fence and there is a small building on site that houses pump and electronic equipment. There is a gated driveway that leads to this building. Three sides of the property are boarded by streets with sidewalks. The fourth side of the property abuts a residential building. The sidewalks are about two feet wide and in many locations the sidewalks are buckled due to tree roots (Figure 3). The incident occurred on a section of the sidewalk.

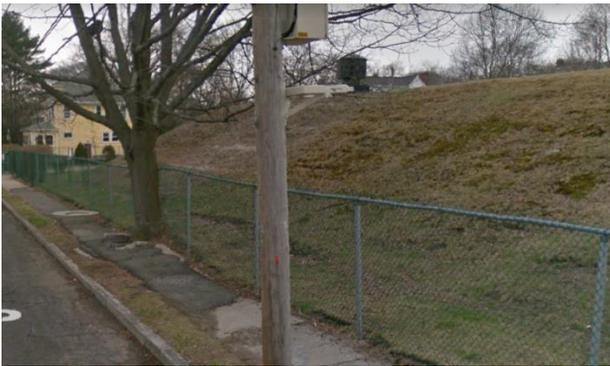
Figure 3 - One of the buckled sidewalk sections

Discussion: Employers can potentially help decrease the risk of acute cardiac events through a combination of scheduling tasks and work breaks, equipment (and chemical) selection and well maintained worksites. Early morning hours, abrupt changes in physical effort and extreme cold air are all associated with increased risk of sudden cardiac events.^{2,3} In this case, the incident occurred at approximately 3:45 a.m. and it was well below freezing. The snow blowers being used were relatively new units that were well maintained. The property where the incident occurred was overall in good repair except for the sidewalks. With the sidewalks being in disrepair, this potentially contributed to making the snow removal process unnecessarily more labor intensive.

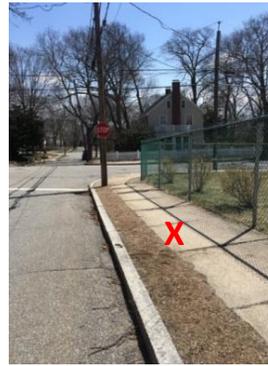
The workers then loaded the snow blowers onto the pickup truck and traveled to the next authority owned location, the incident location. The victim started at the far end of the property and started to clear the snow on the sidewalk while the co-worker remained in the driveway area. The victim had cleared a little more than half of the section of sidewalk when at approximately 3:45 a.m. he suffered a myocardial infarction and fell to the ground (Figure 4). A person who lived across the street from where the victim collapsed found the victim and immediately placed a call for emergency medical services (EMS). Within minutes of the placed call, the police and EMS arrived. The victim was transported to a local hospital where he was pronounced dead.

Figure 4 - Location where the victim was found (red X)

In this case, the victim was paired with a co-worker who was also at the worksite. At the time of the incident, the co-worker was located on the other side of the property, which made the victim outside of the co-workers view. Consequently, the victim's cardiac event and subsequent collapse was unwitnessed and CPR efforts were delayed.
