## FATALITY INVESTIGATION REPORT

### Maintenance Mechanic Dies After Being Burned by Hot Boric Acid Solution While Removing Pump

**REPORT #:** 52-43-2018

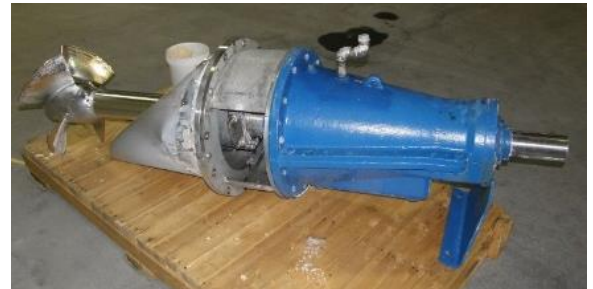
**Photo 1** Recirculation pump, removed from housing.

The plant's boric acid evaporation system had been designed, engineered, and installed by an outside contractor approximately eleven years prior to the incident. The 150 HP recirculation pump (photo 1) used to circulate solution in the boric acid evaporation system had been installed at the same time. It was typically removed 1-3 times a year for maintenance. At the time of the incident, it needed to be removed to repair an oil leak.

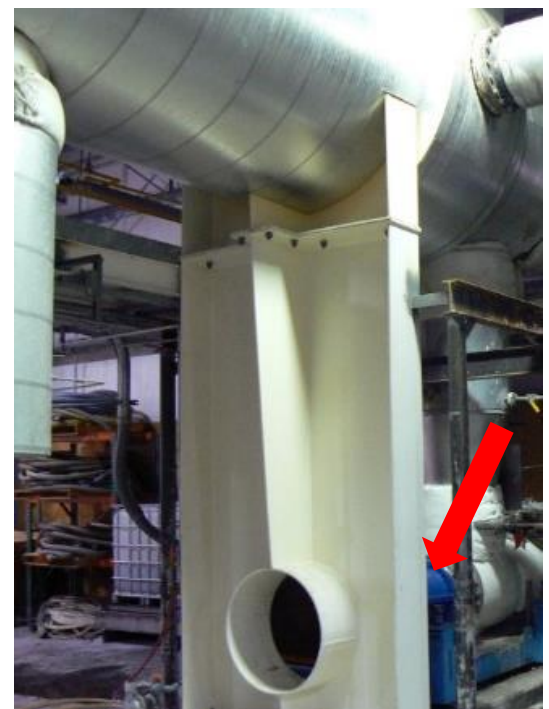
**Photo 2** Recirculation pump location behind heat exchanger support column.

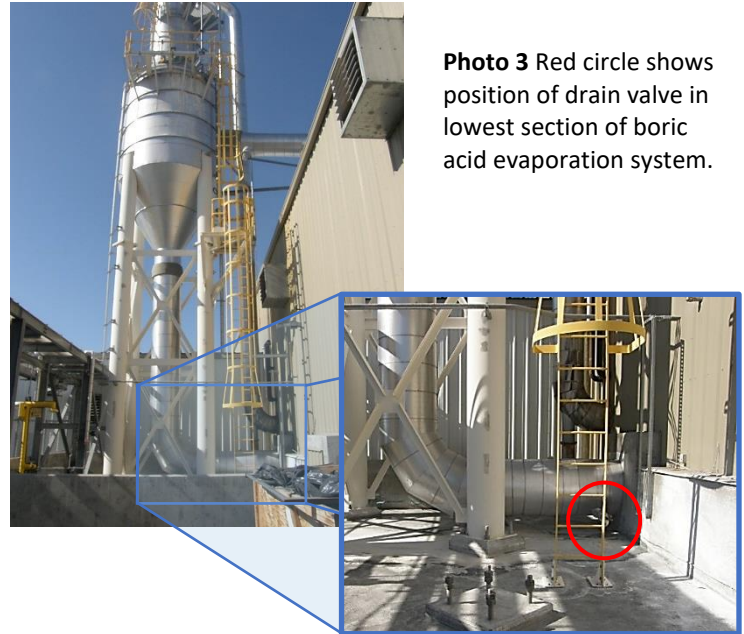
**Photo 3** Red circle shows position of drain valve in lowest section of boric acid evaporation system.

Environmental crew workers reported that they had completed draining the system the night before the incident and checked to make sure that draining was complete. This check was done by confirming that no more solution was flowing out of the lowest ball valve in the system (photo 3). A worker ensured that boric acid solids were not blocking drainage by inserting a metal rod into the valve opening. There were no devices to measure the actual volume of fluid that had drained from or remained in the system.

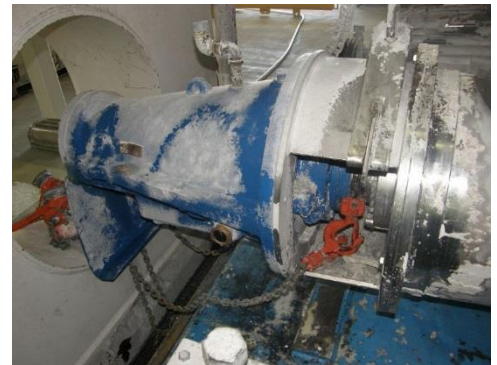
**Photo 4** “Come-along” lever pullers attached to recirculation pump.

When the victim and his co-worker initially attempted to remove the recirculation pump from its housing, it would not come loose. Four other employees were in the vicinity, and two came over to help. They attached two 1.5-ton manual lever pullers, or "come-alongs" to the sides of the pump (photo 4). The victim stood next to the pump and in front of the support column (photos 5 & 6). When they began to pull using the come-alongs, the pump loosened and a small amount of boric acid/ water solution sprayed out from around the pump housing. Workers reported that it was not unusual for a

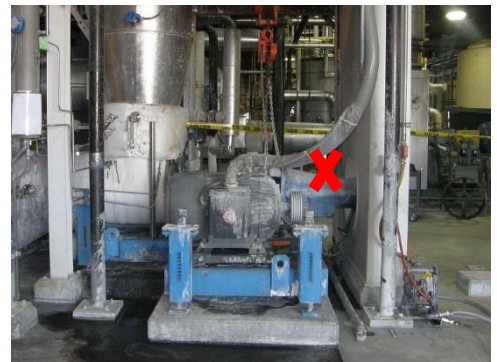
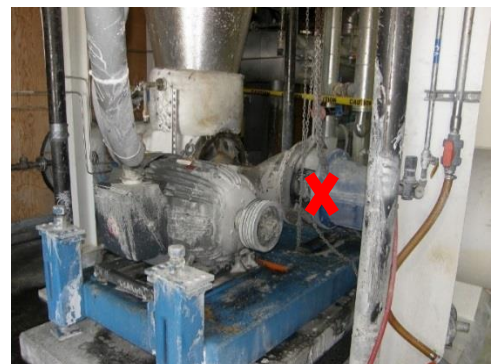
**Photos 5 & 6** Red Xs indicate the approximate position of victim at time of incident.

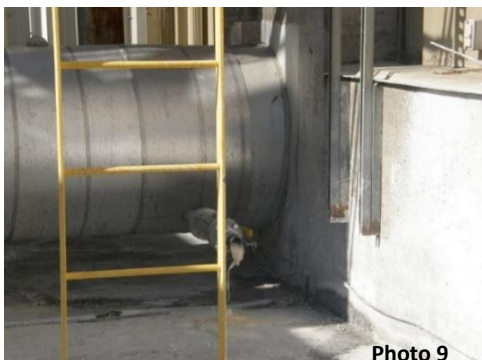
Photo 9

**Photo 9** Boric acid evaporation system drain valve at time of incident.

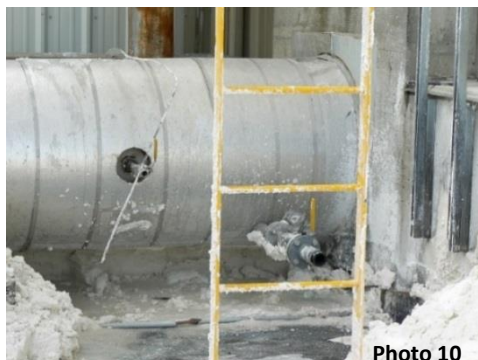
Photo 10

**Photo 10** New sample port installed post-incident above drain level.

An additional sample port was installed above the level of the drain valve that had been used to determine if the system had drained completely. The new valve was designed to be located high enough that it would avoid getting clogged with boric solids and workers could more accurately test if all of the solution had drained (photos 9 & 10).
