FATALITY INVESTIGATION REPORT

REPORT #: 52-44-2018

A Boat Maintenance Crew Supervisor Dies of Carbon Monoxide Poisoning While Using a Gasoline-Powered Pressure Washer

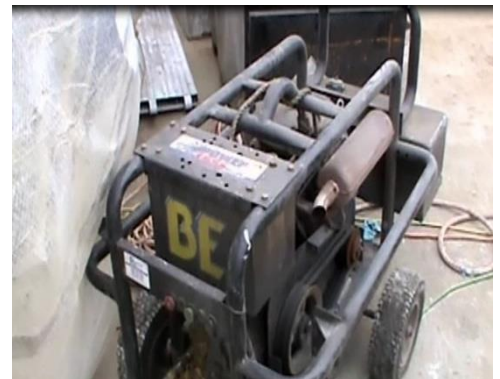
The piece of equipment was a 24 HP, 5,000 PSI maximum pressure gasoline-powered pressure washer. The engine was mounted on a roll cage frame with tires. Its engine was an air-cooled, 4-stroke overhead valve, 2 cylinder, V-Twin. The manufacturer states that this small engine has common applications in powering pressure washers, commercial lawn and garden equipment, tillers, generators, small vehicles, water pumps, and forestry, construction, industrial and agricultural equipment.⁸

Photo 1: Incident gasoline-powered pressure washer.

Recommendation 5: Employers should ensure that CO safety warning labels are attached to pressure washers and that they are replaced when no longer readable.

Discussion: Incident scene photos of the pressure washer do not show any safety labels affixed to the machine warning of CO exposure. It is unknown whether the pressure washer previously had these labels, and if so whether they were worn off or obscured by grime and dust. The manufacturer of the incident pressure washer's engine provides a safety warning label that reads, in part, "engine emits toxic carbon monoxide – do not run in enclosed area."

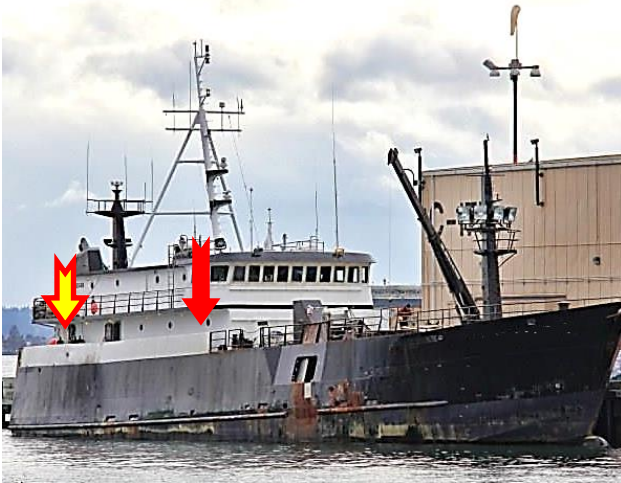
Photo 2: The yellow arrow indicates where the victim had been pressure washing the exterior of the wheelhouse. The red arrow indicates where the victim was found unconscious on top of the pressure washer. Plastic sheeting covered the entire area. [Photo not at incident scene.]

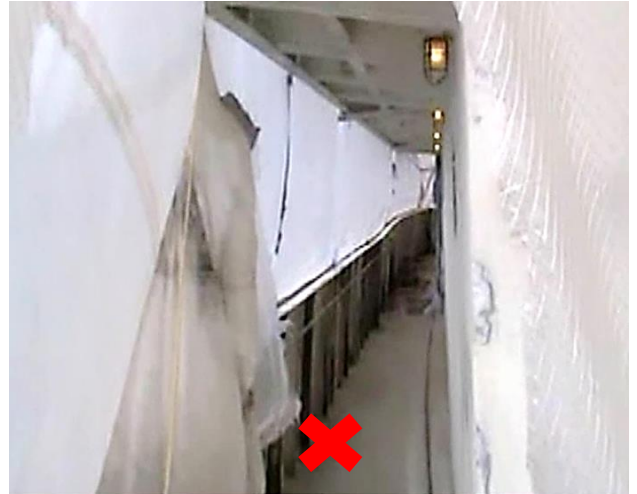
- Using a gasoline-powered pressure washer in an enclosed, unventilated area.
- Victim's apparent lack of awareness of the consequences of CO exposure.
- Air monitoring was not used to ensure that carbon monoxide levels were kept below the permissible exposure level.
- Lack of coordination among multiple contractors at the job site may have caused the pressure washer to be placed in an unsafe location.

Photo 4: The boat's wheelhouse companion way where the victim was found slumped on top of the pressure washer (red "X"). Temporary plastic sheeting enclosed the area (it was cut open by EMS responders). The hose on the deck leads to the stern where the victim had been pressure washing.

Recommendation 1: Employers should ensure that gasoline-powered pressure washers or other fuel-powered equipment and tools are not used in enclosed or partially enclosed areas where CO can build up.

Discussion: When planning work projects, employers should ensure that workers are not exposed to dangerous levels of CO during performance of tasks requiring the use of fuel-powered equipment and tools. Periodic spot checks should be made by the employer or a designated competent person to ensure that safe work procedures are being followed so that workers are not being overexposed to CO.

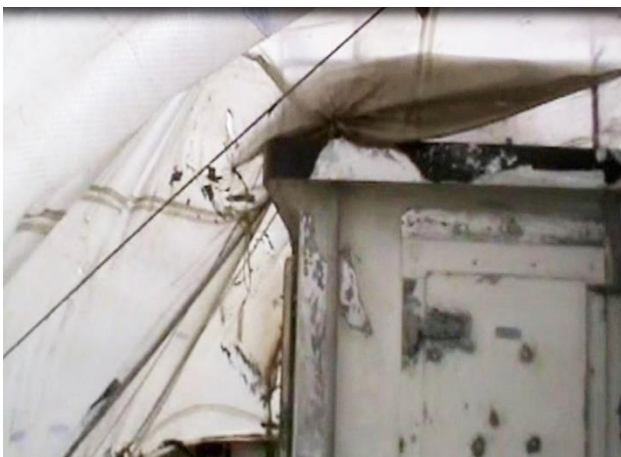
Photo 3: Exterior of the boat covered with a plastic tarp located near the stern where the victim was pressure washing.

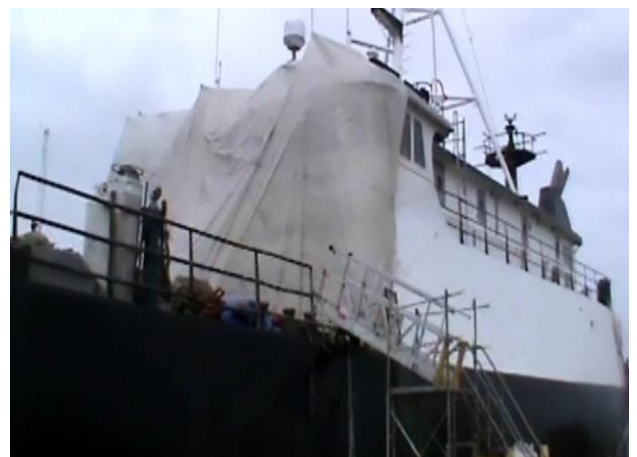
In order to prevent paint chips and dust created by grinding and pressure washing from entering the lake water, the workers had put up plastic tarping covering the front and right side of the boat's wheelhouse.

Photo 5: Exterior of fishing boat showing plastic sheeting covering the front of the boat's wheelhouse.
