REPORT#: 19KY034

Gutter Installer Dies after Falling from Roof

SUMMARY

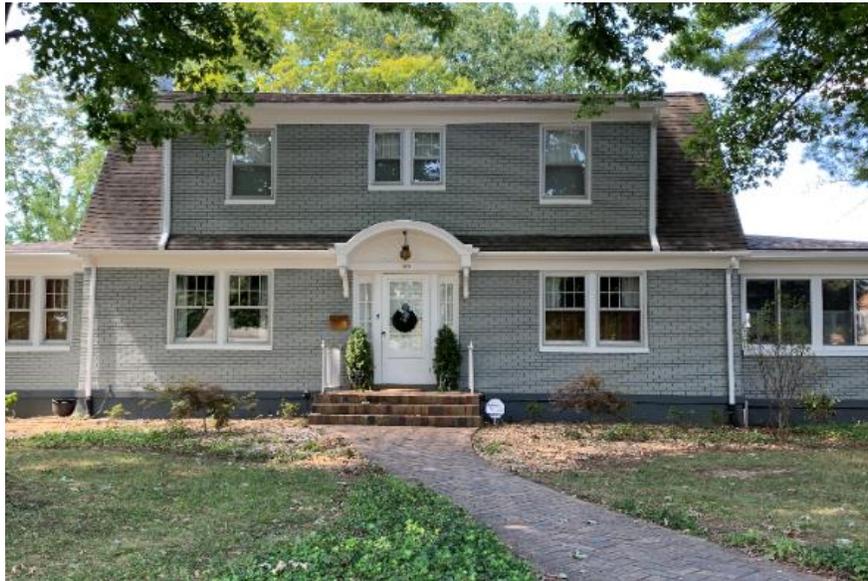
The incident occurred at a private residence. The two-story brick home was constructed in 1920 and contained four bedrooms and 2.5 baths and the roof was covered with architectural asphalt shingles. The home sits on a 0.61-acre lot and measures 5,000 square feet¹.

Photo 1. Front of the private residence where the incident occurred. Photo property of the Kentucky FACE Program.

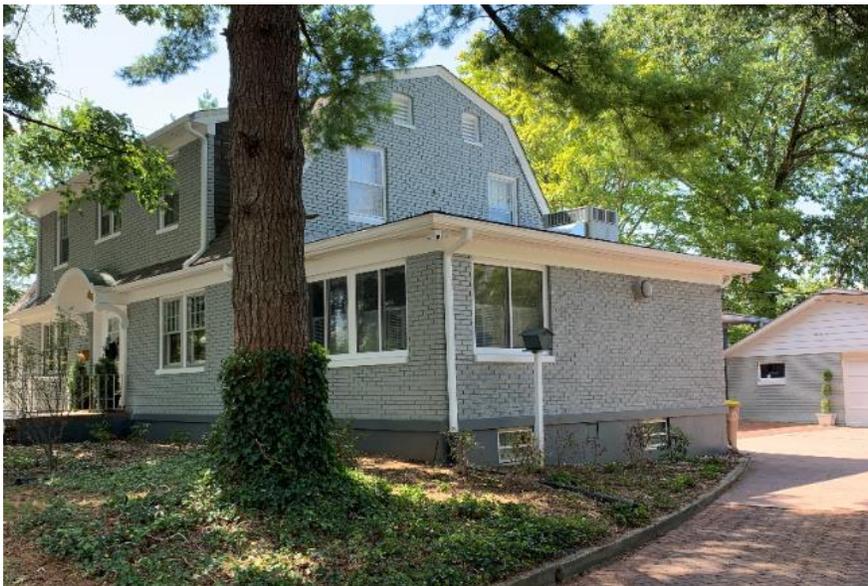
Photo 2. Rear of the private residence where the incident occurred. Photo property of the Kentucky FACE Program.

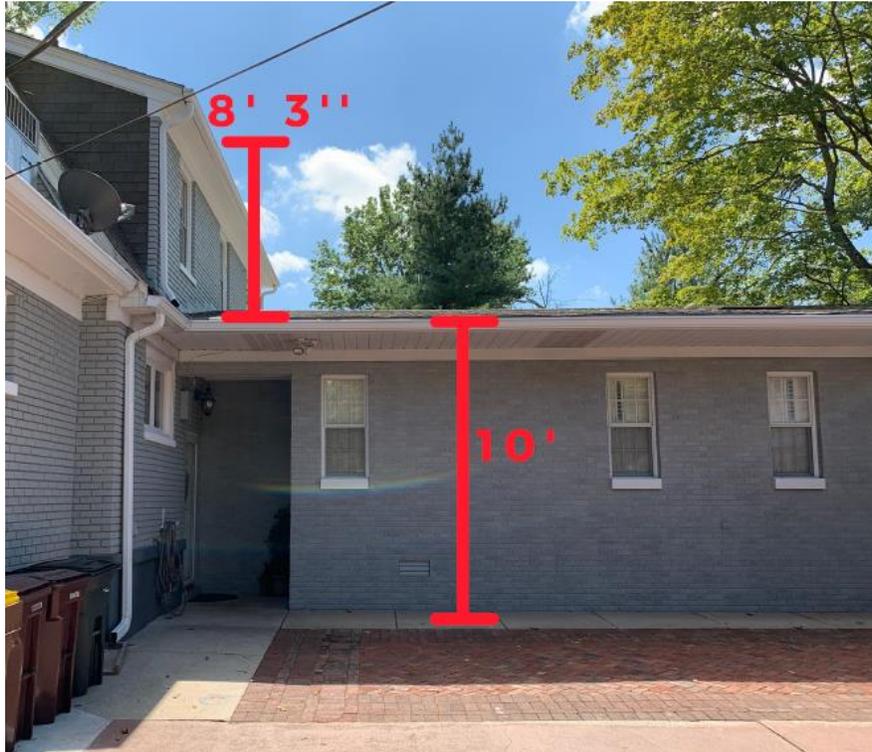
Photo 3. Roofs from which the victim fell. Photo property of the Kentucky FACE Program.

On Saturday, July 20, 2019, two employees, the owner of the company and the victim, arrived at a private residence to install gutter guards on the existing gutters of a two-story, single-family home. The first story is partially covered by a half-roof measuring 10 feet from the concrete driveway below. The second story roof covers the majority of the structure, and measures 8 feet 3 inches above the first story roof. The owner and the victim were working on the second story of the residence just prior to the incident occurring. The second

story roof has a pitch of 1:12, meaning the roof rises one inch for every 12 inches it moves towards the peak. A roof with a 1:12 pitch equates to an angle of approximately 45°. After working for approximately three hours, the owner exited the roof using a two-ladder system; one ladder resting on the first story roof extending to the second story and one ladder between the ground and the first story. The owner departed from the residence to pick up additional supplies needed to finish the job. As the owner was leaving, the victim's girlfriend was arriving at the residence. The owner stated he observed the victim sitting with his legs crossed on the second story roof, leaning forward to install the gutter guards as he pulled out of the driveway and left the premises. Within five minutes of leaving the residence, the owner of the company stated that he received a phone call at 10:30 AM from the victim's girlfriend, informing him that the victim had fallen from the second story roof, struck the first story roof, rolled off, and landed on the concrete driveway below. The owner immediately contacted 911 and returned to the residence. Upon his return, he observed the victim laying on the driveway unconscious, appearing to be suffering from a grand-mal seizure. A grand-mal seizure, also known as a tonic-clonic seizure, typically causes loss of consciousness and violent muscle contractions and is the result of abnormal electrical activity throughout the brain³. Emergency medical services arrived on the scene at 10:42 AM, and transported the victim to a local hospital. He was then airlifted to a larger metropolitan hospital where he was admitted in critical condition. The victim succumbed to his injuries seven days later on July 27, 2019.

Recommendation #1. Train employees on and enforce the use of fall protection when working at heights above 6 feet.

Companies who require employees to work at heights above 6 feet should train employees on fall protection, provide proper fall protection and enforce the use of fall protection in accordance to the associated OSHA standards.
