REPORT#: 19KY047

REPORT DATE: 2-3-2020

Commercial Driver Dies after Overturning on Two-Lane State Highway

Fatality Assessment & Control Evaluation

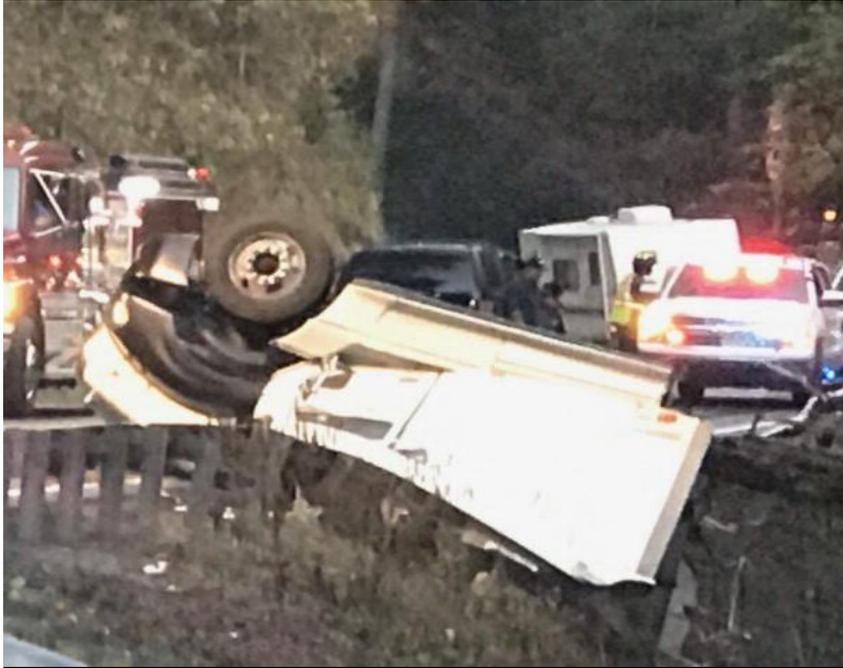
Photo 1. Photo of the semi-truck and trailer involved at the scene of the crash. Photo retrieved from WTVQ.com (Photo was taken from the west)

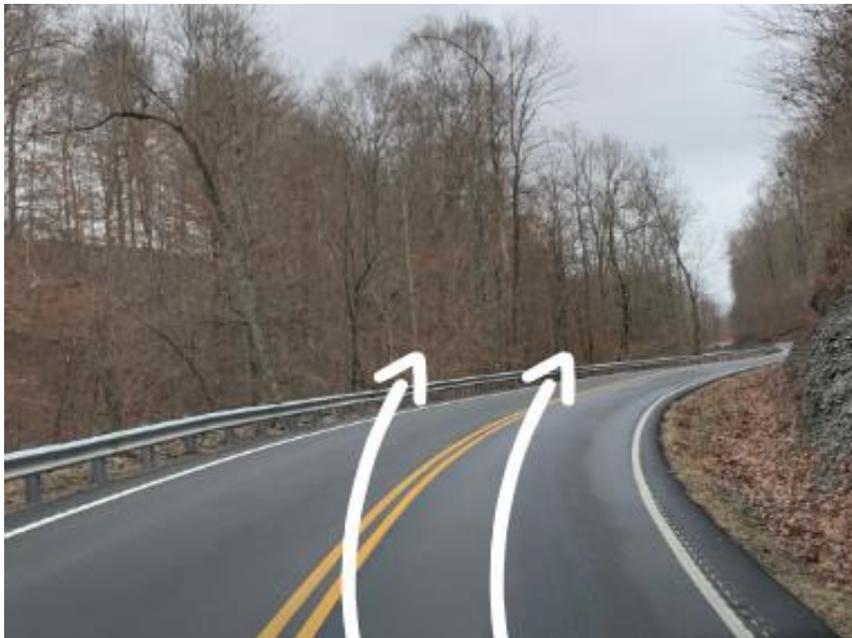
The incident initially began in the eastbound lane of a two-lane state highway with a posted speed limit of 55 miles per hour. This particular section of highway ascends at a grade of approximately 18-degree with a large embankment positioned just beyond the shoulder of the west-bound lane of travel. A standard W-beam guardrail is positioned between the west-bound travel lane and the embankment. While traveling east, the involved tractor trailer exited a sharp turn, crossed into the west-bound travel lane and struck the W-beam guardrail which resulted in the trailer overturning. As the trailer descended down the embankment, the truck overturned as well. The semi-truck came to final rest partially on the west-bound travel lane with the rear of the truck and trailer completely off of the roadway, descending down the embankment.

Photo 2. Photo with animation depicting the path the semi-truck and trailer traveled as it entered the west-bound lanes. Photo created by and property of KY FACE.

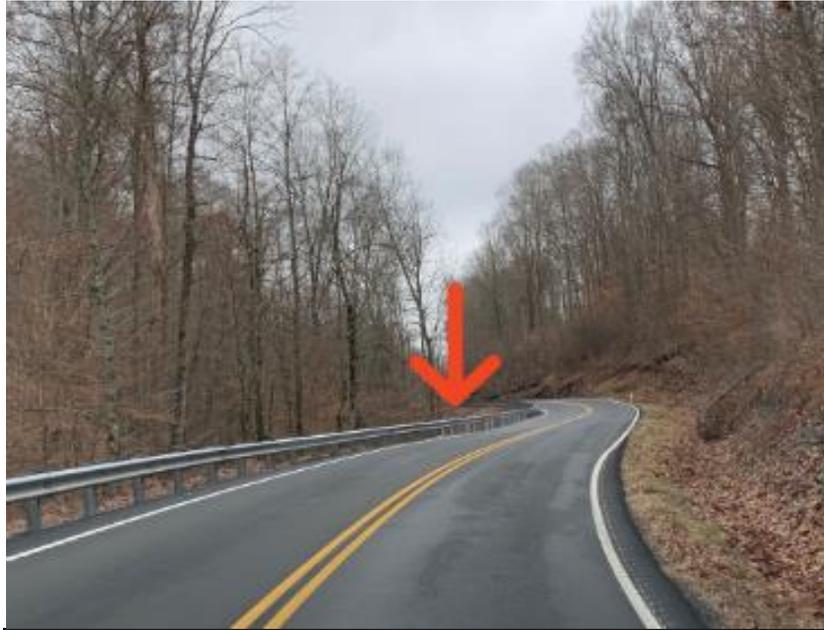
Photo 3. Photo representing the point in which the rear driver's side trailer struck and punctured the W-beam guardrail. Photo by and property of KY FACE.

The force of the impact punctured and compromised the guardrail, and the shifting weight of the cargo pitched the trailer off of the roadway. The trailer overturned as it descended down the embankment, subsequently pulling the tractor down and overturning it as it exited the highway down the embankment. The semi-truck came to final rest partially on the west-bound travel lane with the rear of the truck and trailer completely off of the roadway. First responders arrived on the scene of the crash at 6:37 AM. Upon approaching the vehicle, it was determined that the driver had succumbed to injuries sustained in the crash, and he was pronounced dead at the scene. Accident investigators determined the victim was wearing a seat belt.

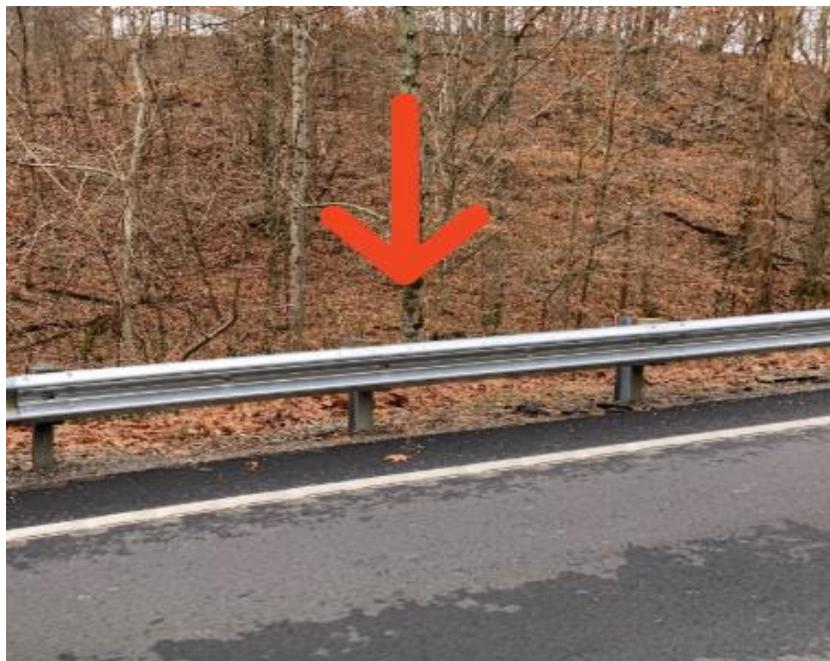
Photo 4. Photo of depicting the area the semi-truck and trailer overturned down the embankment. Photo by and property of KY FACE. (guardrail had been replaced when photos were taken)

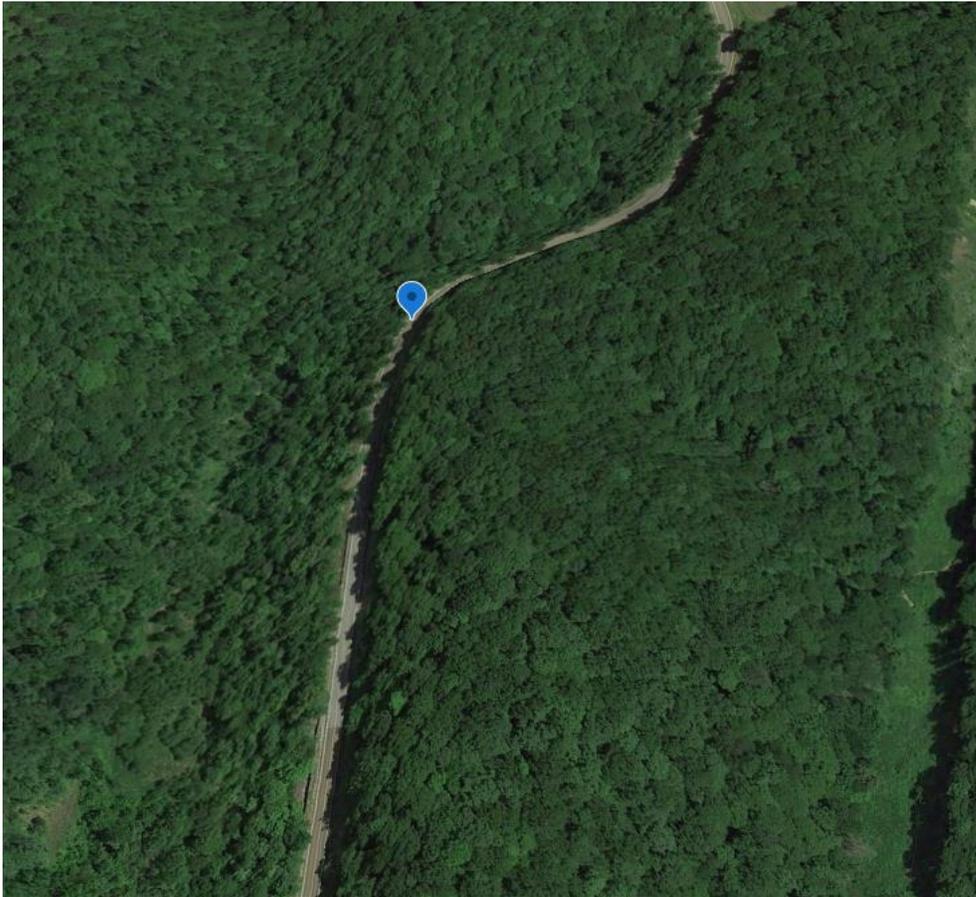
Photo 5. Google Earth image of the collision scene. Photo retrieved from and property of Google Earth.

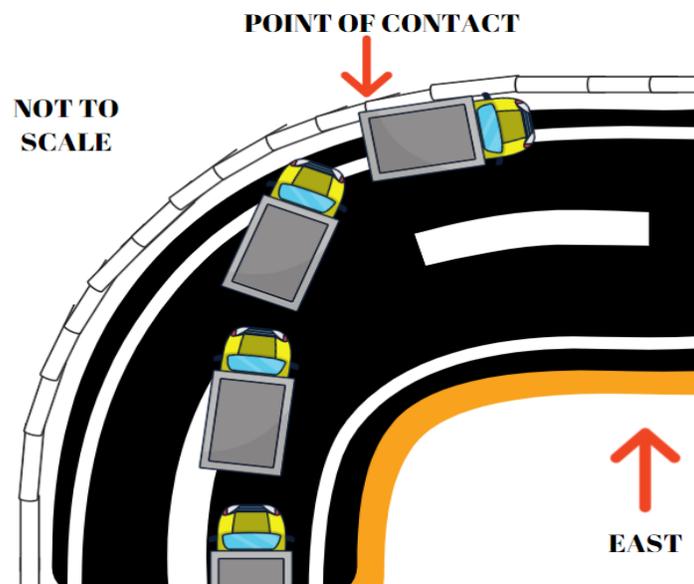
In the early morning of Monday, September 30, 2019, a commercial truck driver was operating a 2003 Freightliner Cascadia semi-truck and trailer east-bound on a two-lane Kentucky state highway. The driver was en route to a Kentucky based business to deliver a load of farm tractor parts. According to the investigating officers, at 6:05 AM, the driver entered a right-hand curve traveling approximately 55 miles per hour, while ascending a hill with a grade of approximately 18 degrees. Investigators determined the speed of the truck was too fast for the type of terrain the semi-truck and trailer was traveling, which resulted in the driver losing control of the vehicle. The driver attempted to regain control of the truck by taking evasive action, but was unable to do so before crossing the centerline and entering the west-bound travel lanes. The trailer struck the W-beam guardrail that separates the west-bound travel lane from a large embankment.

Diagram 1. Diagram showing the path the semi-truck and trailer traveled as it crossed the centerline and struck the W-beam guardrail before descending down the embankment. Photo created by KY FACE.

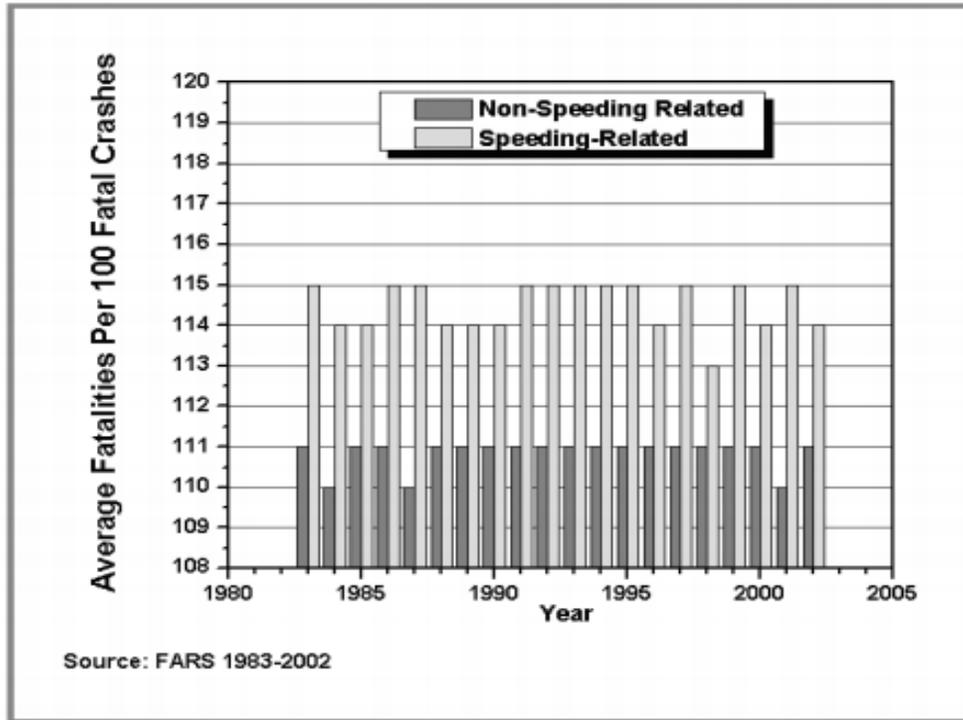
Discussion: Collision investigators determined that the driver was traveling at a speed inappropriate for the type of terrain and vehicle being operated. It was determined that the truck was traveling at or near the posted speed limit of 55 miles per hour; however, this section of highway is particularly curvy with several large ascending hills. Due to the treacherous nature of the highway, investigators stated that the vehicle was traveling at a speed that was too fast for the terrain. According to the Federal Motor Carrier Safety Administration (FMCSA), speed limit signs, especially on curve warning signs are intended for passenger vehicles, not large trucks; FMCSA suggest trucks reduce their speed even further. According to FMCSA, studies have shown that large trucks entering a curve, even at the posted speed limit, have lost control and rolled over due to their high center of gravity. The study also revealed that 40 percent of speeding-related fatalities occur on curves. The FMCSA states that a commercial driver should adjust his/her speed considering the traffic, road, and weather conditions. Additionally, braking in a curve can cause the wheels to lock up and the vehicle to skid³. Due to their high center of gravity, traveling at a safe speed is essential to the secure operation of a commercial motor vehicle.

Chart 1. Chart depicting fatal crashes in which speeding was a contributing factor compared to those in which speeding was not a factor from 1983-2002⁴.

Recommendation #1: Commercial motor vehicle (operators should adjust speed to safely match adverse terrain conditions.

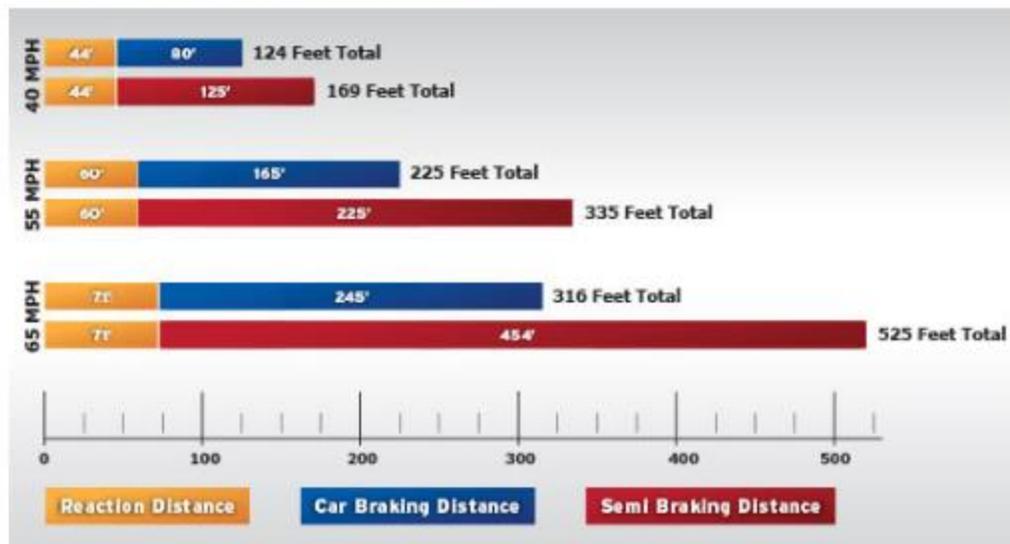
Total Stopping Distances

Taking these three factors into account, the below graph compares car braking distance to semi braking difference. At 55 MPH, the speed limit the victim was traveling, a semi-truck would need approximately 335 feet to come to a complete stop v/s a passenger vehicle needing only 225 feet.

Chart 2. Chart depicting car braking distances v/s semi braking distance⁸.

Considering commercial vehicle size, weight and increase stopping distance, the Kentucky Transportation Cabinet should consider assigning commercial vehicle specific speed limits to state highways.
