**REPORT#: 19KY050**

**REPORT DATE: 3-23-20**

## Construction Worker Dies on Kentucky Interstate in Single Vehicle Collision

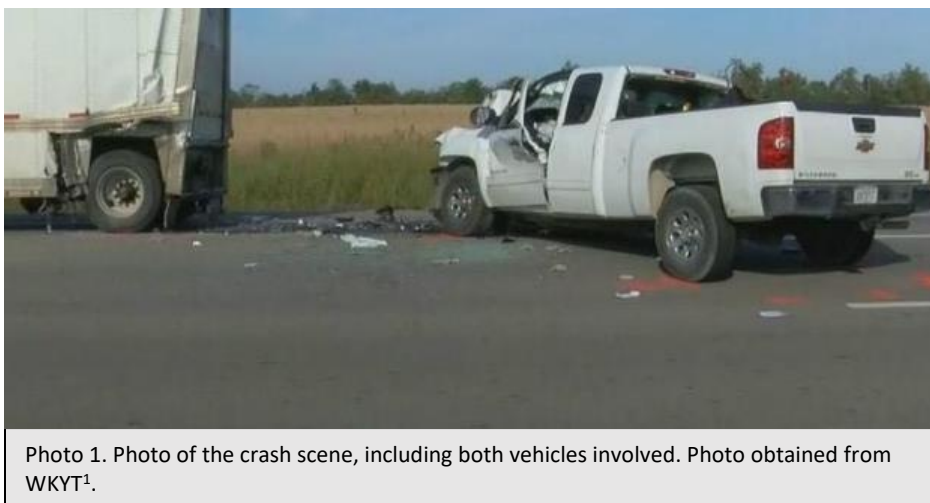
The incident occurred in the right southbound lane of a major, four-lane interstate. North- and south-bound traffic is separated by a standard concrete barrier with a posted speed limit of 70 mph; however, traffic was at a standstill due to a collision that had occurred six-hours earlier, four-miles south.

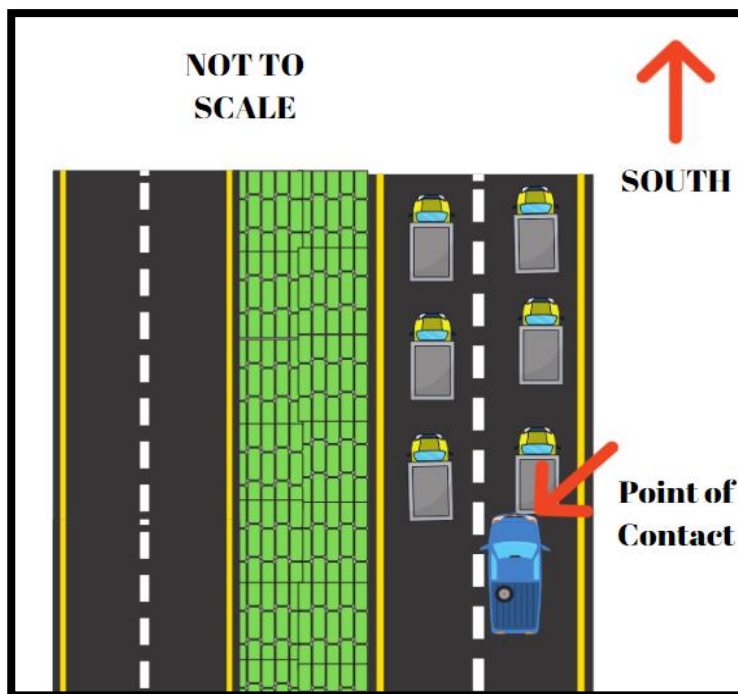
Photo 3. Animation of crash. Animation created by and property of KY FACE.

On Thursday, September 26<sup>th</sup>, 2019 at approximately 8:00 PM, the involved company notified the victim of a job assignment that would need to be completed the next day. His task was to travel to an out-of-state location to obtain building materials for an in-state job site. To complete the job in a timely manner, the victim would have to depart his home by 2:00 AM the next morning. After receiving the assignment, the victim and his spouse departed a local sporting event at approximately 8:45 PM in hopes of obtaining as much sleep as possible. After arriving home, the victim's spouse stated he made preparations for the trip and went to bed at 10:00 PM. According to the spouse, she woke the victim up at 1:30 AM on Friday, September 27<sup>th</sup> and he departed shortly after at 2:00 AM in a company owned, 2013 Chevrolet Silverado. Approximately five hours into the trip, just before sunrise at 7:07 AM traffic on the interstate was at complete stop due to a six-vehicle, fatality collision had occurred nearly six-hours earlier. Although this section of highway was straight, for unknown reasons the victim failed to observe the stopped vehicles. As a result, the pickup truck driven by the victim struck the rear, left bumper of a semi-trailer at an estimated speed of 70 mph. The force of the impact severely damaged the driver's portion of the cab. According to police reports, the victim was not wearing a seat belt at the time of the collision. No decelerating scuffs or skid marks were present at the scene which suggest the victim did not attempt to brake prior to the impact.

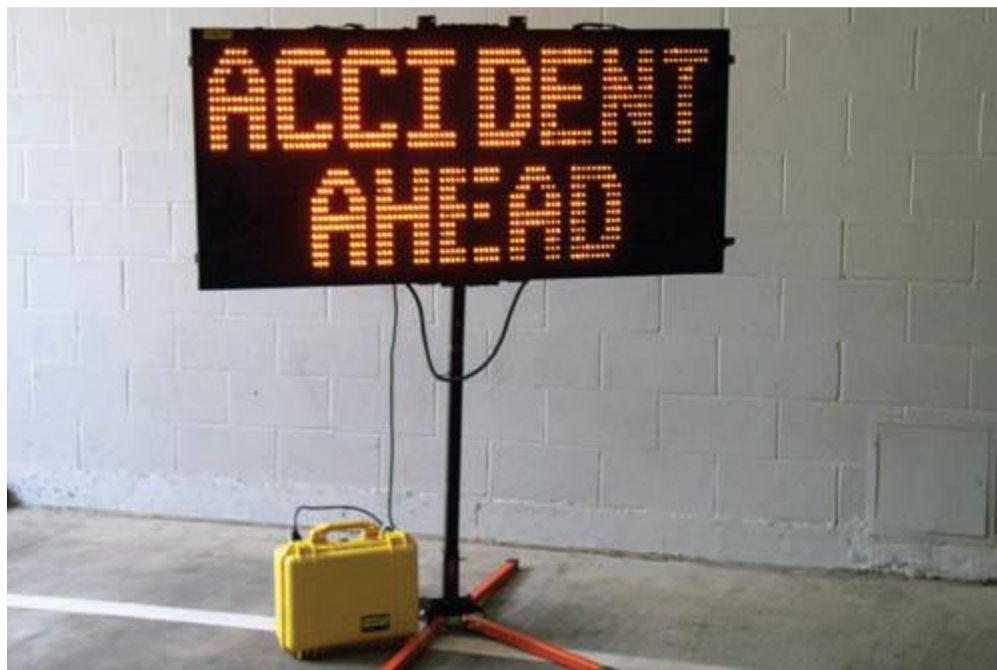
Photo 4. Photo of Changing message sign (CMS)<sup>3</sup>.

Portable CMS should be visible from one-half mile under both day and night conditions. Letter height should be a minimum of 18 inches and legible from at least 650 feet if the sign is mounted on a trailer or large truck. If mounted on service patrol trucks, letter height should be a minimum of 10 inches and visible from at least 330 feet<sup>3</sup>.

collision which provided ample opportunity for such warning devices to be deployed. To protect and warn the motoring public, warning devices such as CMS should be deployed.
