**REPORT#:** 19MA058

**REPORT DATE:** July 15, 2022

## Automotive Mechanic Fatally Burned While Using Welder When Washer Fluid Drum Explodes — Massachusetts

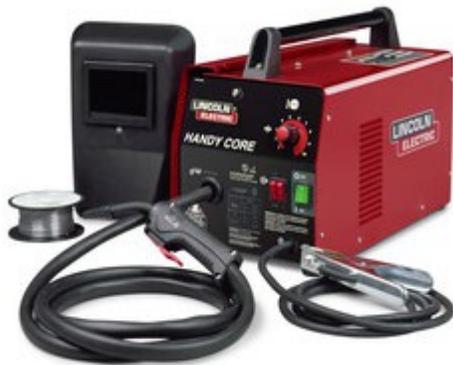
**Figure 1 – Flux core arc welder (manufacturer’s site)**

The welder that was involved in this incident was an electric flux core arc welder (Figure 1). It was a portable plug-in unit that weighed 46 pounds. It used a specially designed consumable electrode (welding wire) to generate an electrical arc and high temperatures in order melt the electrode and fuse it to the piece being welded. The base unit plugged into a standard outlet and a transformer in the unit generated a 17-volt direct current charge at up to 88 amperes (Figure 2).

The welder had two cables to complete the electrical circuit (Figures 1 and 3). A return cable had a clamp and would be attached to the work piece. This provided a pathway for the current to return to the base unit. The hot cable had a handle with a trigger switch that controlled a spool drive motor. The motor would push the flux core wire through the hot cable and out the tip of the handle. The electrical current would pass through the flux wire when it contacted the work piece and melt the flux core wire. Voltage, amperage, and spool/wire feed speed could be adjusted on the base unit to optimize the weld and the amount of flux wire used, creating a reliable weld. These settings could be adjusted depending on the work piece and the desired weld shape and style. The machine was designed to be able to weld steel up to 1/8” thick.

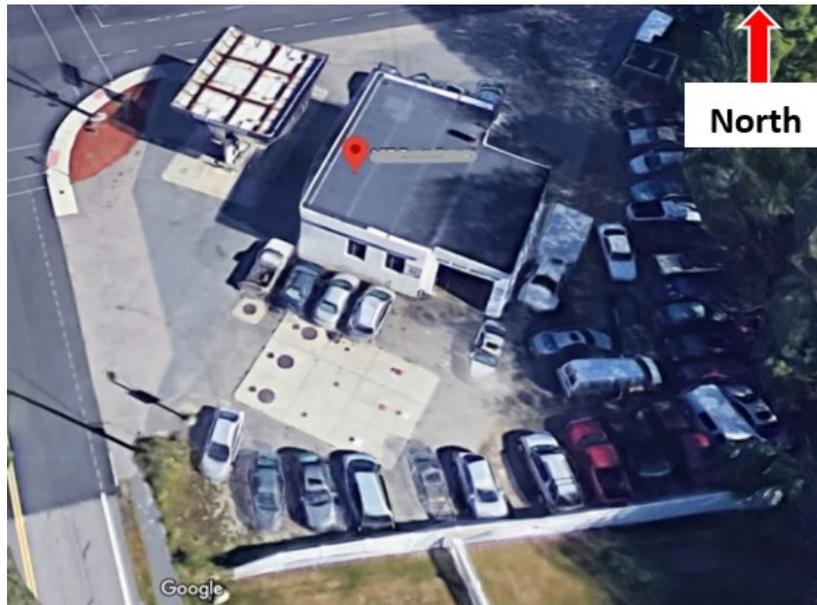
The facility (Figures 4 and 5) was in a residential area of town and was on a corner lot on a street that served as one of the main east/west routes in the town. The outdoor space is flat and mostly paved with asphalt and concrete. Dozens of vehicles were parked around the perimeter of the property. The building had two vehicle service bays, an inspection bay, and a snack shop/service office area. The two service bays had overhead doors that faced the gas pumps and intersection. The inspection bay was on the back of the building and was accessed from the southern side. This entry had an overhead door and there was also an exterior door on the northern side of the inspection bay and an internal doorway that connected to the service bays. The incident occurred in the vehicle service bay area. Both service bays had vehicle lifts and both bays were in use at the time of the incident.

Figure 4 – Gas and service station; the inspection bay entry is visible on this side of the building (image from google maps)

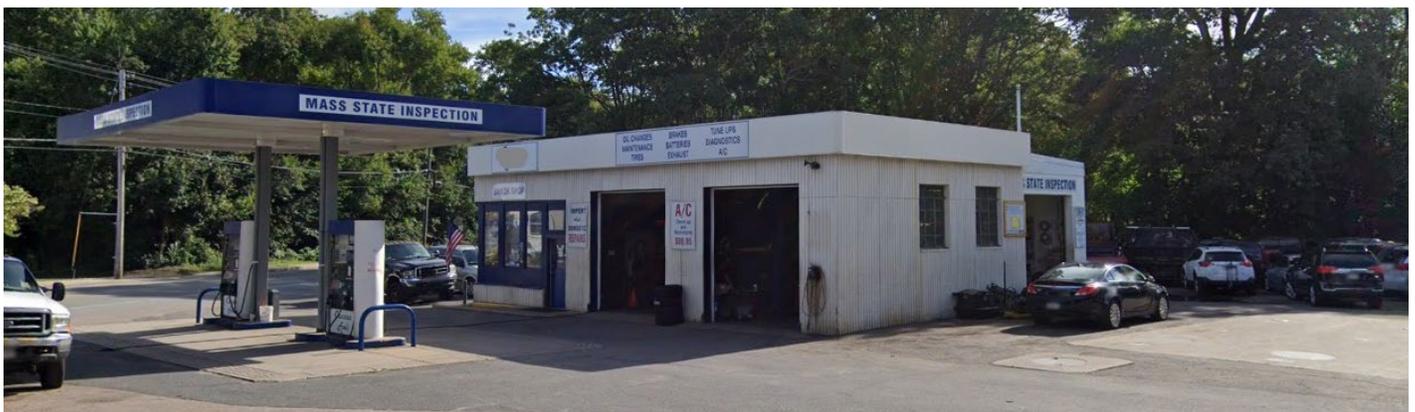
Figure 5 – Gas and service station; the incident occurred at the rear of the service bays (image from google maps)

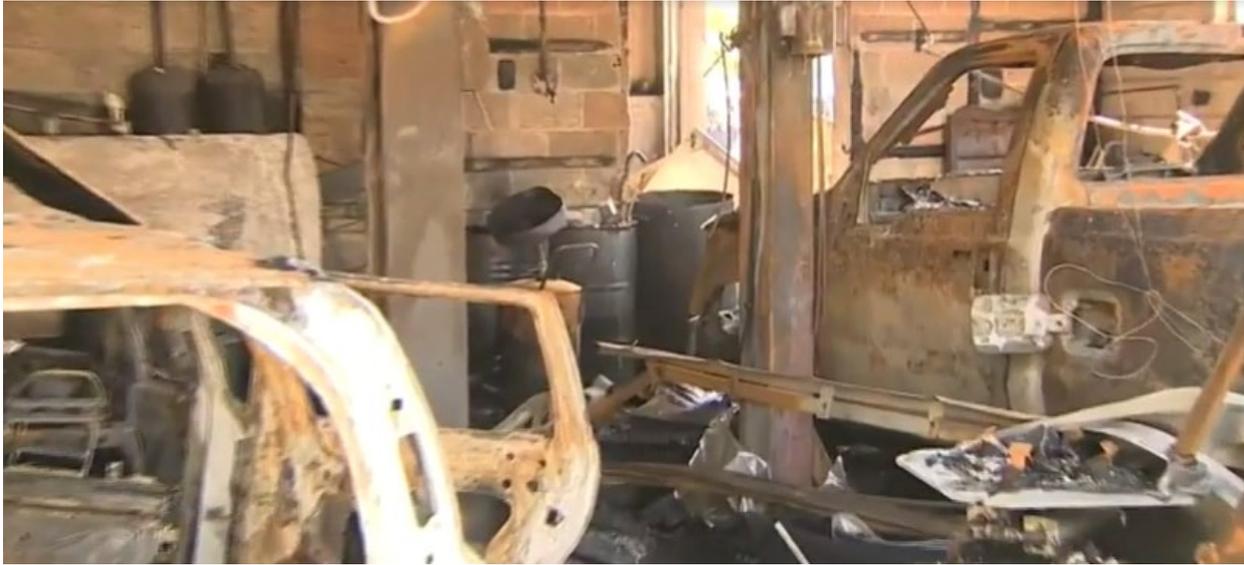
Several steel drums were stored along the rear wall of the service bay. At least one of these drums contained window washer fluid concentrate. The 55-gallon drum had two bung holes in the lid. One hole served as a vent and the other hole had a hand-operated pump and spigot. The workers used this window washer concentrate and diluted it with water for use at the station and to put into bottles for station customers. The drum and pump were supplied by a distributor and on the day of the incident the drum was nearly empty. A new drum was scheduled to arrive in the following days.

Figure 6 – Garage after the fire was extinguished, from scene footage; drums along back wall are in the center of the picture.

***Recommendation #1: Employers should provide an appropriate location to perform welding work. All hot work should be a safe distance away from flammable and combustible liquids. Ensure workers using welding equipment are trained in the safe operation of their equipment.***

The employer described that the station had a welding area and bench or cart with a vise. Records reviewed indicate that this bench was used but also that welding work was performed directly on the vehicles, on the floor, and on top of the drums located in the garage. The presence of the flammable fluid containers in the workspace, and the presence of other flammable materials throughout the garage should have been identified by the employer and would have been identified by the local fire department had a permitting inspection occurred.

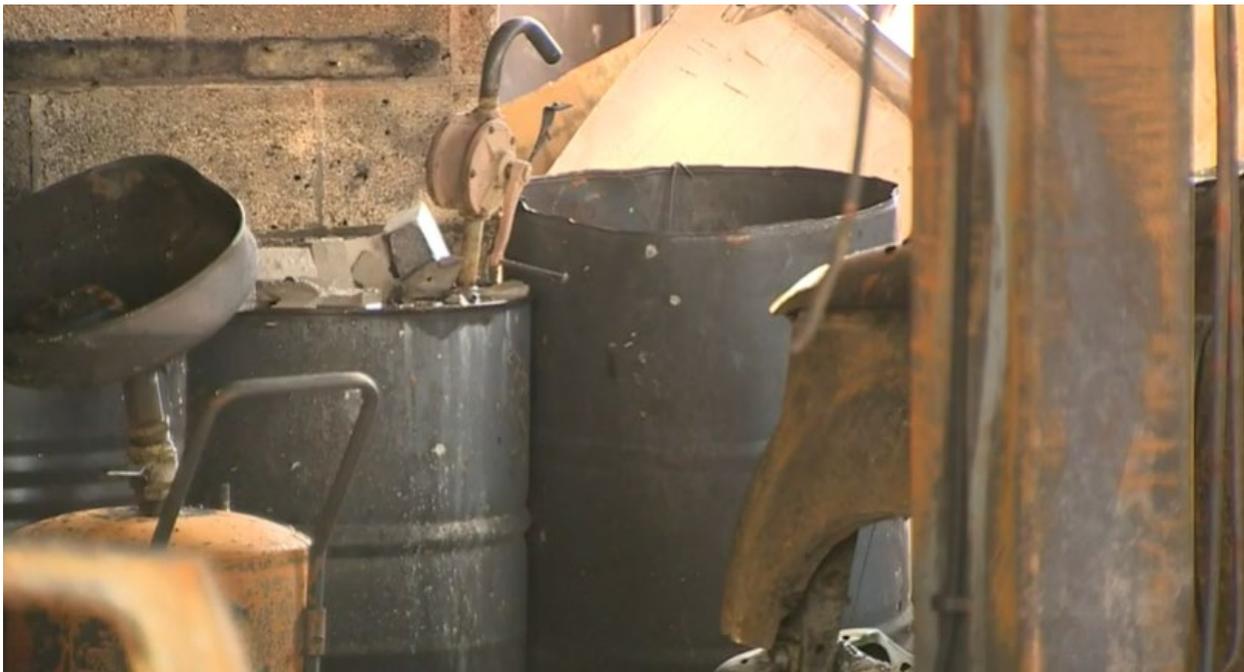
The victim set up a temporary welding station on top of the steel drum. As a coworker held the work piece in position the victim began to make spot welds to assemble the tool. The coworker was holding the piece with his arm extended and was facing away. It is unknown if either worker was using any protective equipment such as a face shield, gloves, and non-flammable clothing. The victim made one weld and was proceeding to make a second weld when the drum exploded.

The top of the drum blew off and the coworker holding the piece suffered a burned arm and facial trauma. He fled the garage as the washer fluid vapors had ignited and the fire began to spread. The victim was covered in burning fluid and was on the floor of the garage underneath one of the vehicles. Workers in the inspection bay and who had been working outside of the building heard the explosion and gathered outside. They realized the victim was still inside and reentered the building to drag him out. They used fire extinguishers to try to put out the flames on his body. His clothing eventually burned and was torn away to fully extinguish the flames on his body.

Figure 7 – A drum with hand pump (left) and a drum with missing top, from scene footage.

This fatal incident underscores the need to use welding equipment in a safe environment and to follow methods and procedures described in the operator’s manual or in applicable regulations. The operator’s manual contained specific information that prohibited use of the welder under the circumstances that led to this incident (Figure 8). Specifically, the welder should not have been used near flammable material or near closed containers. Appropriate and comprehensive training on use of the welder, incorporating the operator’s manual, could have identified these hazards and prohibitions.

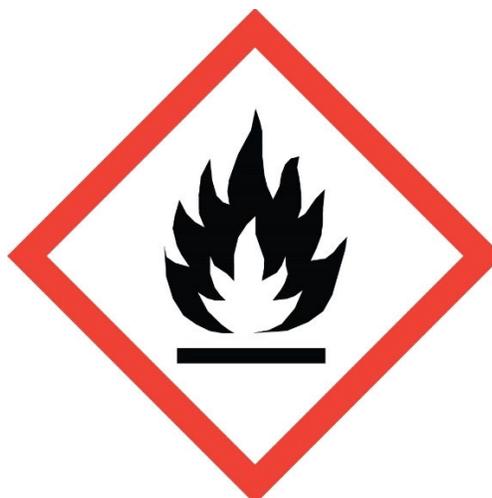
**Figure 9 – OSHA GHS flame pictogram for flammable liquid**

Discussion: The 55-gallon drum of flammable window washer concentrate that exploded was properly labeled on the side and lid with Globally Harmonized System (GHS) pictograms indicating it contained a highly flammable liquid (Figure 9). It was reported that the employees did not have sufficient training to understand what this labeling meant. The Safety Data Sheet (SDS) for the material indicated it was >99% methanol with a balance of blue colorant and had a flash point of 11 degrees Celsius (52 degrees Fahrenheit), meaning the fumes escaping the barrel would have combusted in the presence of an ignition source.

**Recommendation #2: Employers should ensure that all workers are properly trained about hazardous materials in the workplace.**

The employer did not properly train the workers about what chemicals were present at the site, how to store them, how to handle them, and how to respond to the fire involving the chemicals. The gas station was constructed at a time when station-wide fire suppression systems were not required. The station had four class A-B-C, 25-pound hand-held fire extinguishers that had just had their annual inspection. While workers at the station were able to shut off the fuel valves for the fuel pumps, all four extinguishers were used to try to put out the flames on the victim. This type of extinguishing media would have been effective and appropriate to extinguish the burning washer fluid on the victim. Because of how the chemicals were stored in the facility and because of other materials in the garage, the fire was able to spread very quickly and ultimately destroyed the building and caused a vehicle adjacent to the building to also catch fire.

It is worth noting that less-flammable and non-flammable window washing products are available. Elimination of the flammable products from the worksite by substituting a safer alternative is a preferred method to control this hazard.
