REPORT#: 22CA003

REPORT DATE: November 1, 2023

Day Laborer Dies in a Collapsed Trench Being Dug to Repair a Sewer Line — California

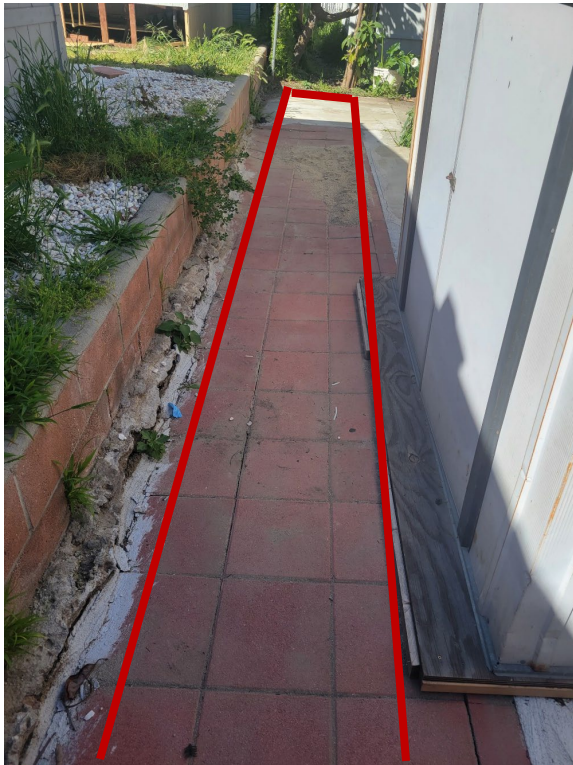
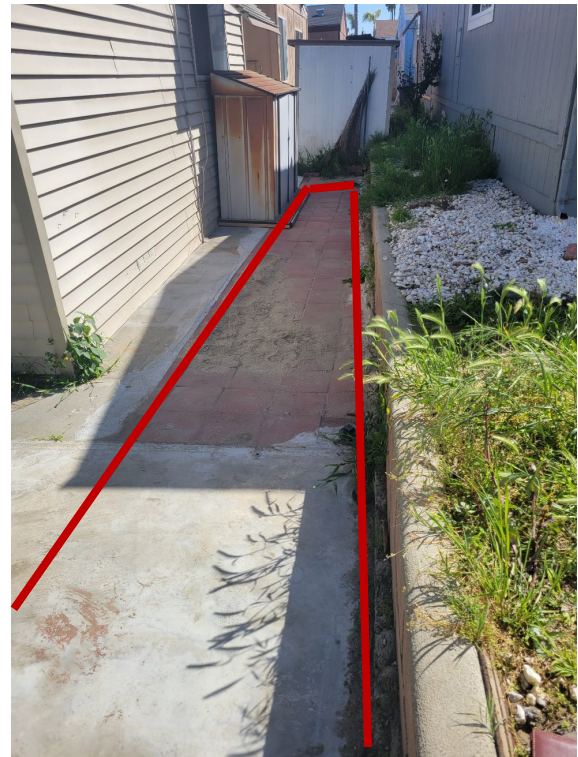
The incident scene was a walkthrough between mobile home residences where a trench was being dug to repair a sewer line (Exhibits 1 & 2). The trench was parallel to a mobile home and approximately four ft. wide, 30 ft. long, and eight ft. deep. There was also a water line in the trench (running parallel) approximately three feet below surface level.

The incident location looking east (Exhibit 1) and looking west (Exhibit 2). At the time the photos were taken, the trench had been covered with tiles and concrete. Photos by CA/FACE program.

Recommendation #1: Ensure that trenches five feet deep or greater are properly shored, shielded, or sloped.

Discussion: In this incident, the victim was working in an unprotected trench with a depth of eight feet. Any employee in a trench, five feet deep or more, is required to be protected from cave-ins by an adequate protective system. For all trenches or excavations five feet or deeper into which any person is required to descend, Cal/OSHA requires a permit. For any trench at risk of cave-in, Cal/OSHA requires sloping, benching, shoring, or shielding to protect workers from cave-ins.¹ A qualified licensed contractor will also ensure that trenches five feet deep or more are properly shored, sloped, or shielded. The type of protective system, support system, or shield system used would be determined by the soil conditions found in the excavation. This is usually determined by the employer, competent person, or a licensed engineer. In this incident, the protective system should have included a trench shield (also known as a trench box), shoring, or a combination of shoring and shielding. Sloping would not have been appropriate because of the limited space within the motor home park. Employers can also consult tables located in the appendices of the Cal/OSHA Excavation Standard (CCR, Title 8, Subchapter 4, Article 6) that detail the protection required based upon the type of soil and environmental conditions present at the site. In addition, employers can consult with manufacturers of protective systems to obtain detailed guidance for the appropriate use of this equipment. In this incident, no protective system had been placed at any point in the trench. Had the trench been properly shored or shielded, this incident could have been prevented.

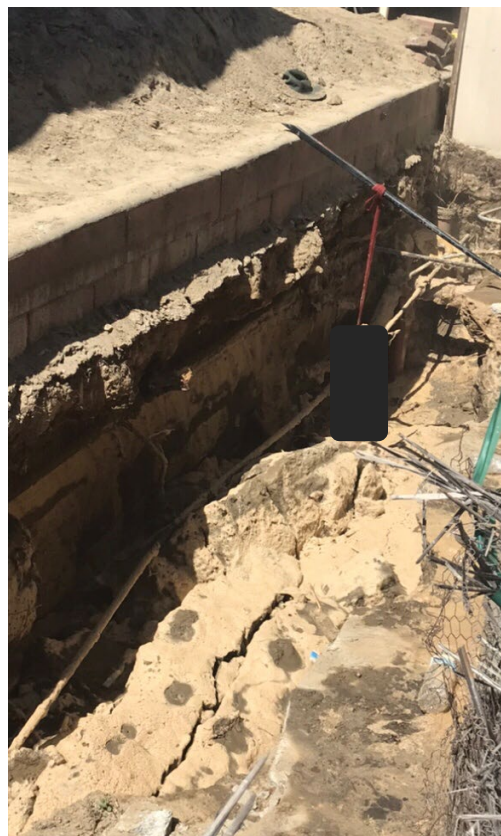
began, or once it was uncovered. At approximately 11 a.m., as two laborers were in the trench about eight feet below grade, the exposed water line above them suddenly broke and began filling the trench with water and dirt that was being knocked loose from the pressurized water. When the two day laborers above the trench witnessed this, they immediately attempted to rescue their co-workers. The water and mud were already up to the chest of the trapped laborers when the two co-workers above the trench tried to pull them out. It took approximately ten minutes before one of the laborers was pulled from the mud-filled trench. Unfortunately, the victim was completely submerged under the water and mud and was not able to be lifted out by co-workers (Exhibit 3). There was an unsecured ladder in the trench for egress and ingress, but it was not able to be used in the attempted rescue of the trapped workers.

Exhibit 3. The trench after the water was removed. Photo by CA/FACE program.

Recommendation #2: Ensure that the trench is inspected by a competent person.
