Kentucky Injury Prevention and Research Center
Bona fide agent for Kentucky Department for Public Health
333 Waller Avenue, Suite 242 • Lexington, KY 40504 • 859-257-5839

INCIDENT HIGHLIGHTS

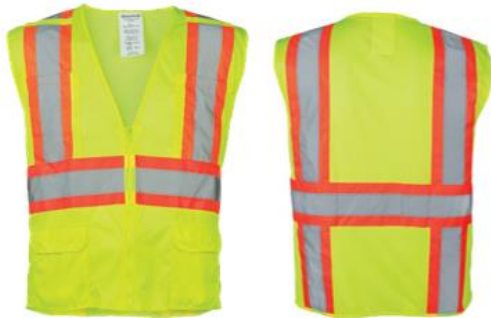
Photo 10. Photo depicting an ANSI Class 2 safety vest. Photo retrieved from and property of criticaltool.com.

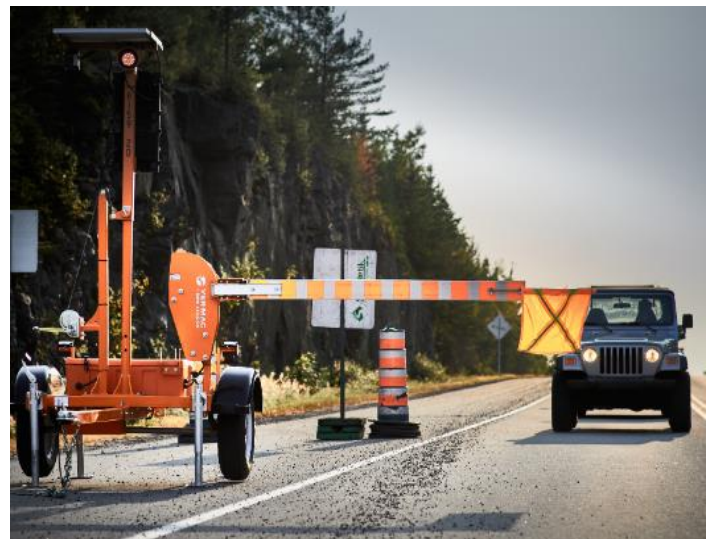
Photo 16. Photo of AFAD in use. Photo retrieved from and property of ver-mac.com.

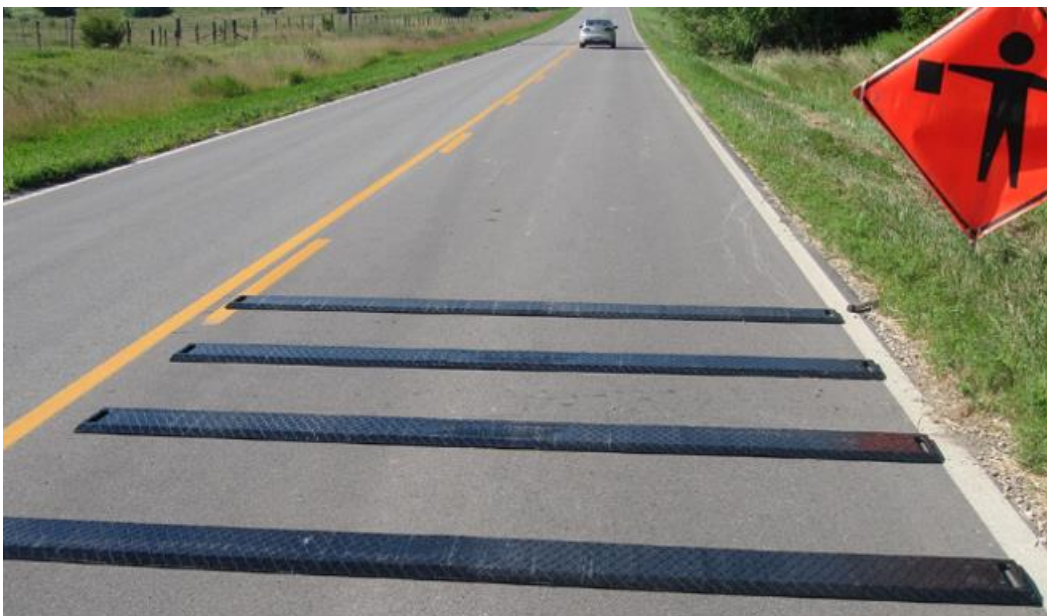
Photo 17. Photo of portable temporary rumble strips in use. Photo retrieved from Google Image search on 03-22-23.
