FACE IT: Report Slides

State Trooper Struck by Tractor Trailer While Conducting a Commercial Vehicle Traffic Stop - Illinois (NIOSH LEO 2022-01)

REPORTR: L2022-01 **REPORT DATE:** September 5, 2023

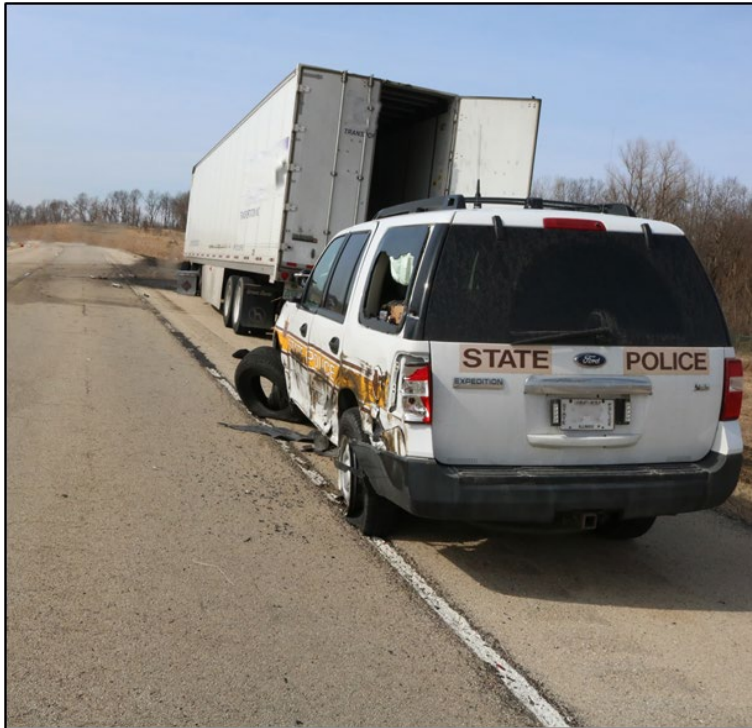
Photo of the Trooper's vehicle along with the commercial motor vehicle after the fatal incident.
(Photo courtesy of the Illinois State Police.)

- On March 28, 2019, a 34-year-old state trooper assigned to patrol duties as a Commercial Vehicle Enforcement Officer (CVEO), initiated a traffic stop of a tractor trailer on the right shoulder of a 4-lane highway.
- After she conducted her inspection, the trooper was standing on the driver's side running board of the truck talking to the driver.
- Another tractor trailer traveling westbound stuck the trooper, throwing her off the running board and into a ditch parallel to the highway.
- First responders attempted life saving measures but were unsuccessful.
- The trooper was pronounced deceased at the scene.

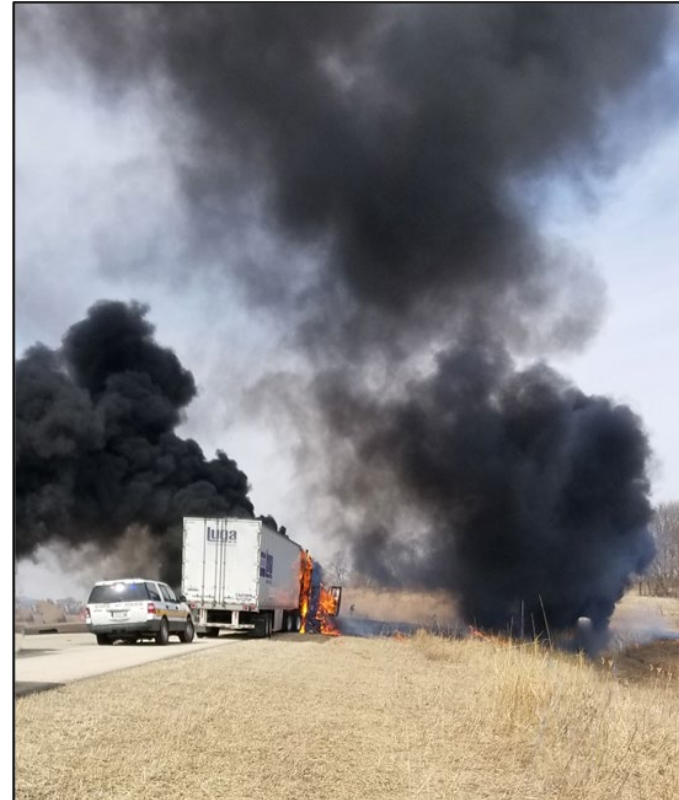
Photo of commercial vehicles on fire at the scene after the impact. (Photo courtesy of the Illinois State Police.)
