FACE Report Number 2013-04

Hispanic Worker Dies After Being Hit With a Projectile From a Nearby Commercial Lawnmower—North Carolina

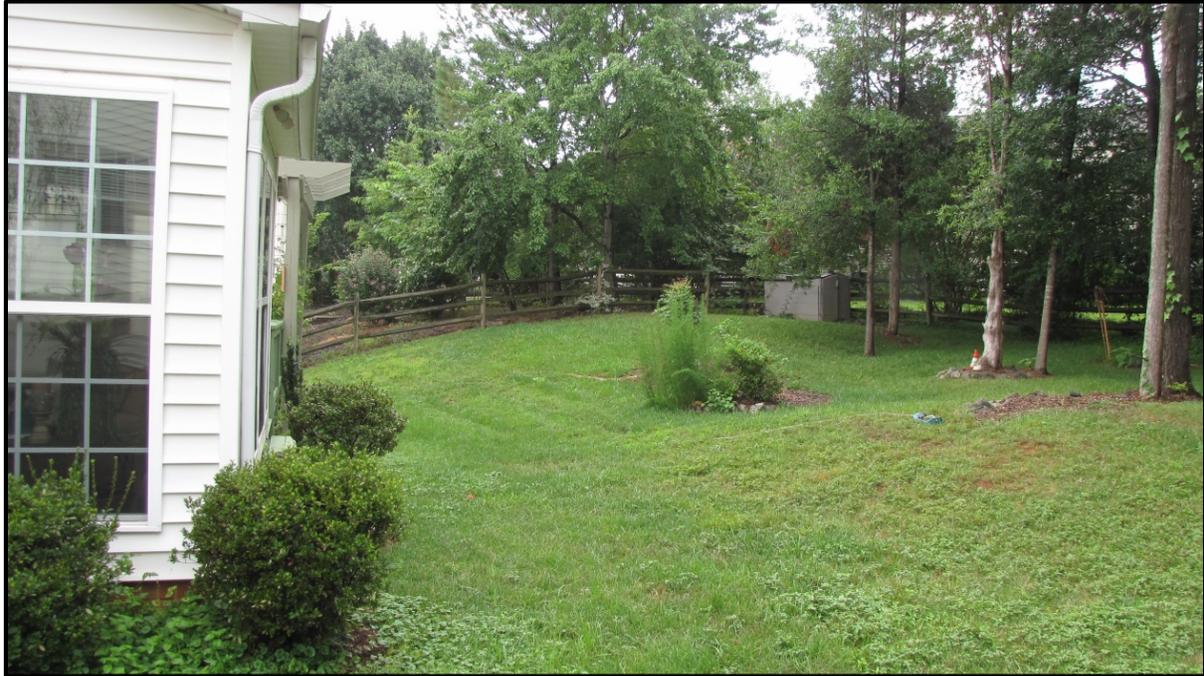
At the time of the incident, the lawn care worker was using a weed trimmer in the backyard of a private residence. The homeowner was a customer during the February through November cutting season for nearly 2 years prior to the incident. The home is set on a 13,000-square-foot lot with an approximately 7,500-square-foot backyard. The yard drops approximately 15 feet from the back of the property to the front of the property line, with some minor variations in grade. The metal projectile was from a spiral pet tie-out stake used to secure a pet on a leash in the homeowner’s backyard. The backyard has several mature trees, garden décor, and equipment (Photo 1). The lawn care worker was located approximately 25 feet from the operating lawn mower while using a trimmer.

Photo 1. Incident scene. Backyard of private residence.
(Photo courtesy of NCDOL/OSH.)

Recommendation #1: Employers should require a thorough examination of a work area for debris and fixtures before lawn mowing and require employees to flag or mark objects that cannot be removed.

Discussion: OSHA and other lawn maintenance organizations recommend a thorough sweeping of a work area, removing debris and temporary fixtures, such as metal stakes, before performing any landscaping tasks [OSHA no date; KSU 2009]. Employees or homeowners should flag or mark objects that cannot be removed so they are more visible. OSHA provides the following specific recommendations on sweeping an area before mowing in order to reduce the risk of injury from thrown objects:

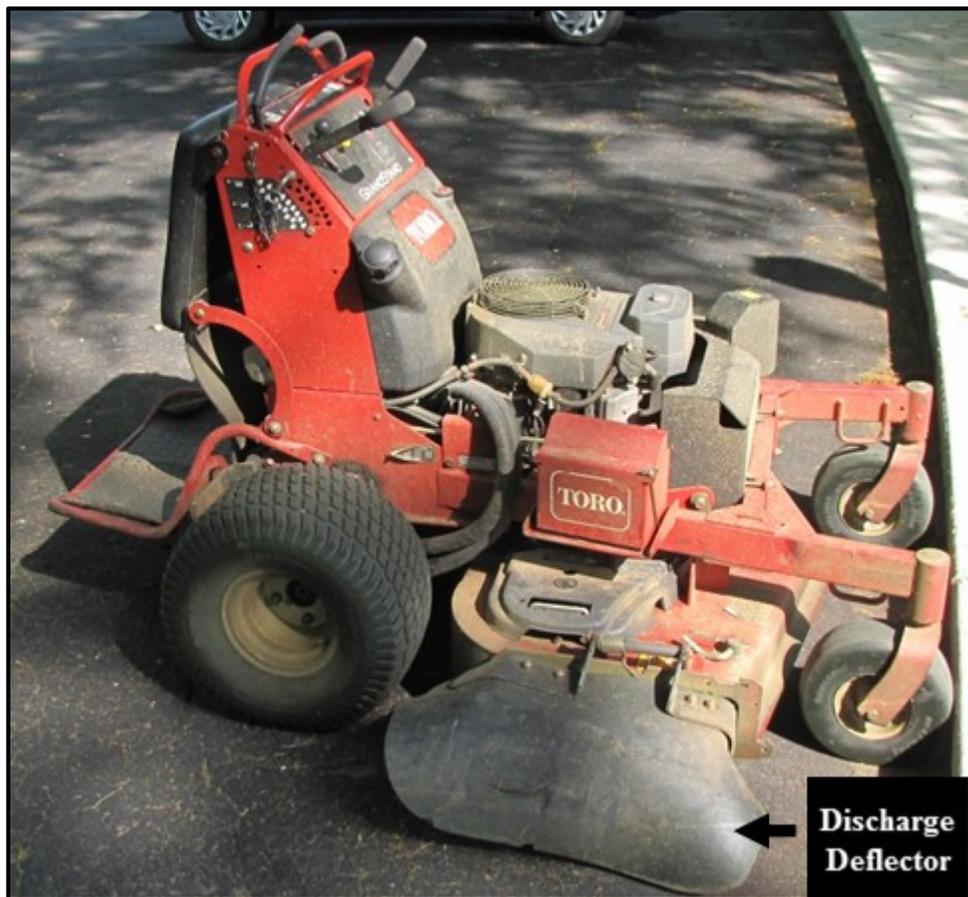
The mower was a 2009 Toro Grandstand commercial stand-on mower, model 74558, and purchased new at the start of the business, approximately 3 years before the incident (Photo 2). The mower was maintained and serviced regularly, according to manufacturer recommendations, by employees or the local dealer. The mower's operator manual is available online from the manufacturer's website in English, Spanish, and French [TORO 2008]. The distance from the ground to the bottom of the mower deck was about 4 inches. The distance from the ground to the flexible rubber grass discharge deflector ranged from 1–9 inches. According to the manufacturer, the maximum travel speed of the lawn mower moving over the ground was approximately 8 miles/hour, and the speed of the blade of this mower was 8,500 feet/minute or 96.6 miles/hour at the tip of the blade. Lawn mowers operate at blade speeds of 3,000 revolutions/minute and can propel an object at a speed up to 232 miles/hour [Coopwood 1976].

Photo 2. Stand-on lawn mower involved in this incident.
(Photo courtesy of NCDOL/OSH.)

lawn mower and hitting the lawn care worker on the side of the head. The discharge deflector was facing the area where the lawn care worker was standing when the incident occurred, although his exact location when struck by the metal projectile is not clear. There was no information on whether the deflector was in the horizontal position, as recommended by the manufacturer, at the time of the incident (Photo 2). The homeowner was working in their home office and noticed a loud noise but returned to work after seeing the lawn care worker on the phone. The homeowner was unaware the lawn care worker was involved in an incident until the ambulance had arrived.

Recommendation #3: Landscaping companies should consider adding a mulching chute attachment to lawn mowers to catch projectiles.

Discussion: Operators should keep the deflector lowered as outlined in the owner's manual, unless operating a grass catcher. Commercial lawn mowers can be fitted with a mulch chute to recycle cut grass to help catch any projectiles. Such accessories can be added by the distributor during purchase or later to the unit. Discharge deflectors can warp, diminishing their structural integrity and reducing the ability of the deflector to prevent an object from becoming a projectile. A damaged or warped discharge deflector should be replaced.
