# FACE IT: Report Visual Extension

# City Electric Maintenance Worker Electrocuted While Installing Lines for Security Cameras – Ohio (FACE 2019-01)

**REPORT#: 2019-01** **REPORT DATE: July 29, 2021**

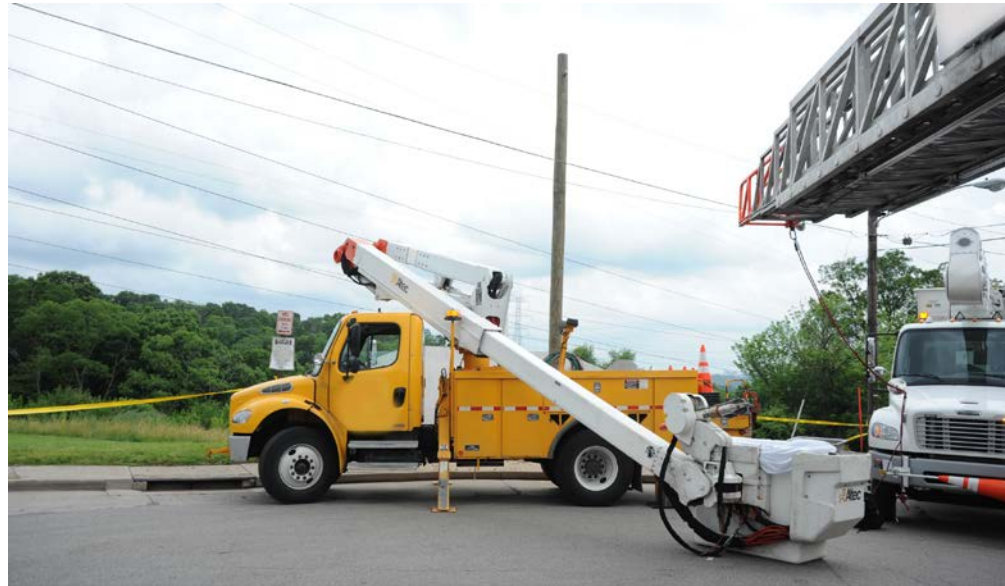
Freightliner M2 Aerial Lift Boom Truck  
(Photo courtesy of the City)

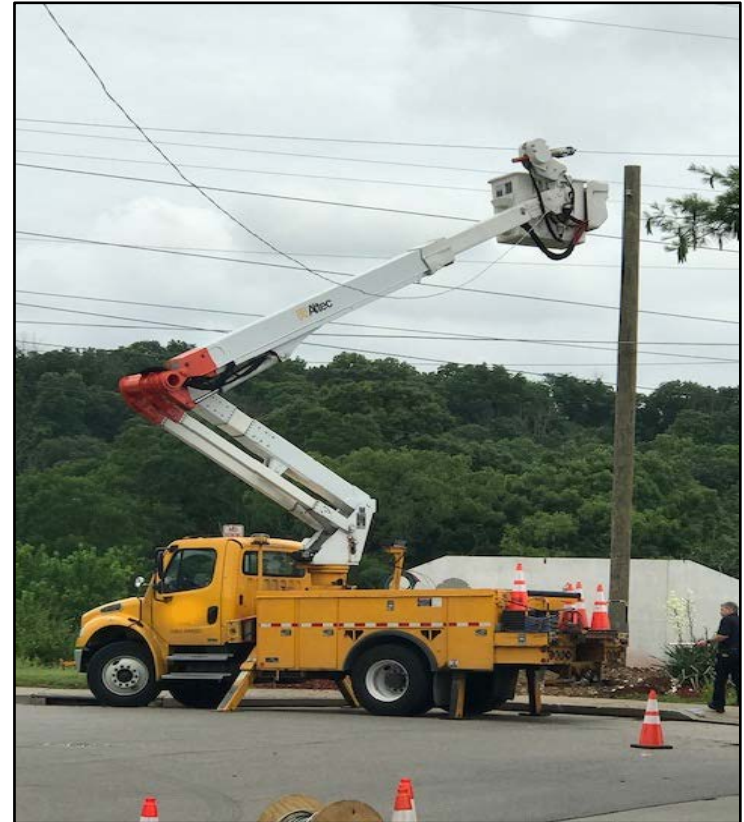
Position of bucket truck in cul-de-sac at the time of the incident. (Photo courtesy of the City)

- It is believed the worker did not realize his proximity to the power lines while performing this task and contacted his right shoulder with the energized power line
