REPORT#: 2021-01 **REPORT DATE:** May 16, 2022

Sanitation Worker Struck by Backing Refuse Truck – North Carolina

Fatality Assessment and Control Evaluation (FACE) Program

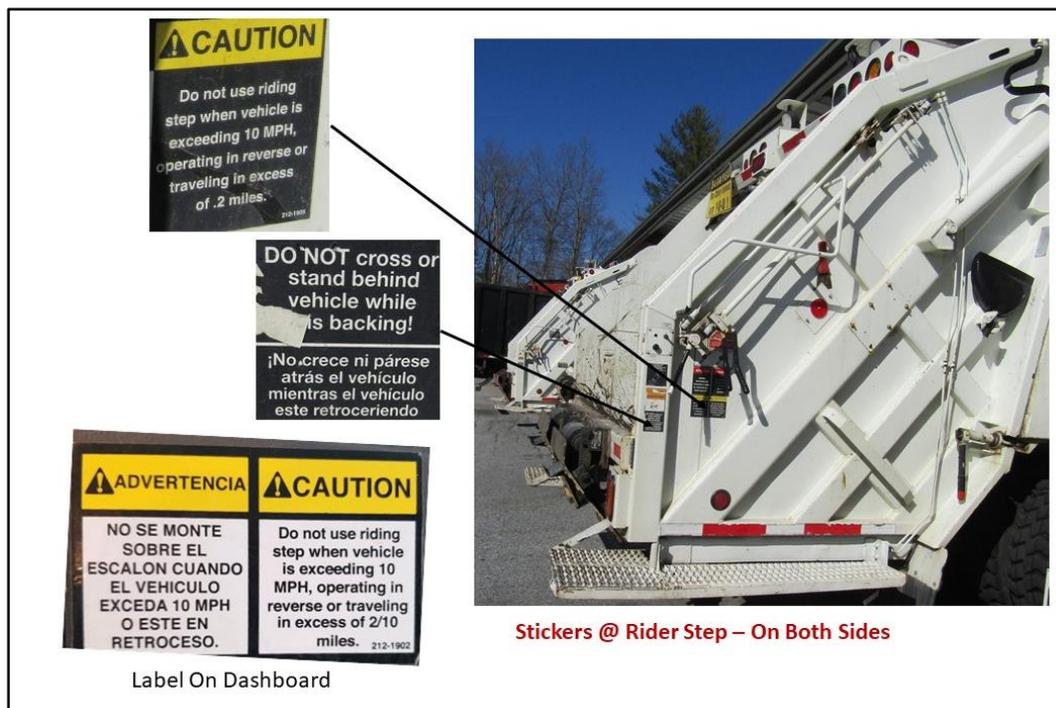
Photo 1. Passenger side rear label with locations on refuse truck. *Photo courtesy of NC OSHA*

Employees should be trained on safe driving and riding positions on refuse trucks when hired, yearly, as standards or equipment changes, and when an incident happens. Employers should ensure employees follow instructions on warning labels. The manufacturer stickers on the refuse truck instruct riders not to ride steps when in truck is operating in reverse, when traveling above 10 miles per hours, or when traveling continuously for 2/10 of a mile or more [Photo 1] [[ANSI 2017](#)].

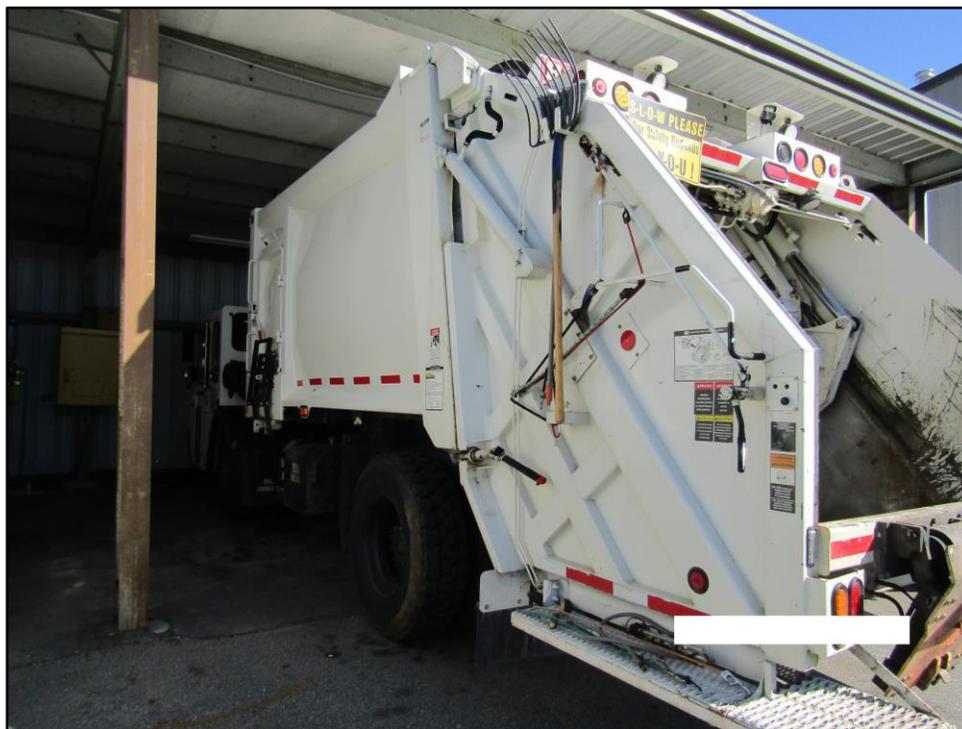
Photo 2. 2016 Crane Carrier model LETZ-30 truck chassis with a 2016 Heil model PT1000 refuse collection attachment. *Photo courtesy of NC OSHA*

The residential refuse collections are Heil refuse collection units with Hines Specialty Vehicle bodies. The truck was a 2016 Crane Carrier model LETZ-30 truck chassis with a 2016 Heil model PT1000 refuse collection attachment [Photo 2]. Designed with rider steps on both the right back (passenger) and left back (driver) sides [Photo 3]. The refuse truck had manufacturer installed grab handles on the side above the rider steps [Photo 4]. The manufacturer stickers on the

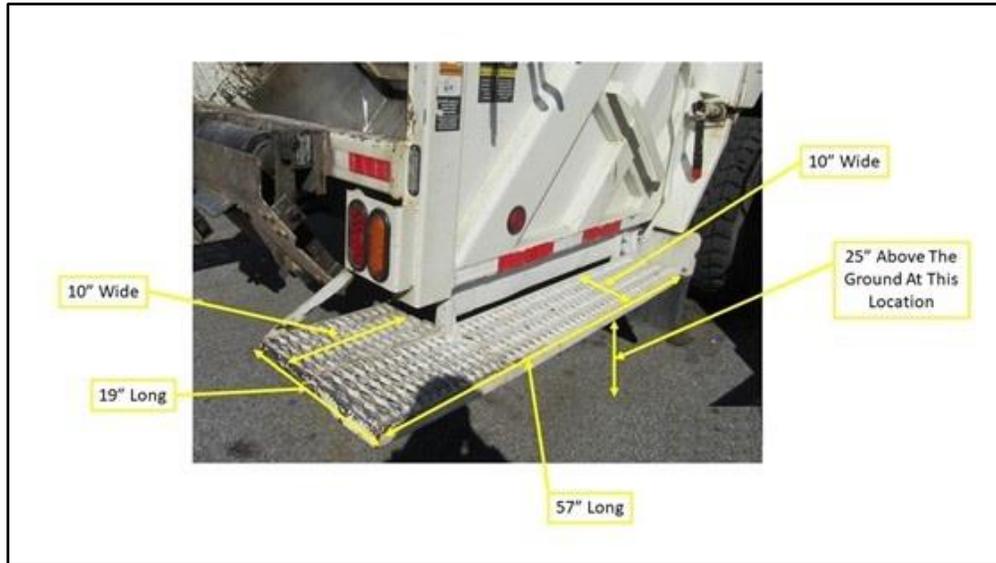
Photo 3. Rider step of refuse truck. *Photo courtesy of NC OSHA*

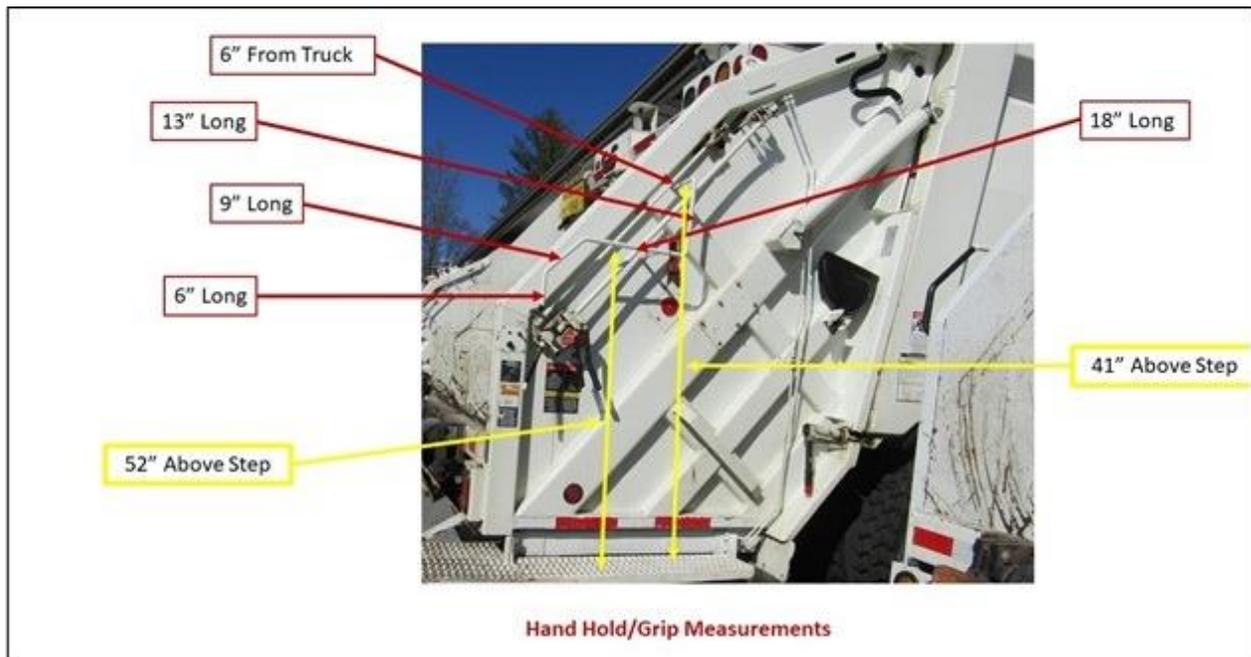
Photo 4. Hand holds of refuse truck. *Photo courtesy of NC OSHA*

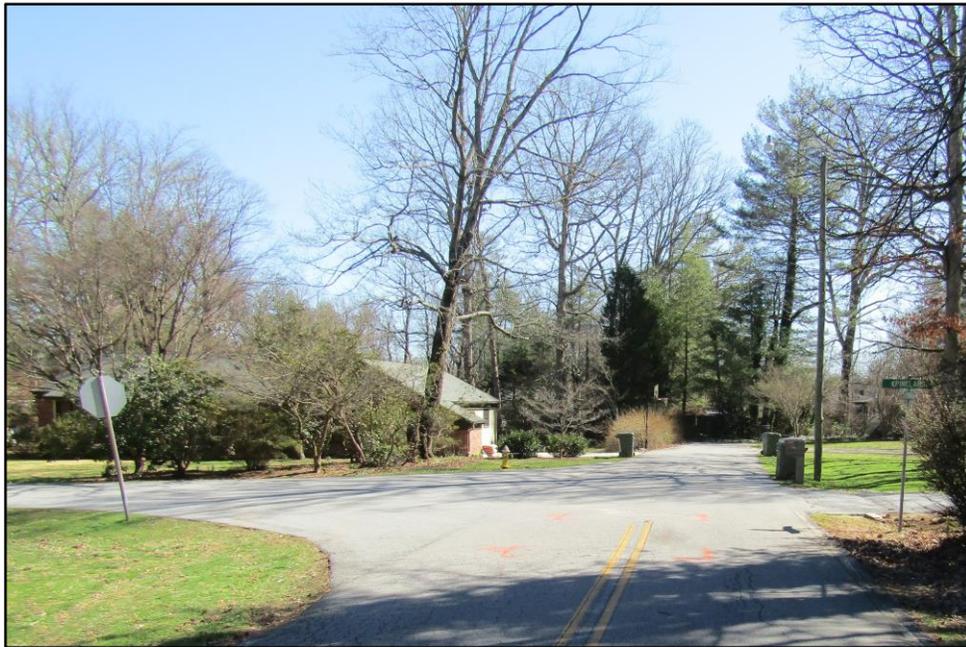
The incident occurred in a residential area at a “T” intersection of two streets. One of the arms of the T was a dead-end street [\[Photo 5\]](#). There were three dead-end streets on this specific residential route which required backing. The crew was on the shortest of the three dead-end streets, which was approximately 125 feet. The other dead-end streets were approximately 500 feet and 300 feet. The housing development where the incident occurred was established in the 1970s. The streets were paved with a posted speed limit of 20 mph. There was no room for street parking, no cars parked on the street, and no sidewalks. The street was 20 feet wide, and the sanitation worker was struck 153 feet from the dead end of the street near the “T” intersection [\[Diagram\]](#).

Photo 5. Incident scene. *Photo courtesy of NC OSHA*

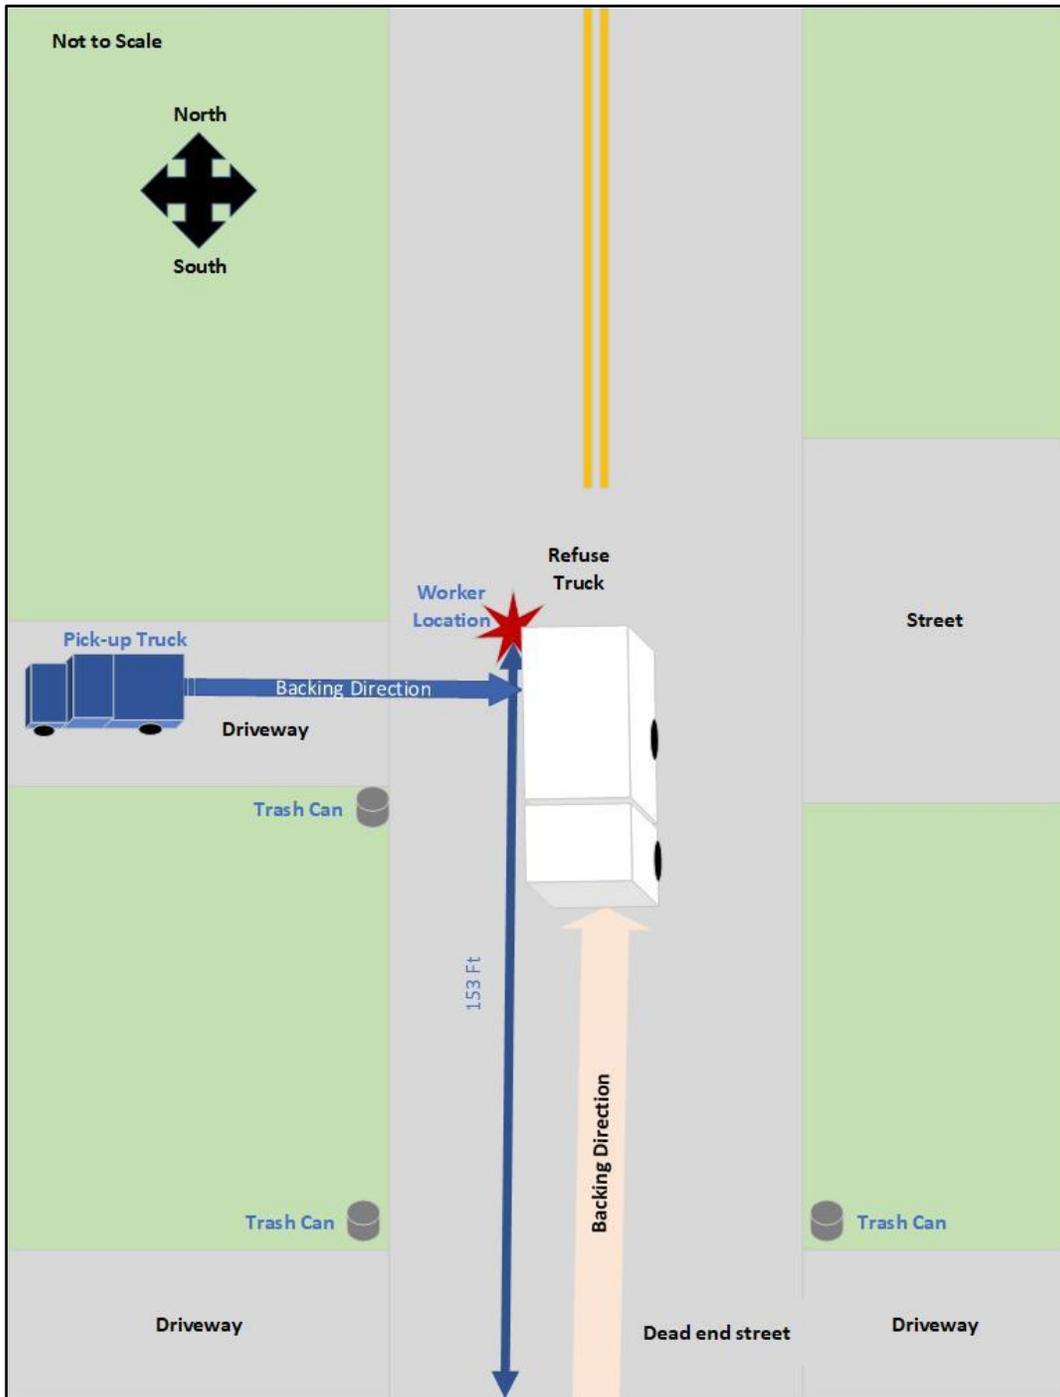
Diagram. Incident scene

With both sanitation workers riding on the back rider step following the stop at the “T” intersection [[Diagram](#)], the operator drove the refuse truck forward into the dead-end near the end of the pavement and stopped. One sanitation worker exited the right passenger side of the refuse truck to get the container on the right and the second sanitation worker exited on the left (driver’s side of the truck) to get the container on the left. At approximately 8:40 am, after dumping the containers, the two sanitation workers got back on their rider steps, and the operator began backing the refuse truck out of the dead-end. At some point the sanitation worker on the right got off the step and was walking along the right passenger side of the refuse truck getting trash cans. As the refuse truck backed up, the sanitation worker on the right observed a pick-up truck from a residence backing out of the driveway on the driver’s side of the truck at a rapid rate and thought it would hit the truck. The sanitation worker on the right yelled at the sanitation worker on the left and pointed to the backing vehicle. The sanitation worker on the left was startled by the backing pick-up truck and jumped from the rider step and landed on the road behind the moving refuse truck. The sanitation worker on the right hit the buzzer to notify the operator to stop. The refuse truck operator did not hear the buzzer notification and might have had the windows up with heat running. The refuse truck operator applied the brakes but was not able to stop the truck before it ran over the victim. The sanitation worker on the right reported the pick-up truck stopped on the road and only missed the refuse truck by about six inches. Following the incident, the operator placed a call to 911 then to the employer. Emergency response personnel were dispatched by 911 and pronounced the worker dead at the scene.
