FACE IT: Report Slides

Sanitation Worker Struck by Backing Refuse Truck – North Carolina (FACE 2021-01)

REPORT#: 2021-01 REPORT DATE: May 16, 2022

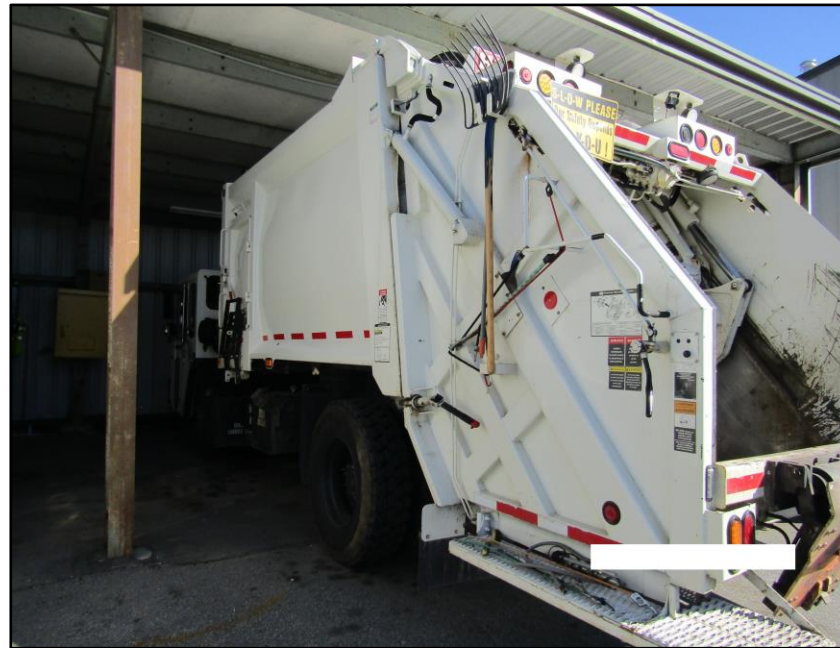
2016 Crane Carrier model LETZ-30 truck chassis with a 2016 Heil model PT1000 refuse collection attachment. *Photo courtesy of NC OSHA*

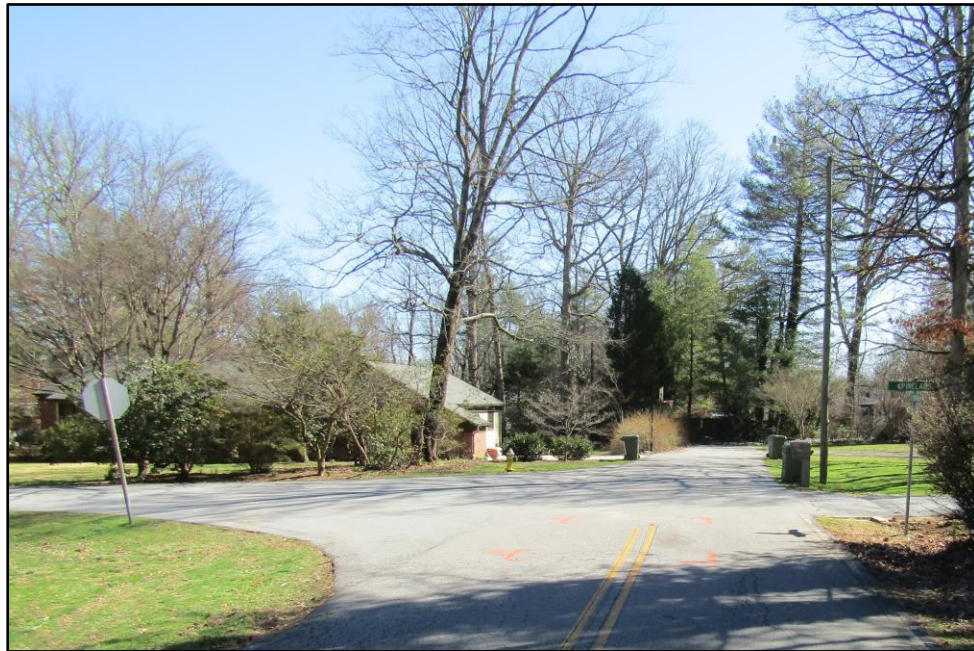
Incident scene. *Photo courtesy of NC OSHA*

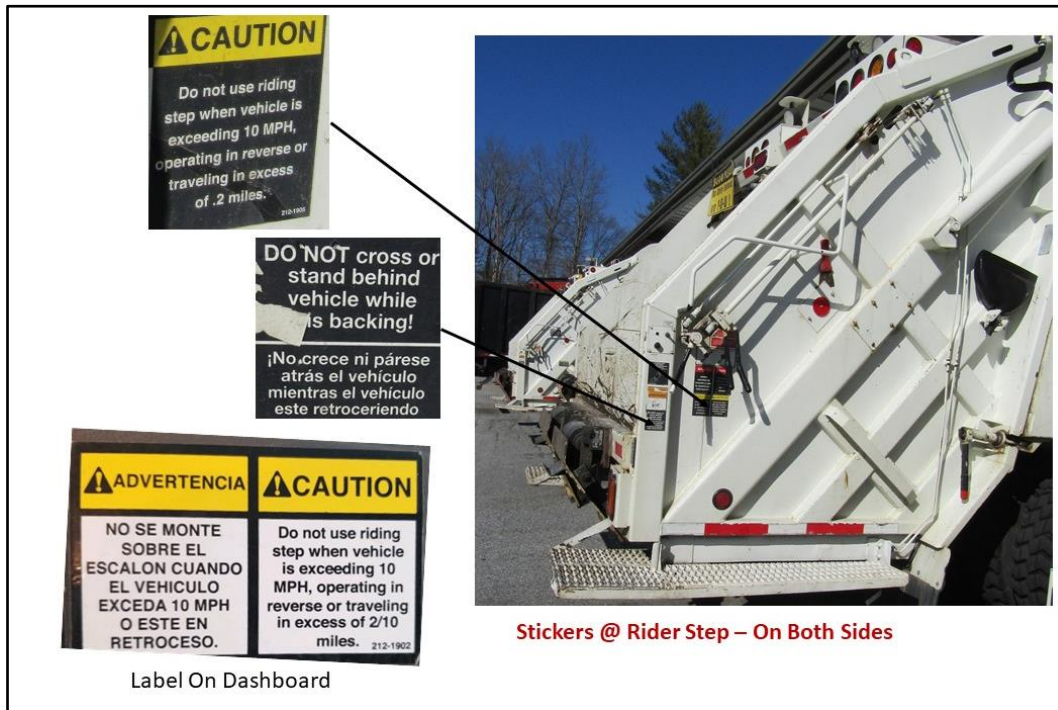
Passenger side rear label with locations on refuse truck. Photo courtesy of NC OSHA
