FACE IT: Report Slides

City sanitation refuse truck driver struck-by motorist – North Carolina 2022-01

Fatality Assessment and Control Evaluation Program

REPORT#: 2022-01 **REPORT DATE:** April 24, 2023

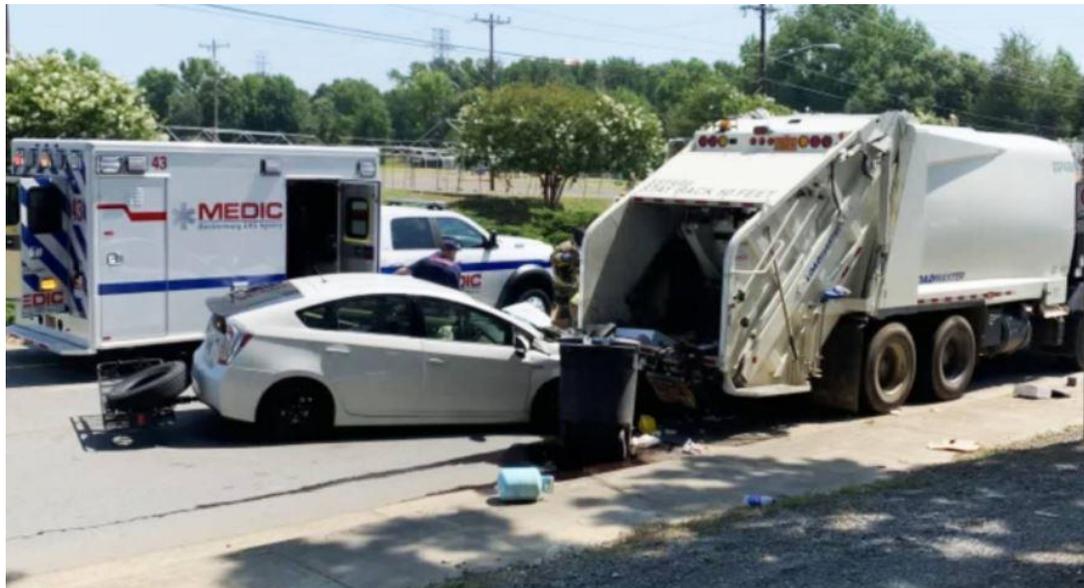
Photo of the scene where the incident occurred. (Photo courtesy of NC OSH)

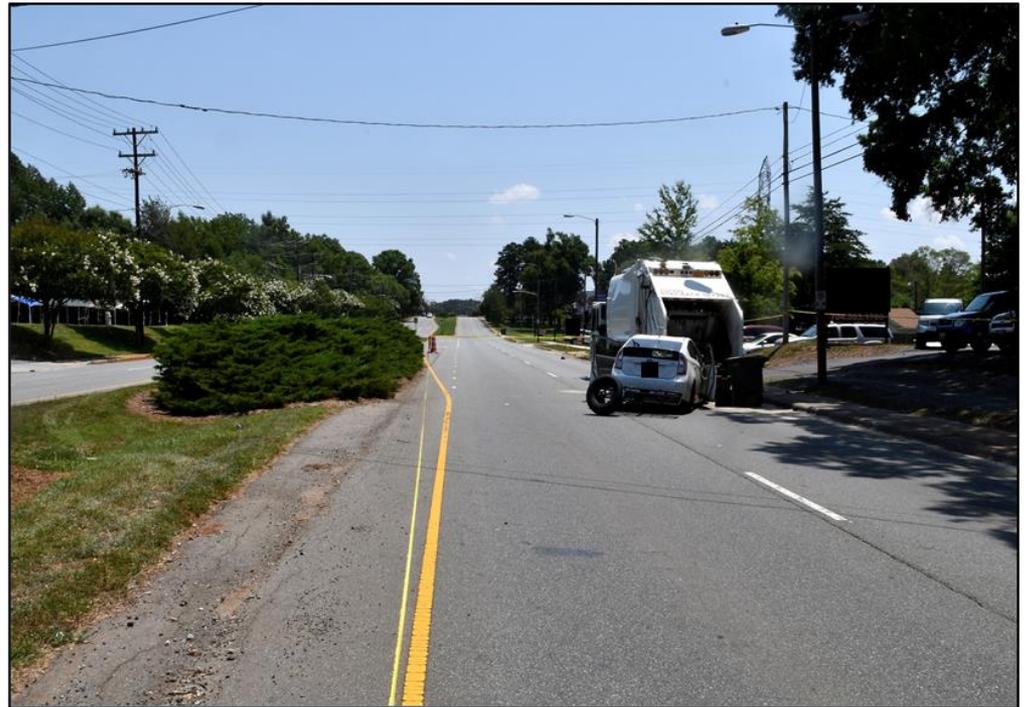
Photo of the scene where the incident occurred. (Photo courtesy of NC OSH)

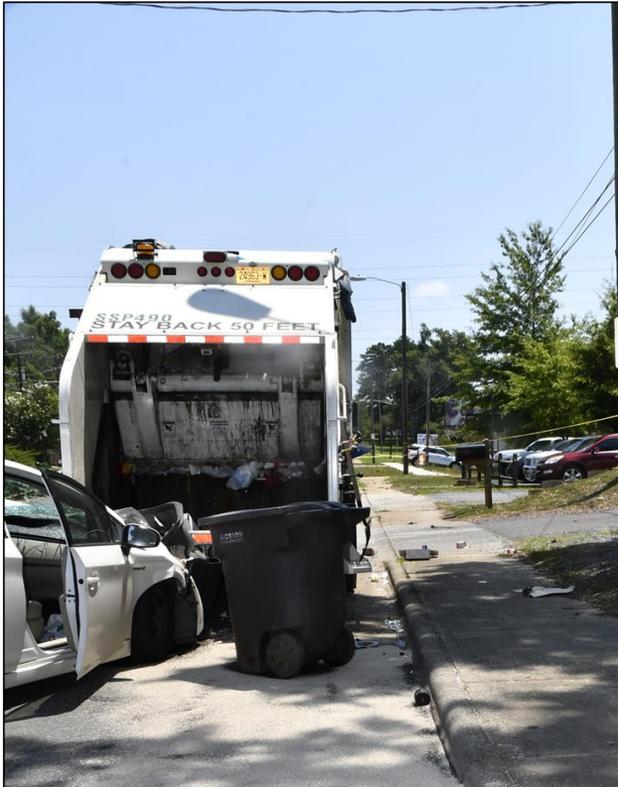
Photo of the scene and back of the sanitation/refuse truck. (Photo courtesy of NC OSH)

- The city sanitation refuse truck driver was at the back driver side of the refuse truck loading trash along with a sanitation technician who was positioned at the back passenger side of the truck at the time of the incident.
- A male motorist in his mid-60s did not brake or change lanes away from the refuse truck and collided with the refuse truck, pinning the sanitation refuse truck driver.
- The sanitation refuse truck driver was transported to the hospital and later died as a result of his crushing injuries.

- Employers should select refuse equipment that reduces struck-by injury hazards and minimizes roadside traffic exposure to sanitation workers.
- Employers should conduct job hazard analysis (JHA) to identify potential hazards and risk factors and develop effective measures to prevent worker injuries associated with each refuse collection task.
- Employers should educate and train employees on risks associated with working on roadways with passing motorists and the need to maintain heightened situational awareness.

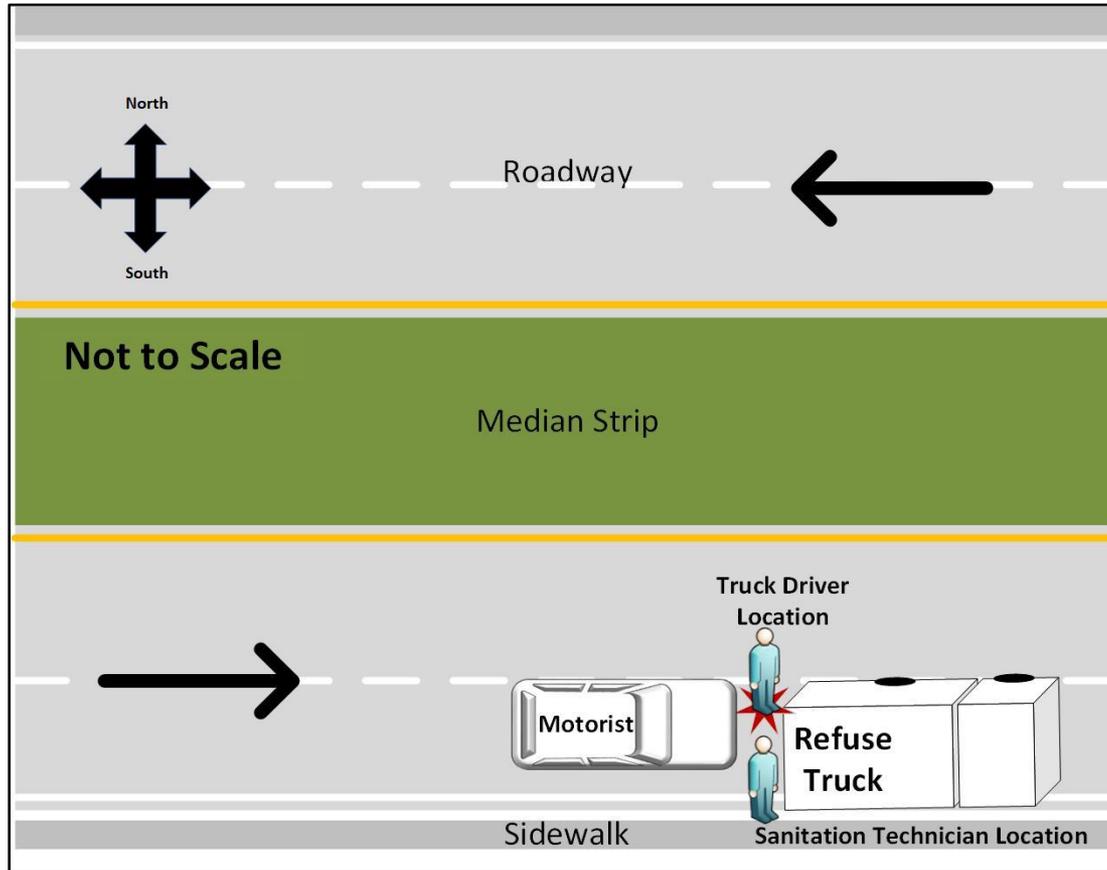
Drawing of the location of the sanitation workers and motorist at the time of the incident.

(Note: diagram is not to scale)

- Sanitation truck driver position in relation to traffic flow
- Motorist travel position, speed, and inattention

- Employers should ensure workers are visible to motorists.
- Employers should ensure equipment is visible to motorists.
- States, counties and municipalities should consider creating and promoting public awareness campaigns to educate motorists on move over laws.
