Status Investigation Report of One  
Self-Contained Breathing Apparatus  
Submitted by the  
Washington Police Department  
Washington, Pennsylvania

NIOSH Task No. 15057

January 18, 2008

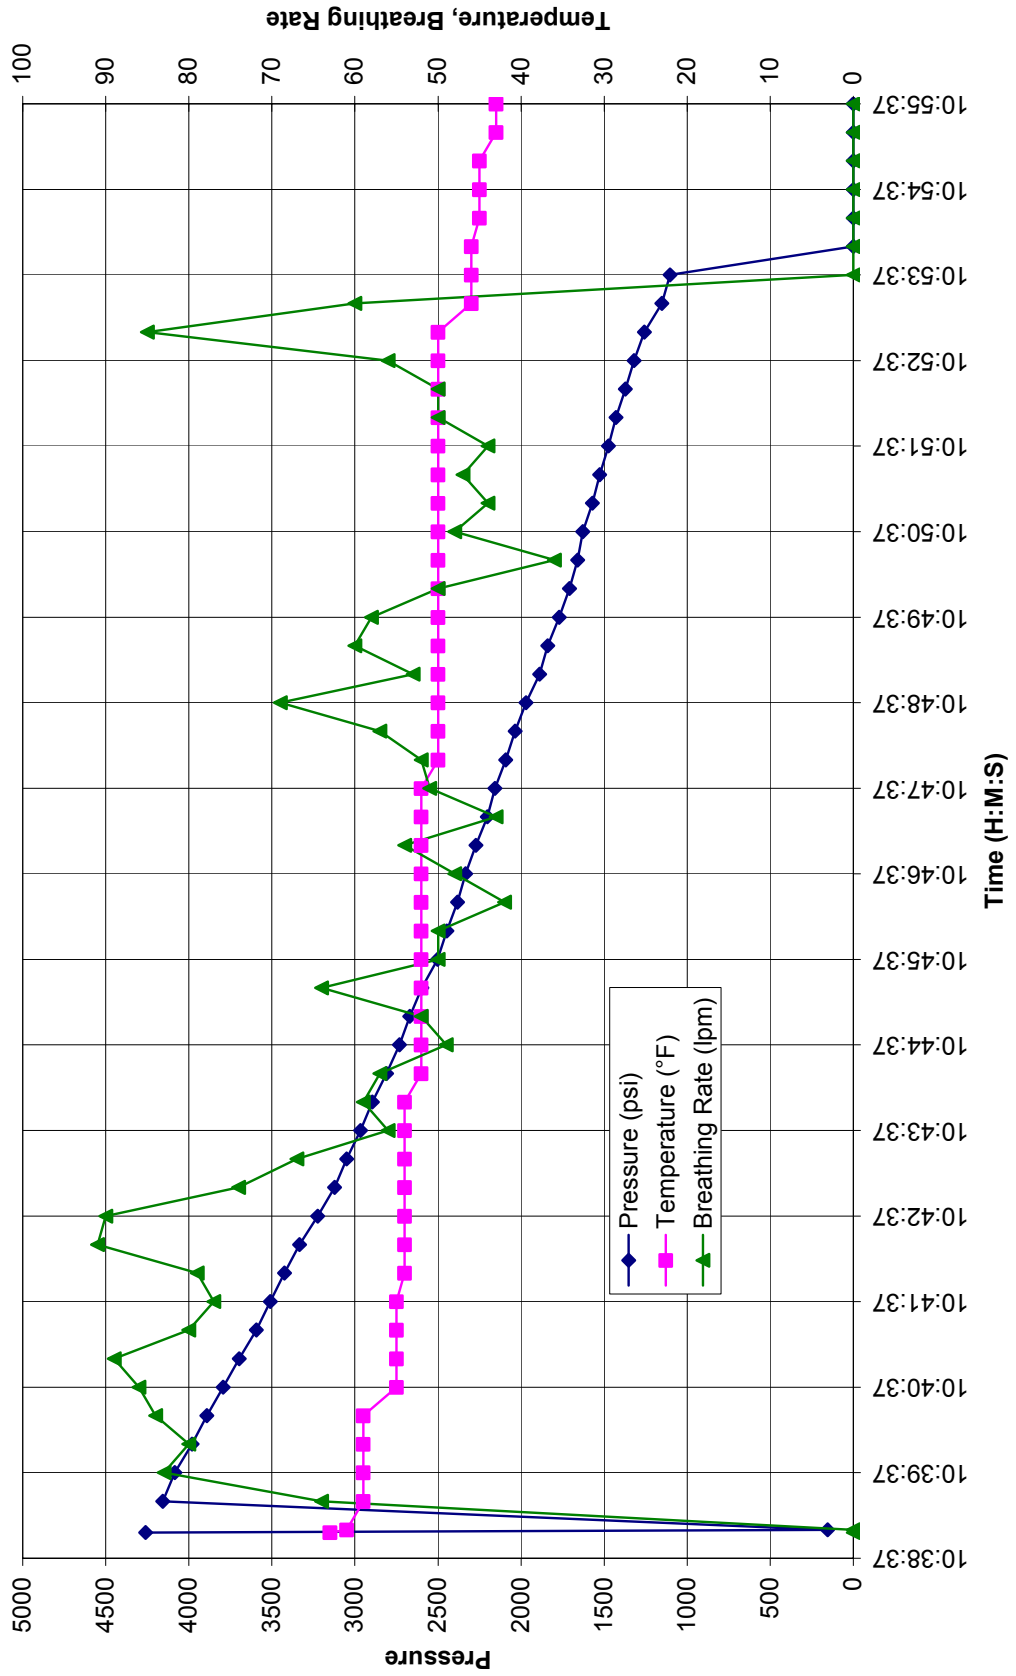
It was found that the unit contained usage data marked with the dates 12/31/1998, 7/5/2000, 7/12/2000, 7/16/2000, 8/6/2000, 8/10/2000, 8/25/2000, 9/6/2000, 9/13/2000, 9/19/2000, 9/25/2000, 9/27/2000, 10/5/2000, 11/23/2000, 11/24/2000, 12/20/2000, 12/27/2000, 2/11/2001, 2/13/2001, 2/15/2001, 2/17/2001, 3/26/2001, 5/18/2001, 5/19/2001, 6/7/2001, 6/18/2001, 7/8/2001, 7/15/2001, 8/11/2001, 10/11/2001, 10/18/2001, 12/30/2001, 12/31/2001, 12/30/2003, 5/11/2004, 5/25/2004, 5/27/2004, 7/30/2004, 8/17/2004, 9/7/2004, 11/8/2004, 1/4/2005, 3/9/2005, 3/24/2005, 3/29/2005, 4/20/2005, 4/27/2005, 5/17/2005, 7/27/2005, 10/12/2005, 11/23/2005, 12/30/2005, 12/31/2005, 1/19/2007, 1/30/2007, 2/1/2007, and 2/5/2007. Graphs of the data from 2/5/2007 are attached in **Appendix II**. According to the downloaded data, the PASS device alarmed due to lack of motion at 11:37:15 on 2/5/2007, and the alarm was never manually activated on that date. The full data file will be provided on disc along with this report. It could also be determined that the device's thermal alarm was not activated, the half-empty warning alarm was enabled at 2230 psi, and the device was configured for a 30-minute duration 4500 psi cylinder.

Sentinel Data, 5 February 2007, Use #1

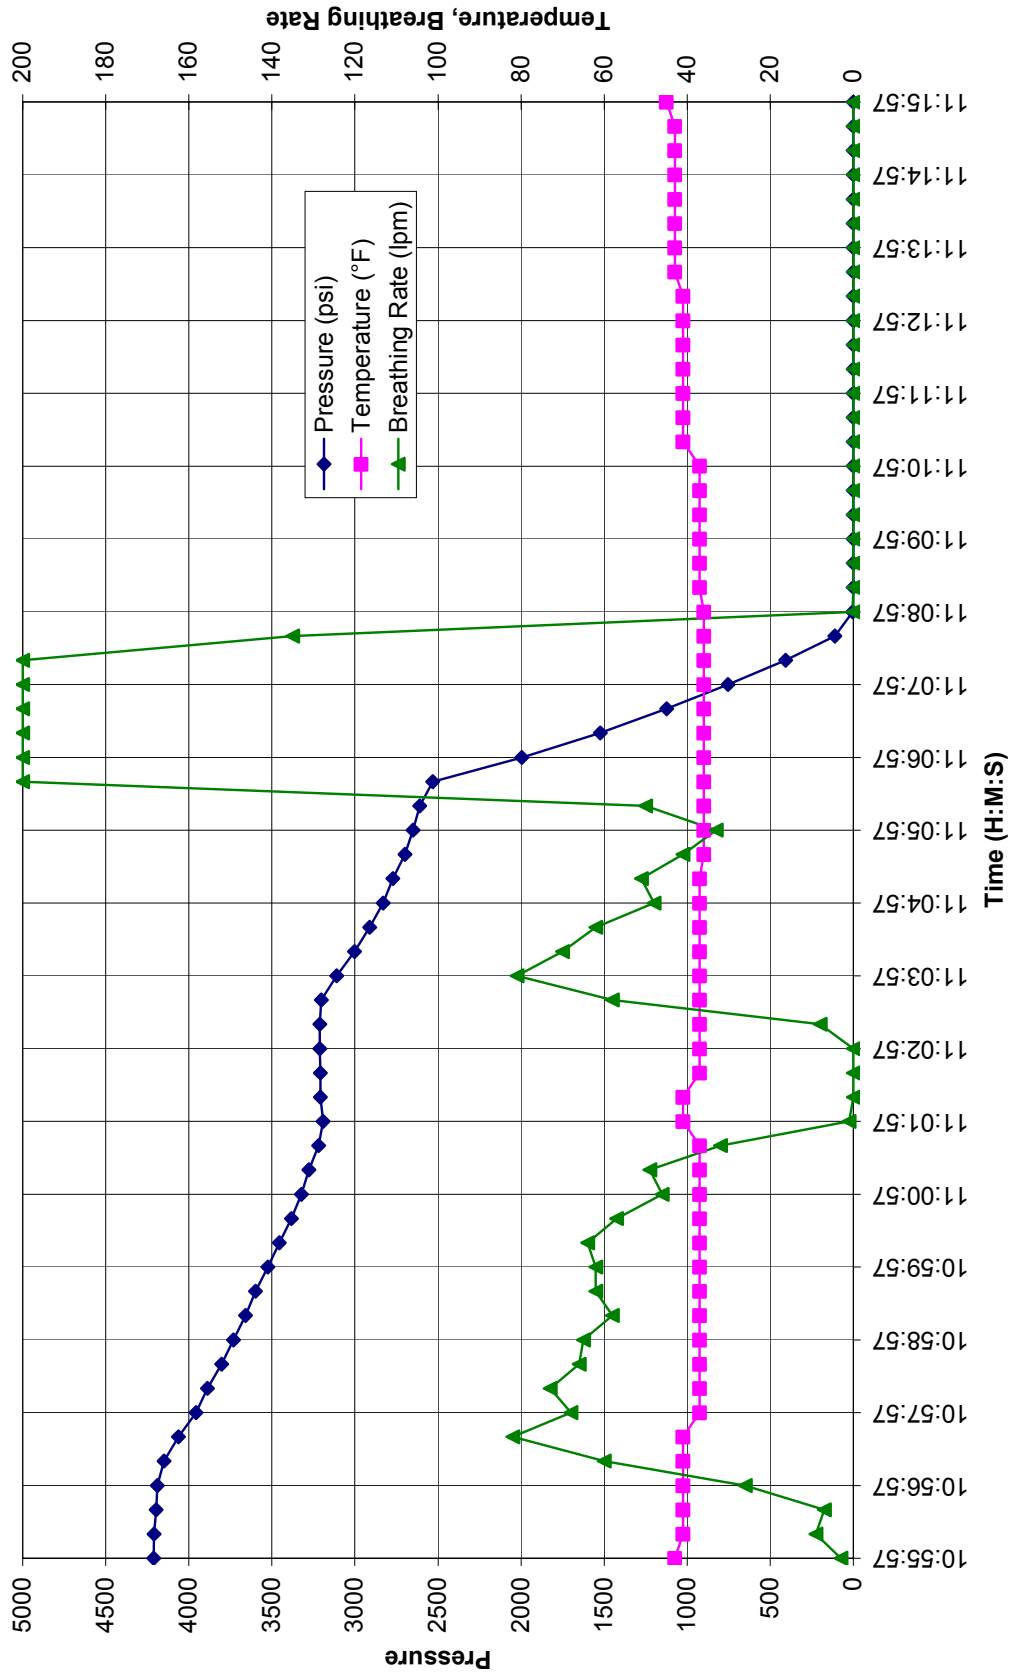
Sentinel Data, 5 February 2007, First 20 min. of Use #2

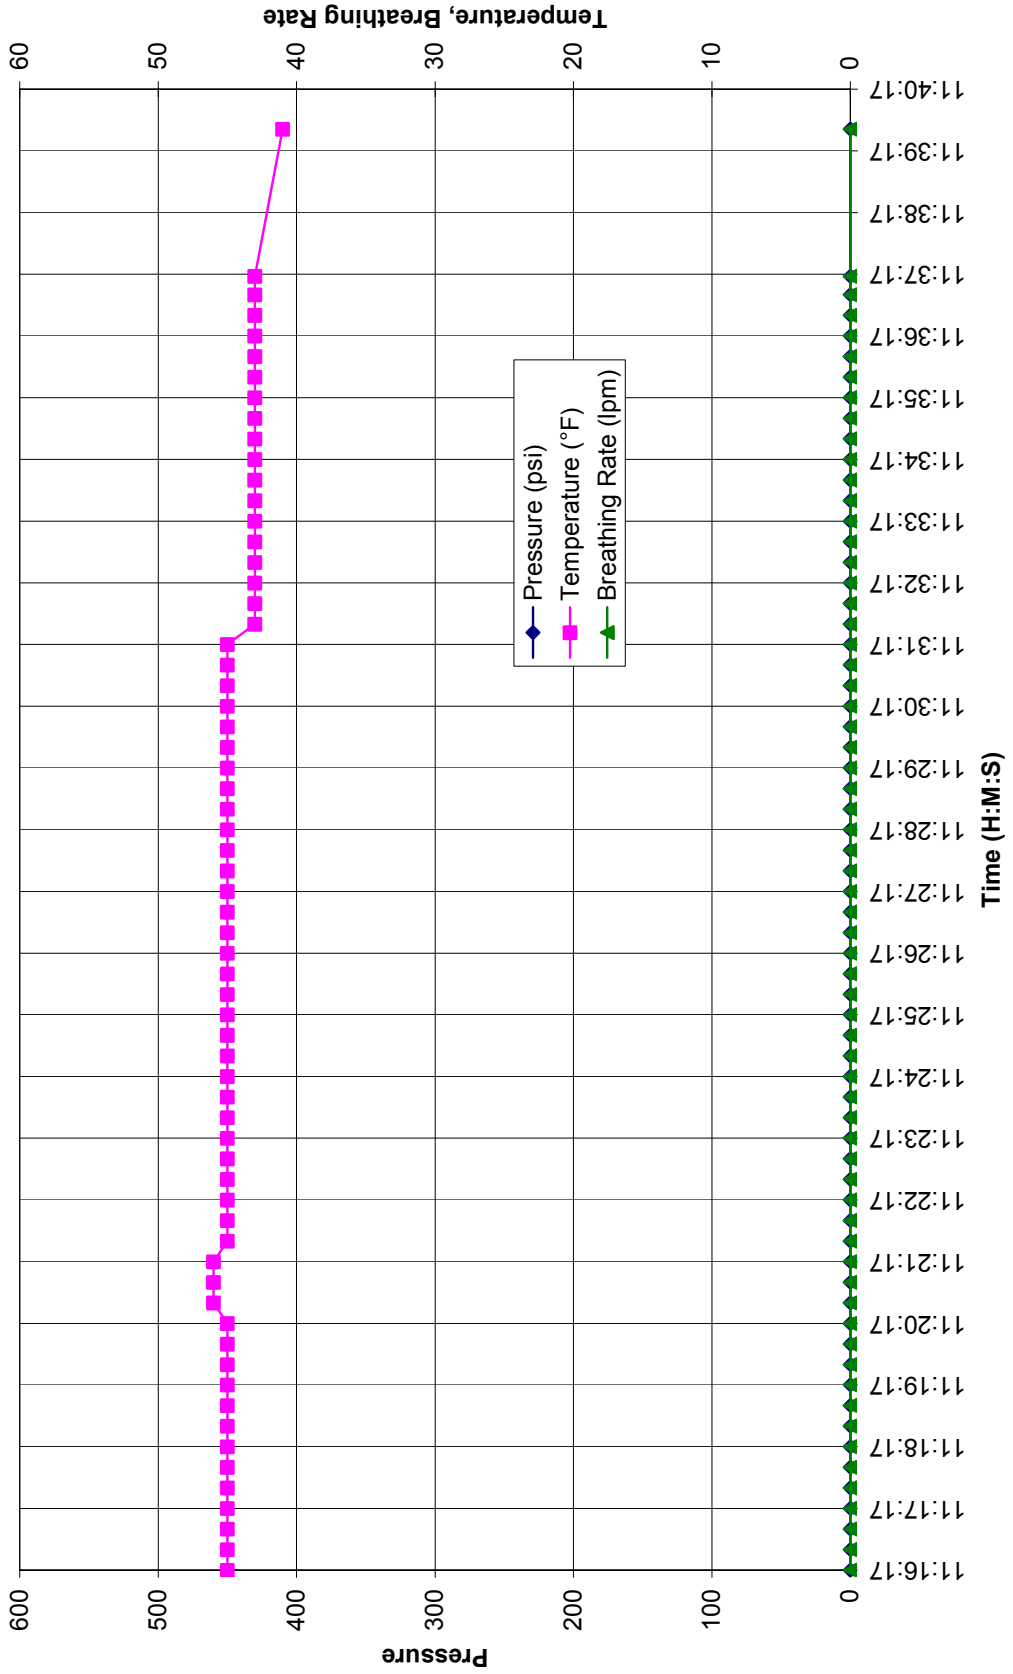
Sentinel Data, 5 February 2007, Remainder of Use #2

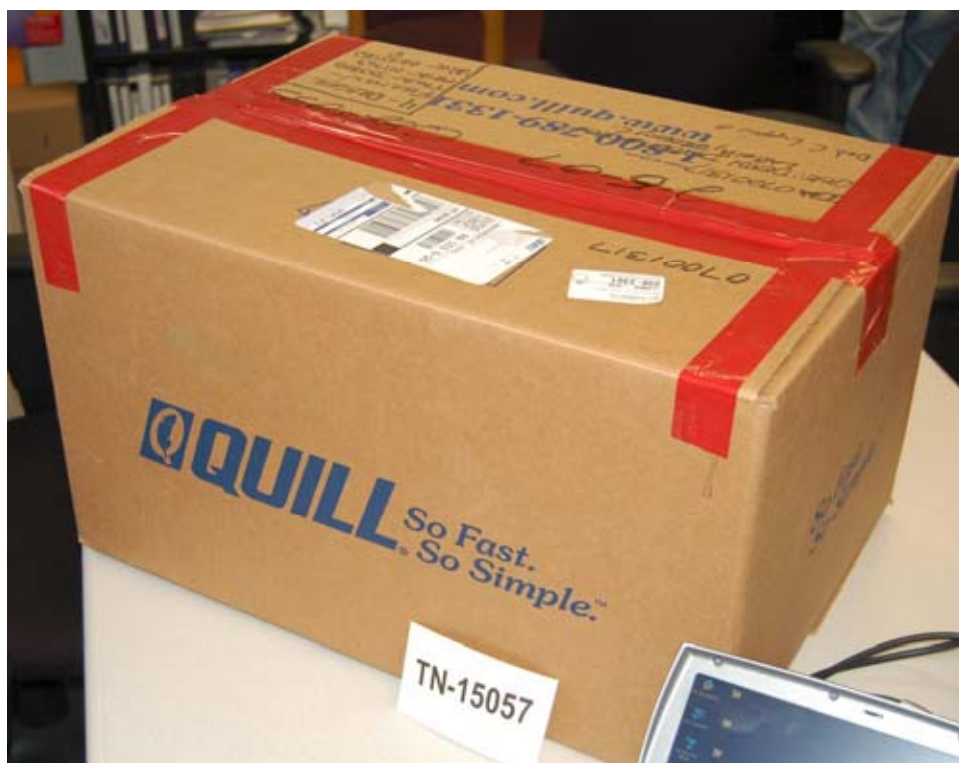
As received, the SCBA was packaged in a corrugated cardboard box (refer to **Figures 1 and 2** in **Appendix IV**).

Figure 1 – SCBA as Received from the Washington Police Department

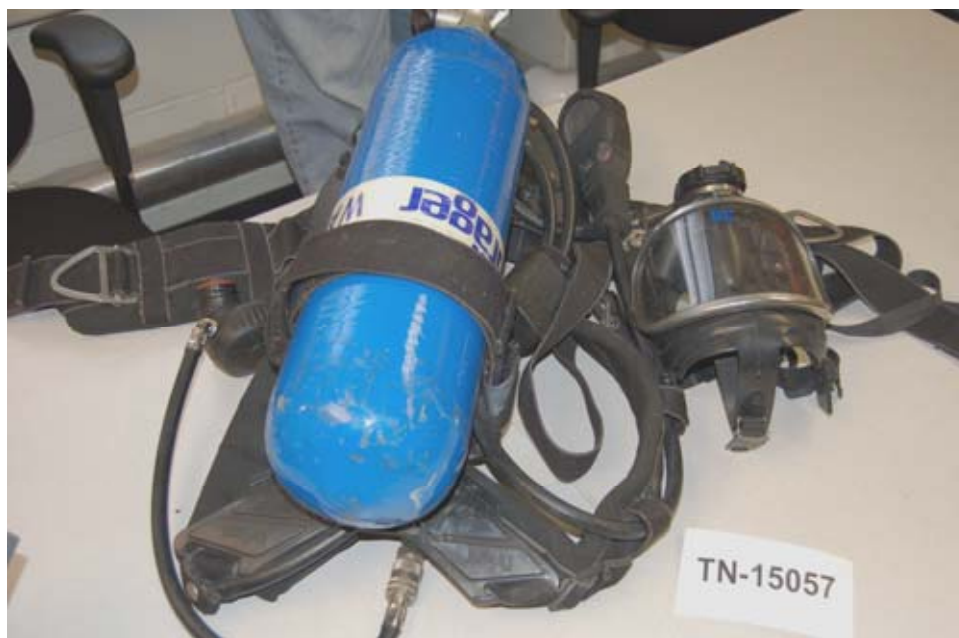
Figure 2 – SCBA Ready for Inspection

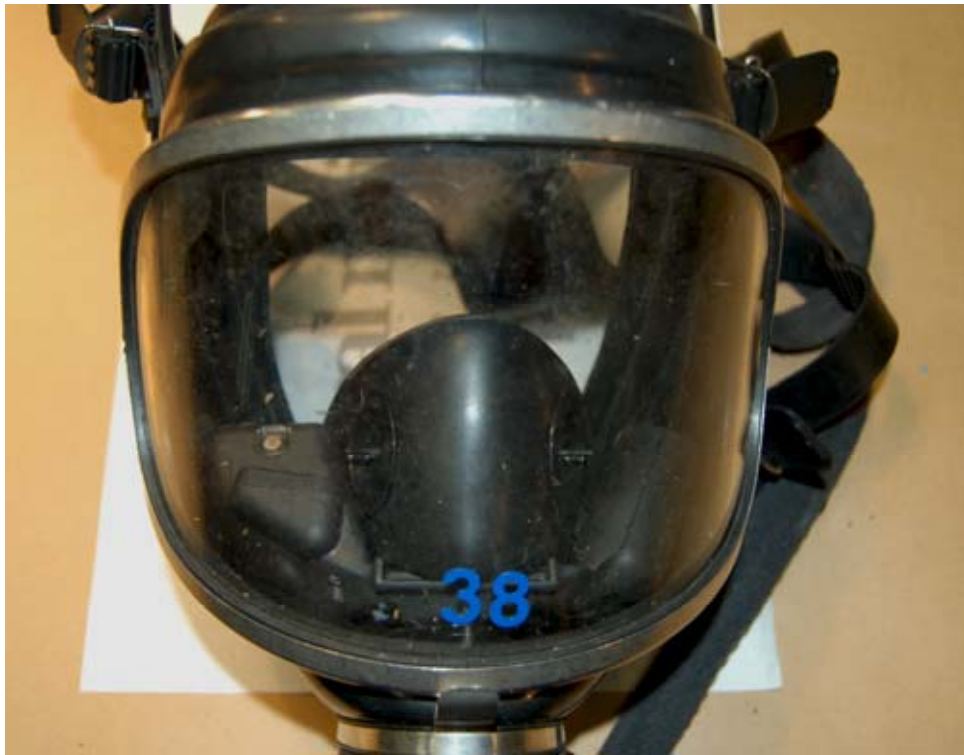
The facepiece appears to be a Dräger Panorama Nova EPDM facepiece assembly which consists of a rubber facepiece seal, lens, lens clamp, and rubber head harness. Overall the facepiece is in very good condition. The lens surface has a few scratches and is slightly dirty but remains intact. Visibility through the lens is very good to excellent. The number “**38**” is affixed to the bottom center of the lens. The lens clamp holds the lens to the faceseal. The clamp is intact and the two screws holding the clamp halves together appear to be fully tightened.

Figure 3 – Facepiece

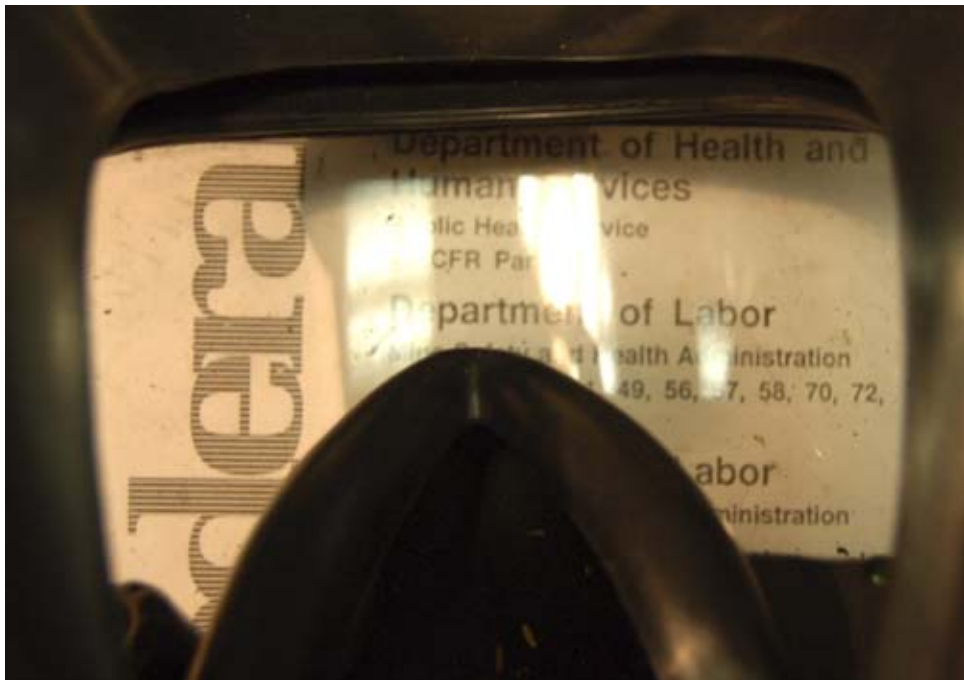
Figure 4 – Visibility through Facepiece Lens

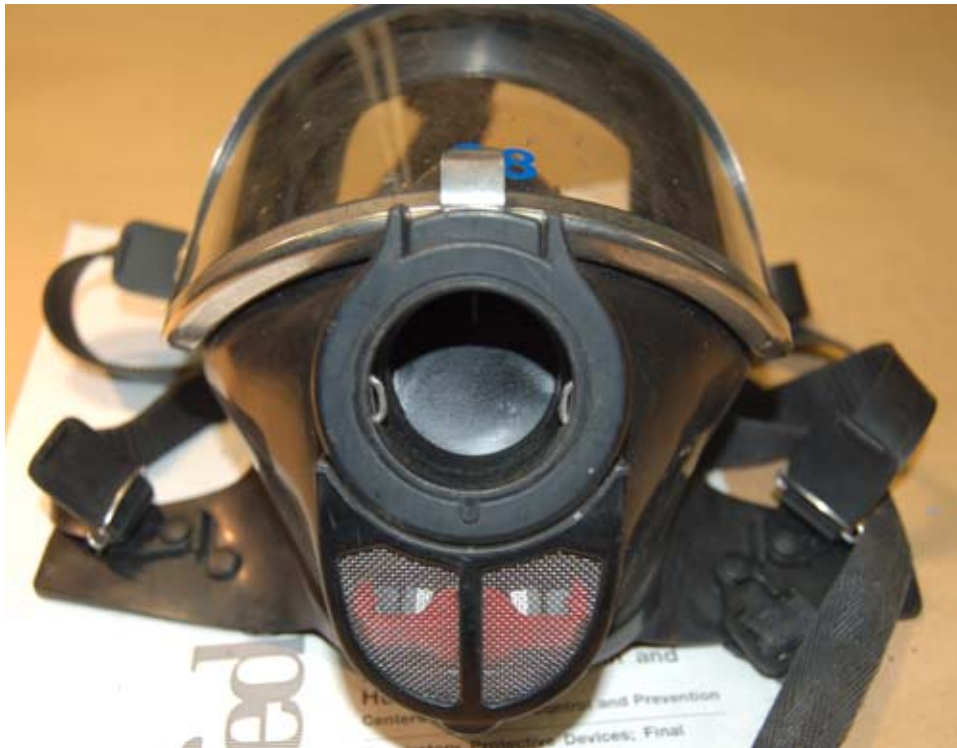
The assembly that houses the demand valve port, speech diaphragm, and exhalation valve sub-assemblies is in very good condition. The exhalation valve appears to be properly seated. A speech diaphragm is installed and appears normal. The demand valve can be easily attached to and removed from the housing. The clamp holding the housing to the faceseal is secure.

Figure 5 – Facepiece Demand Valve Port

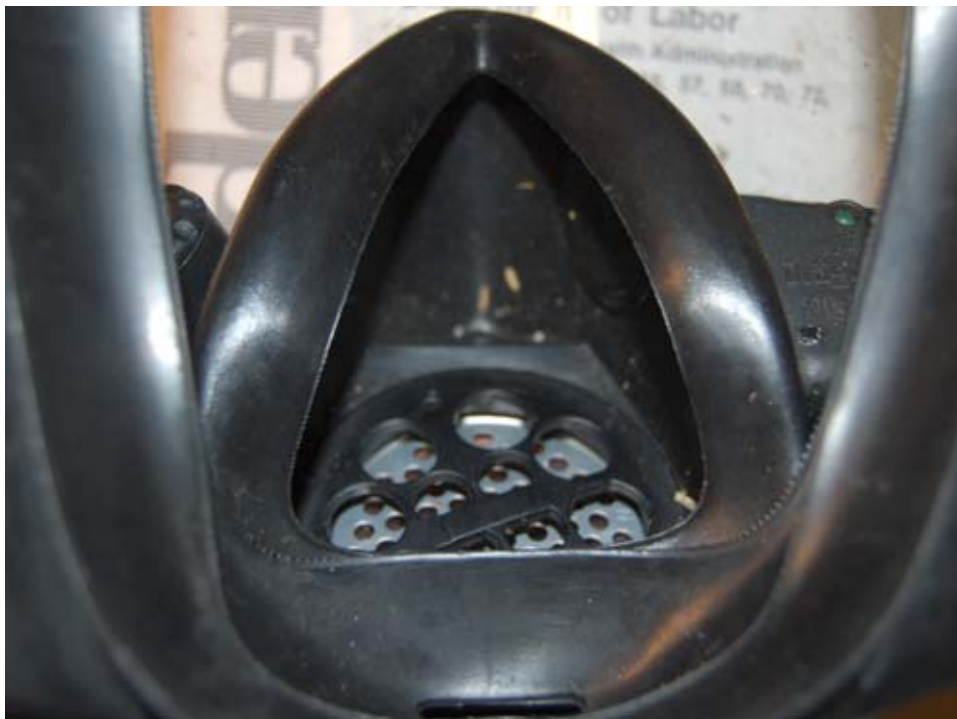
There is a black rubber nosecup assembly installed in the facepiece. The nosecup is firmly

attached to the facepiece assembly and the rubber is flexible and appears undamaged. The two inhalation valves installed in the nose cup are undamaged. There is a small amount of yellowish debris inside the nose cup. Molded on the nose cup interior is the part number “**R52822**” and a circular date code indicating it was molded in the **first half of 2004**.

Figure 6 – Nosecup Interior

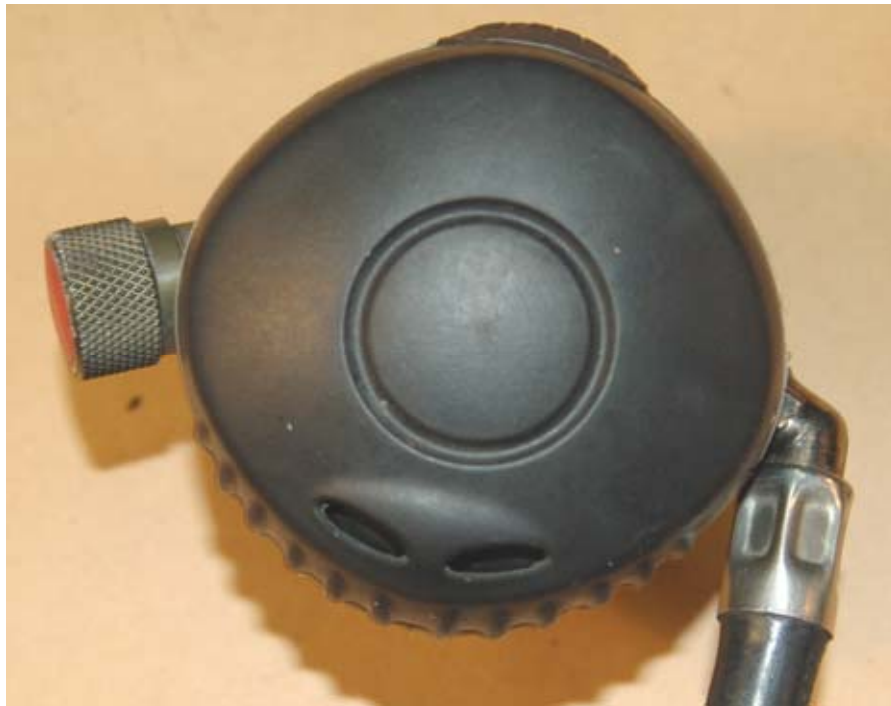
The facepiece-mounted lung demand valve (also known as the second stage pressure demand regulator) assembly is in very good condition overall. The barrel which connects to the facepiece is slightly separated from the rest of the housing body on the left side. The serial number “**BRSJ 1852**” is marked at the bottom, along with the letter “**P**.” The bypass valve on the right side is in the fully open position and operates smoothly. The donning switch is not engaged, and it can be set and released properly. The o-ring seal is intact and slightly dirty. The low pressure hose swivels freely where it connects to the demand valve.

Figure 7 – Lung Demand Valve

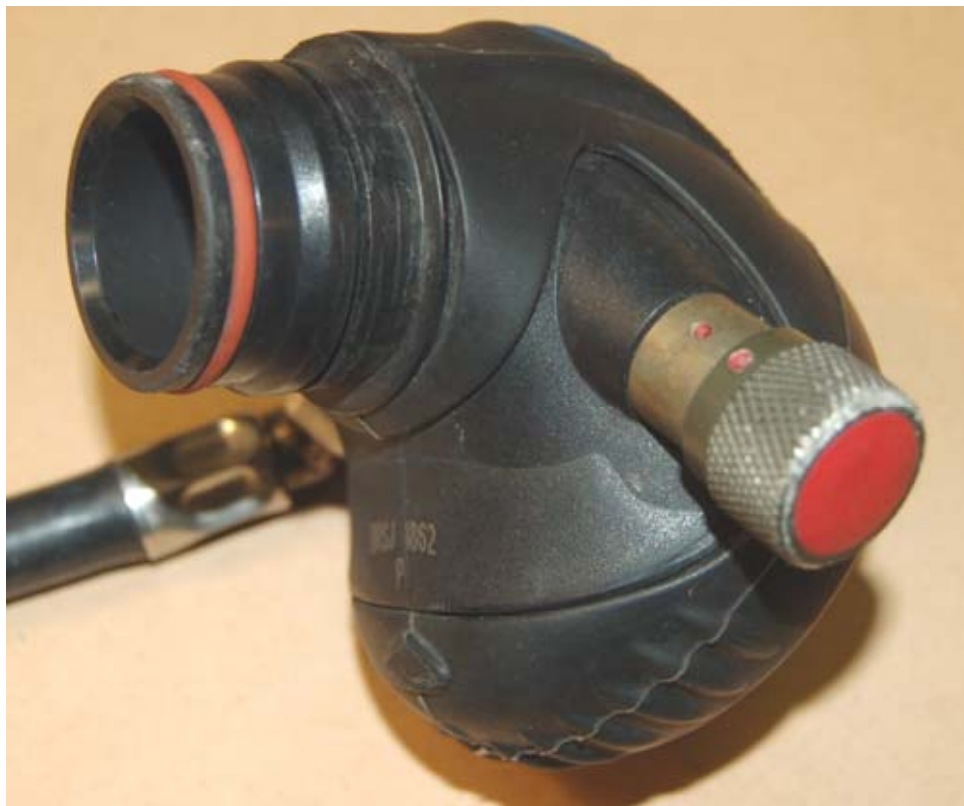
Figure 8 – Side View of Lung Demand Valve

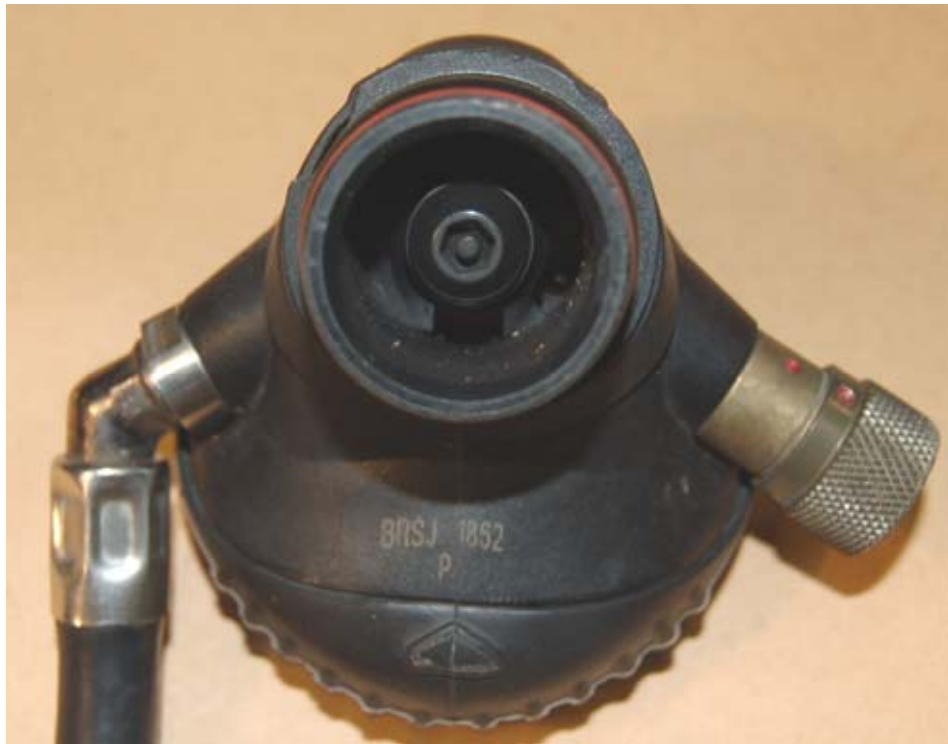
Figure 9 – Rear View of Lung Demand Valve

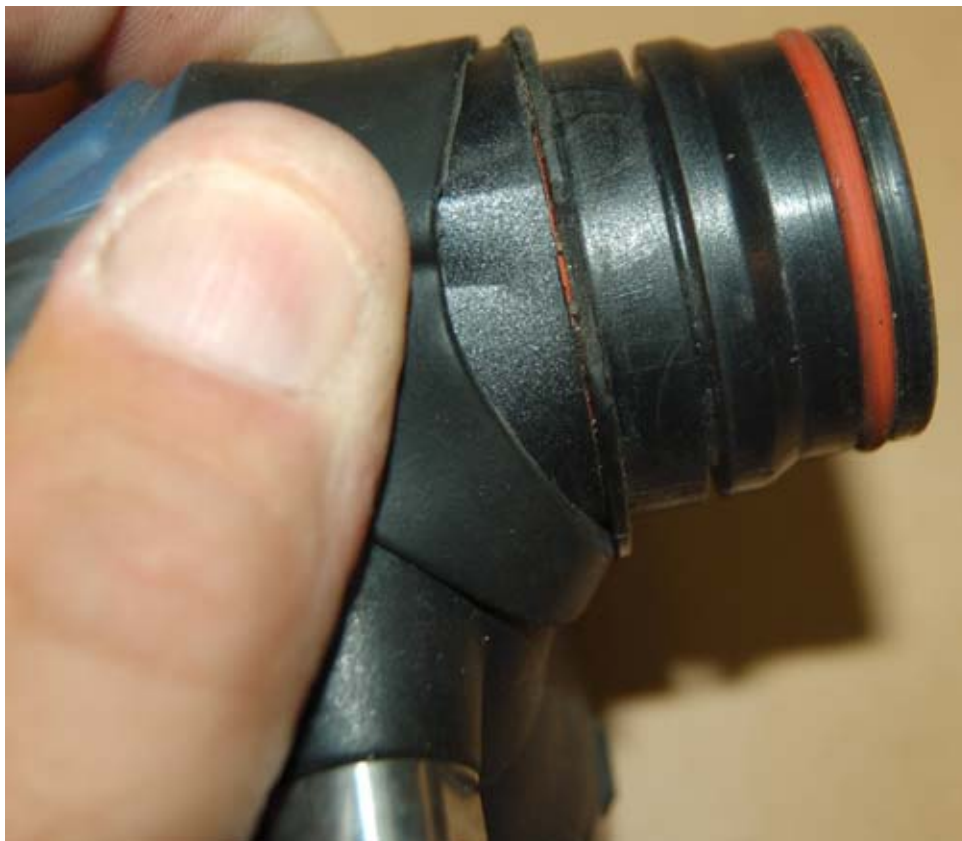
The SCBA generally appeared to be undamaged and overall in very good condition. The barrel of the lung demand valve was slightly separated from the housing body. Also, a few gouges were noted in the cylinder surface. Although this damage may require repair before the cylinder is returned to use, it was judged that the cylinder could safely be used for laboratory testing with appropriate precautions being observed.

Figure 10 – Separation of Barrel from Lung Demand Valve Housing

If the SCBA is to be placed back in service, it must be thoroughly inspected, repaired, and tested by a qualified service technician. The damage to the cylinder should be evaluated and, if necessary, repaired by a certified retester before it can be put back into use.

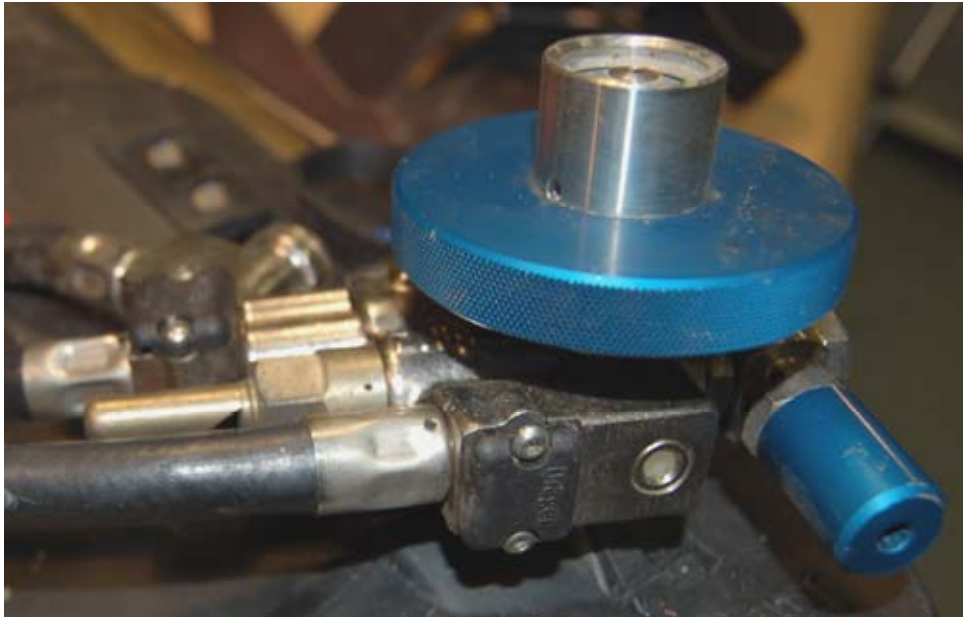
The air pressure reducer (also known as the first stage regulator) appears to be in very good condition. The exterior of the metal housing is somewhat dirty but undamaged. The reducer is securely fastened to the backframe. The housing is marked with the serial number “**BRTM 4657**” along with the designations “**03**” and “**3351941**.” The low-air alarm whistle attached to the housing is intact and the whistle outlet is not blocked. The cylinder connector nut and handwheel are undamaged. There is a small amount of white powdery corrosion on the cylinder sealing nipple, and the o-ring is clean and intact.

Figure 11 – Pressure Reducer

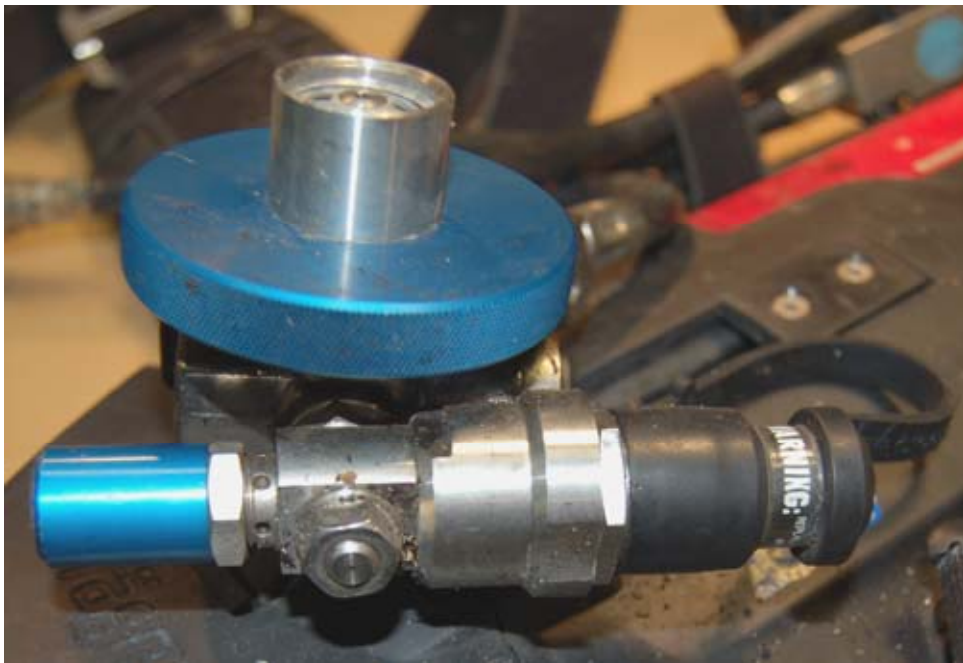
Figure 12 – Pressure Reducer

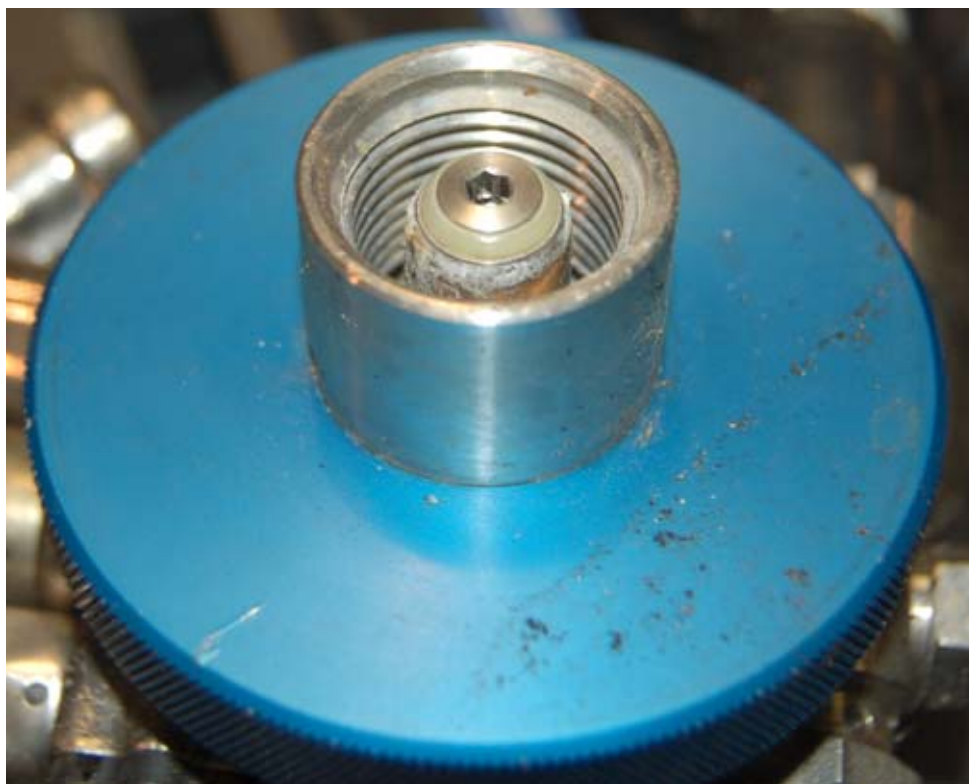
Figure 13 – Cylinder Connector Nut

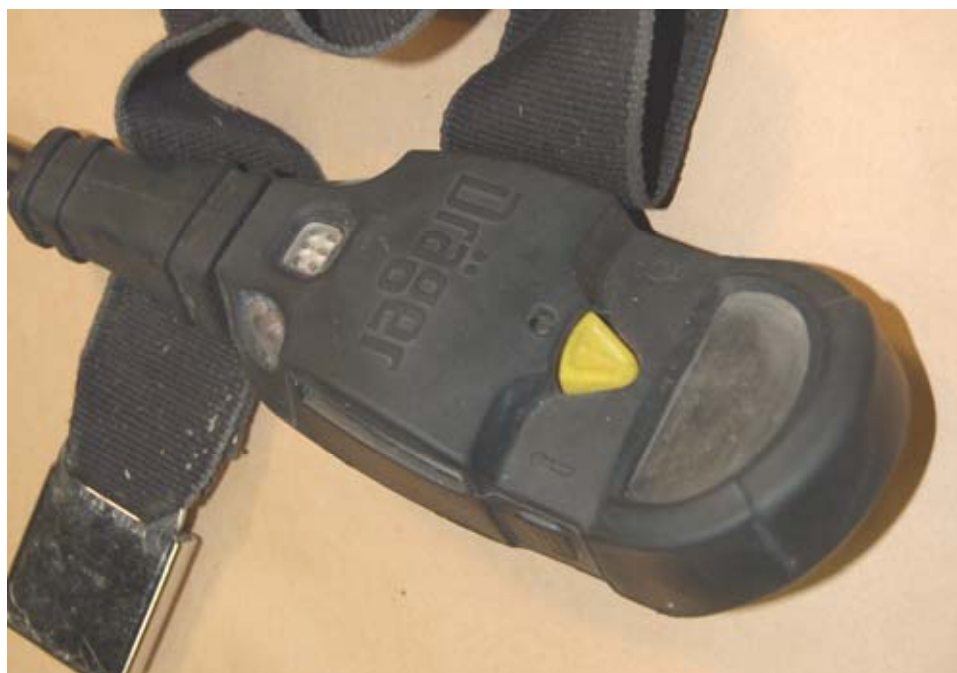
This SCBA is equipped with a Sentinel electronic remote air pressure gauge and PASS device. The gauge body is covered with a protective rubber boot. The lens is somewhat scratched and dirty, but the gauge still appears to be readable. The PASS device appeared to function normally. It was activated with the alarm button and went into full alarm, then was manually reset into the sensing mode. The device appeared to properly enter pre-alarm and was reset by motion. It was then allowed to proceed through pre-alarm to full alarm, which could not be reset by motion. Although NFPA 1982 contains specific requirements for the sensitivity, sound level, and other characteristics of PASS devices, these were not evaluated because NIOSH does not certify PASS devices. On the back of the unit is a label certifying the device to the **1998 edition of NFPA 1982** along with the serial number “**BRSL-1091**” and the manufacture date “**SEP/02.**”

Figure 14 – Remote Pressure Gauge/PASS Device

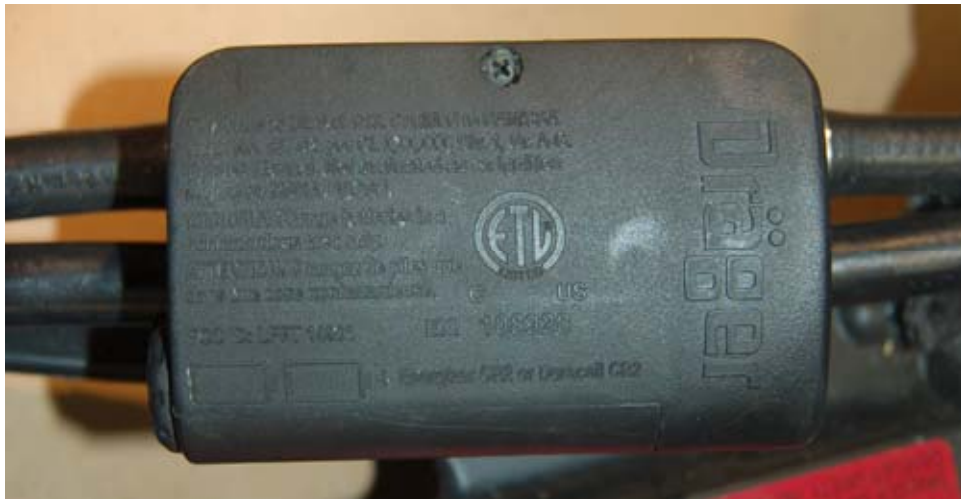
The gauge hose is undamaged is routed through the left shoulder strap to the heads-up display transmitter housing mounted on the left side of the backframe. This hose is marked “**Draeger R21034 07/03**” along its length. The heads-up display transmitter housing is in very good to excellent condition. A blue circular label handwritten with “**007328**” is affixed to the front. The hose running from the housing to the pressure reducer is also undamaged and is marked “**Dräger R21034 10/03.**”

Figure 15 – Heads-Up Display Transmitter

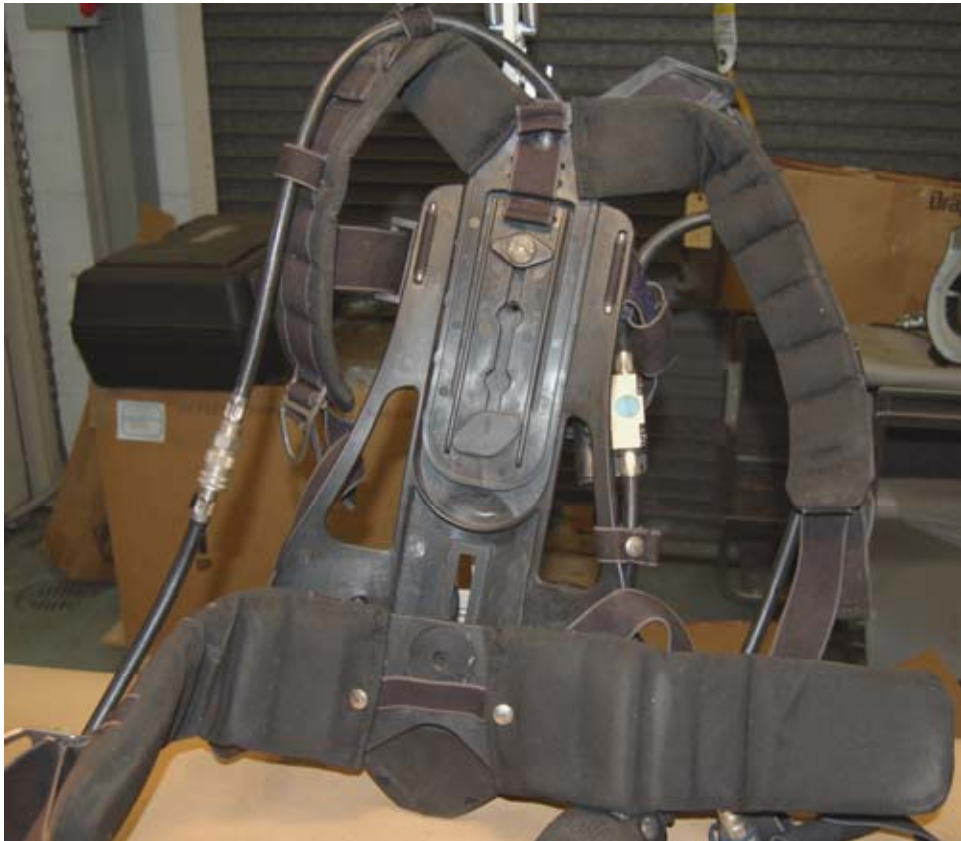
The backframe body is made of molded plastic. It is basically undamaged with not much evidence of wear and appears structurally sound. The cylinder retention webbing is in very good condition and properly secures the cylinder to the backframe.

Figure 16 – Backframe

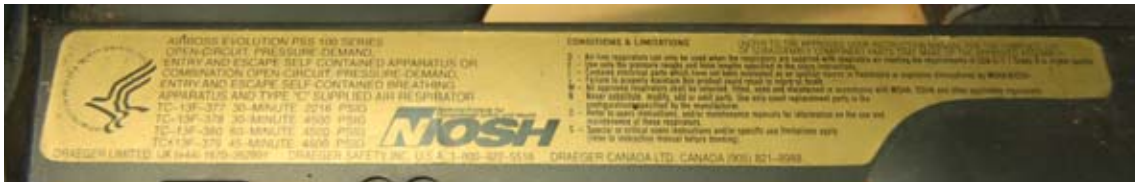
Affixed to the back of the backframe is a NIOSH approval label showing that the SCBA was manufactured under the approval number **TC-13F-378**. Also on the back is a label indicating the unit is certified to the **2002 edition of NFPA 1981**; this label is hand-marked with the serial number “**BRSK-3813.**” A “**DrägerService**” label indicates that the unit was due for inspection in **November 2003.**

Figure 17 – NIOSH Approval Label

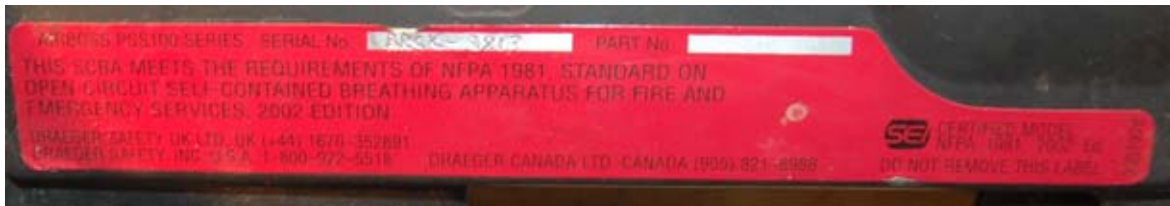
Figure 18 – NFPA Certification Label

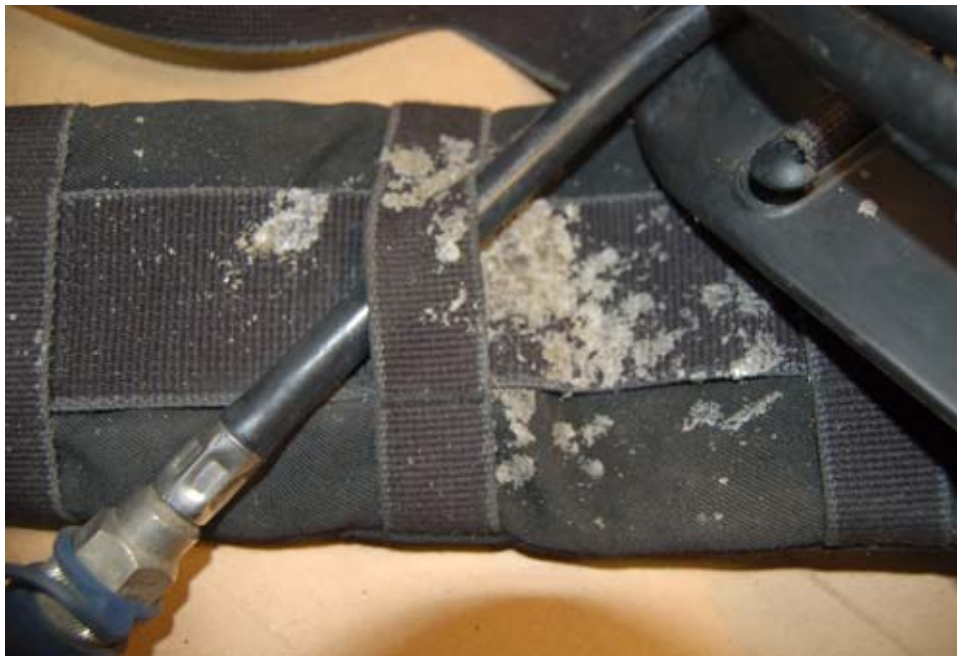
The waistbelt is securely fastened to the backframe, and its webbing and fabric components are also in very good to excellent condition. The waistbelt buckle and both adjustment mechanisms function properly. There is some whitish molten material adhered to the left side of the waistbelt near the backframe.

Figure 19 – Left Side Waistbelt

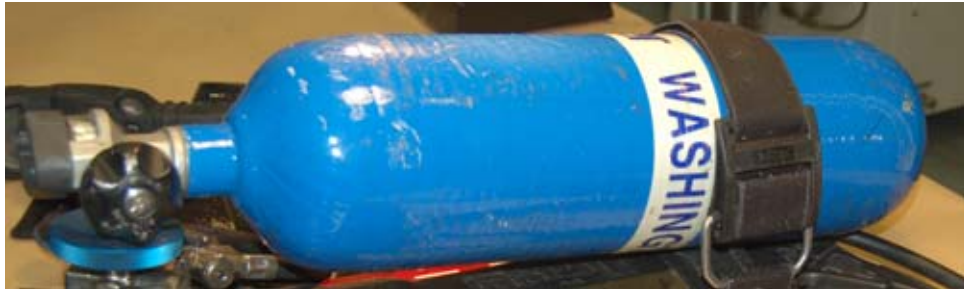
The cylinder is fully wound with composite reinforcement. The cylinder exterior is generally in very good condition and shows few signs of wear, however there are a few gouges approximately 3/8" across. The cylinder is rated for a pressure of **4500 psi** and was manufactured by the Pressure Technology Division of Carleton Technologies Inc. under Department of Transportation (DOT) exemption **E11194**. The DOT label indicates that the cylinder is serial number "**6112-10633**," Dräger part number "**3338042**," and was produced in **November 2002**. A wraparound label under the composite reads "**WASHINGTON 010**" along with a Dräger logo.

Figure 20 – Cylinder Mounted on SCBA

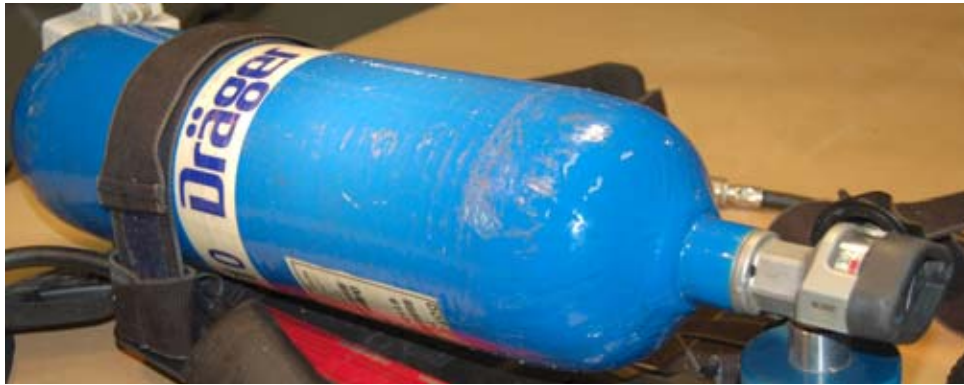
Figure 21 – Cylinder Mounted on SCBA

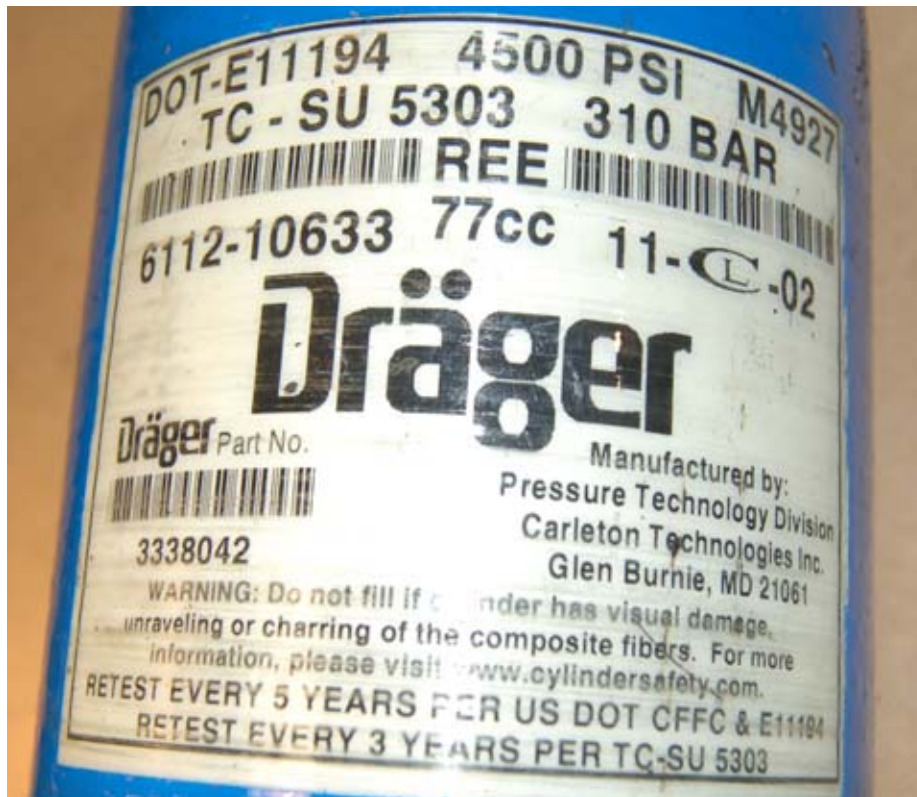
Figure 22 – Cylinder DOT Label

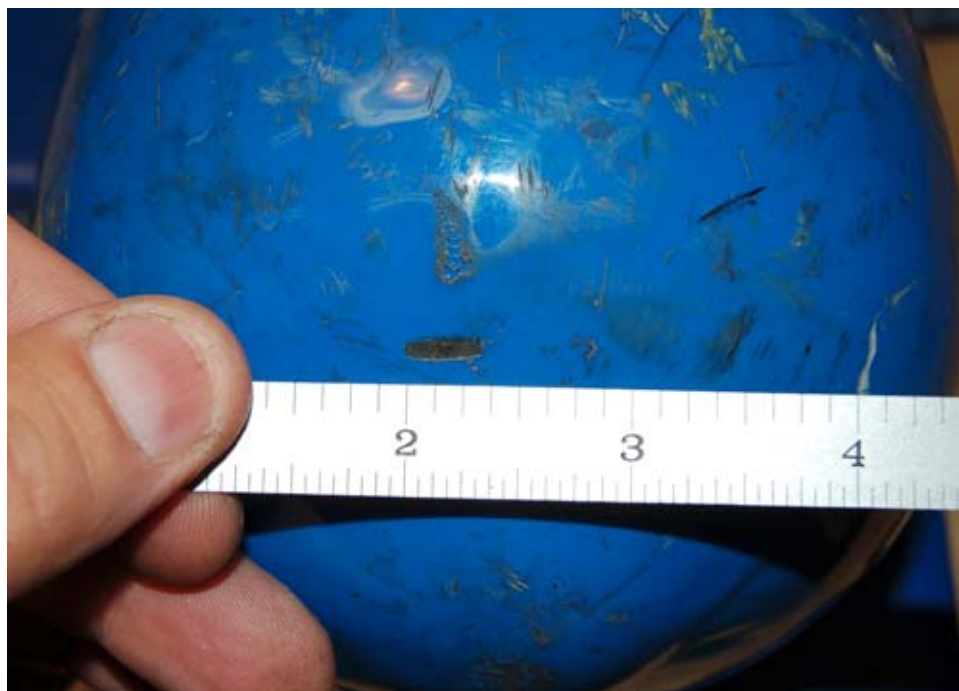
Figure 23 – Gouge in Cylinder Dome

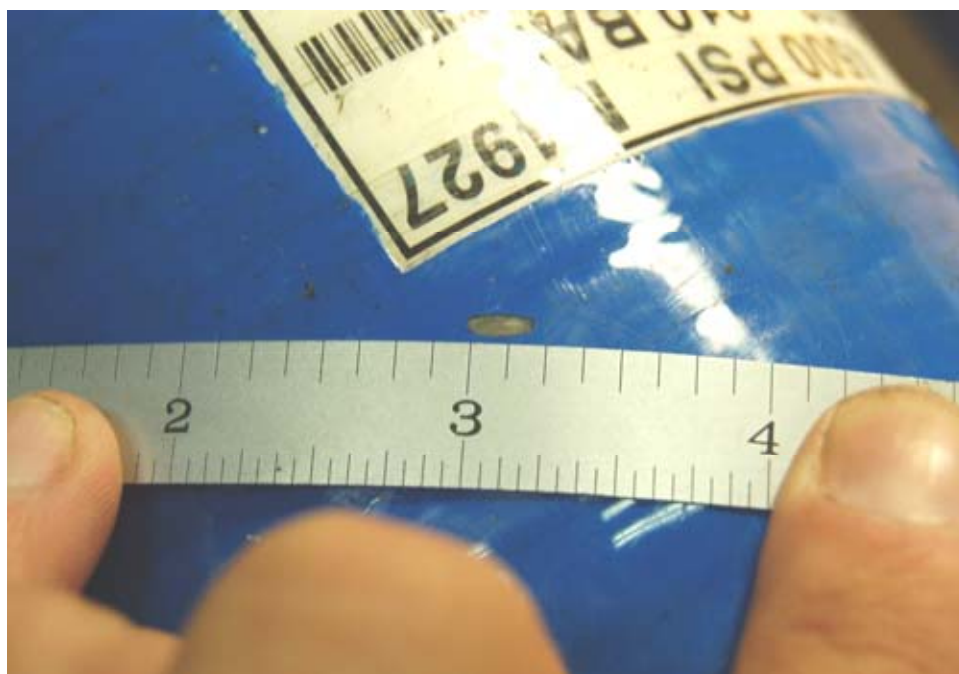
Figure 24 – Gouge in Cylinder Sidewall
