Status Investigation Report of One  
Self-Contained Breathing Apparatus  
Submitted by the  
Washington Police Department  
Washington, Pennsylvania

NIOSH Task No. 15057

January 18, 2008

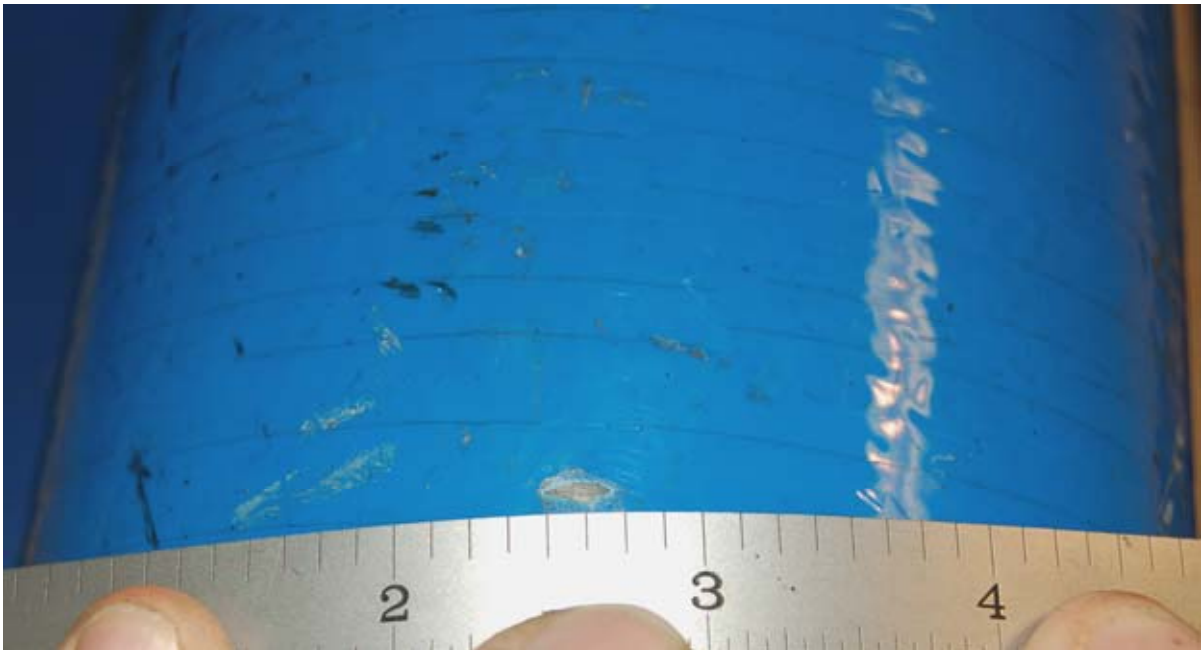
The SCBA generally appeared to be undamaged and overall in very good condition. The barrel of the lung demand valve was slightly separated from the housing body. Also, a few gouges were noted in the cylinder surface. Although this damage may require repair before the cylinder is returned to use, it was judged that the cylinder could safely be used for laboratory testing with appropriate precautions being observed.

The cylinder is fully wound with composite reinforcement. The cylinder exterior is generally in very good condition and shows few signs of wear, however there are a few gouges approximately 3/8" across. The cylinder is rated for a pressure of **4500 psi** and was manufactured by the Pressure Technology Division of Carleton Technologies Inc. under Department of Transportation (DOT) exemption **E11194**. The DOT label indicates that the cylinder is serial number "**6112-10633**," Dräger part number "**3338042**," and was produced in **November 2002**. A wraparound label under the composite reads "**WASHINGTON 010**" along with a Dräger logo.

Figure 25 – Gouge in Cylinder Sidewall

If the SCBA is to be placed back in service, it must be thoroughly inspected, repaired, and tested by a qualified service technician. The damage to the cylinder should be evaluated and, if necessary, repaired by a certified retester before it can be put back into use.

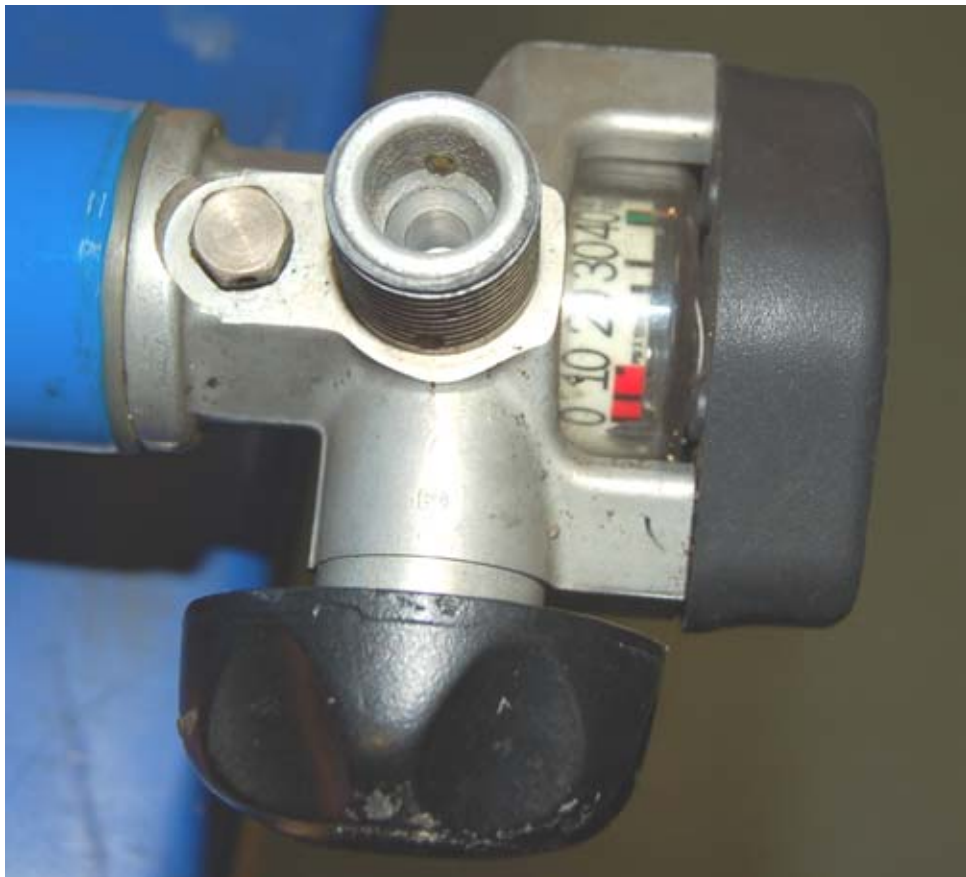
The cylinder valve assembly is in very good to excellent condition. Visibility of the pressure gauge is excellent and the gauge reads empty. The valve handwheel operates smoothly. A burst disc assembly is installed in the valve. The cylinder outlet threads are slightly dirty but remain undamaged.

Figure 26 – Cylinder Valve
