**NIOSH**  
Fire Fighter Fatality Investigation  
and Prevention Program

# Death in the line of duty...

## Structure Fire Claims the Lives of Three Career Fire Fighters and Three Children—Iowa

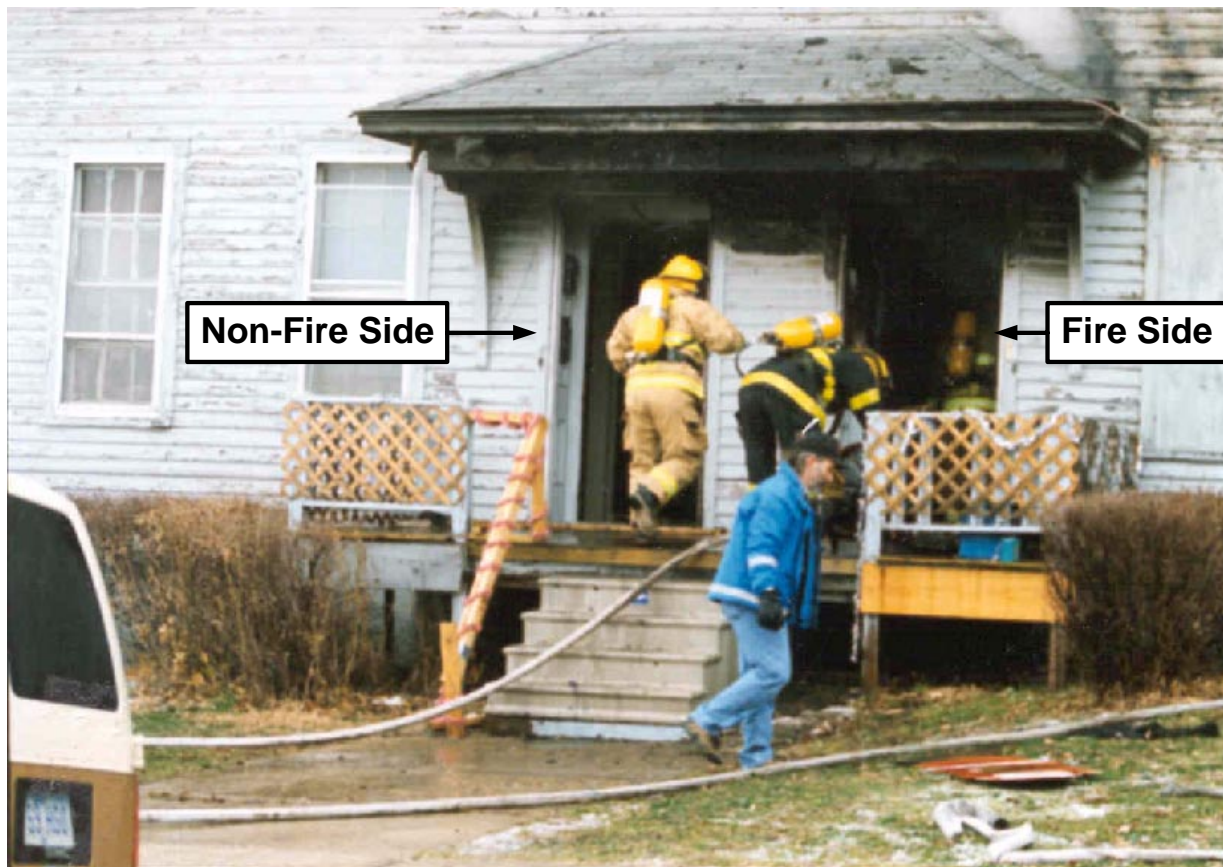
*Photo 2. Doors in Which Fire Fighters Entered*

side of the building (Photo 2). *Note: The neighbor’s car was parked in front of the house, causing concern among onlookers that he was still inside the structure.* At this time the IC ordered the Lieutenant from Engine 3, the Lieutenant from Engine 6, and Assistant Chief #1 to form a three-man search-and-rescue team to search the apartment located on the top floor of the non-fire side.

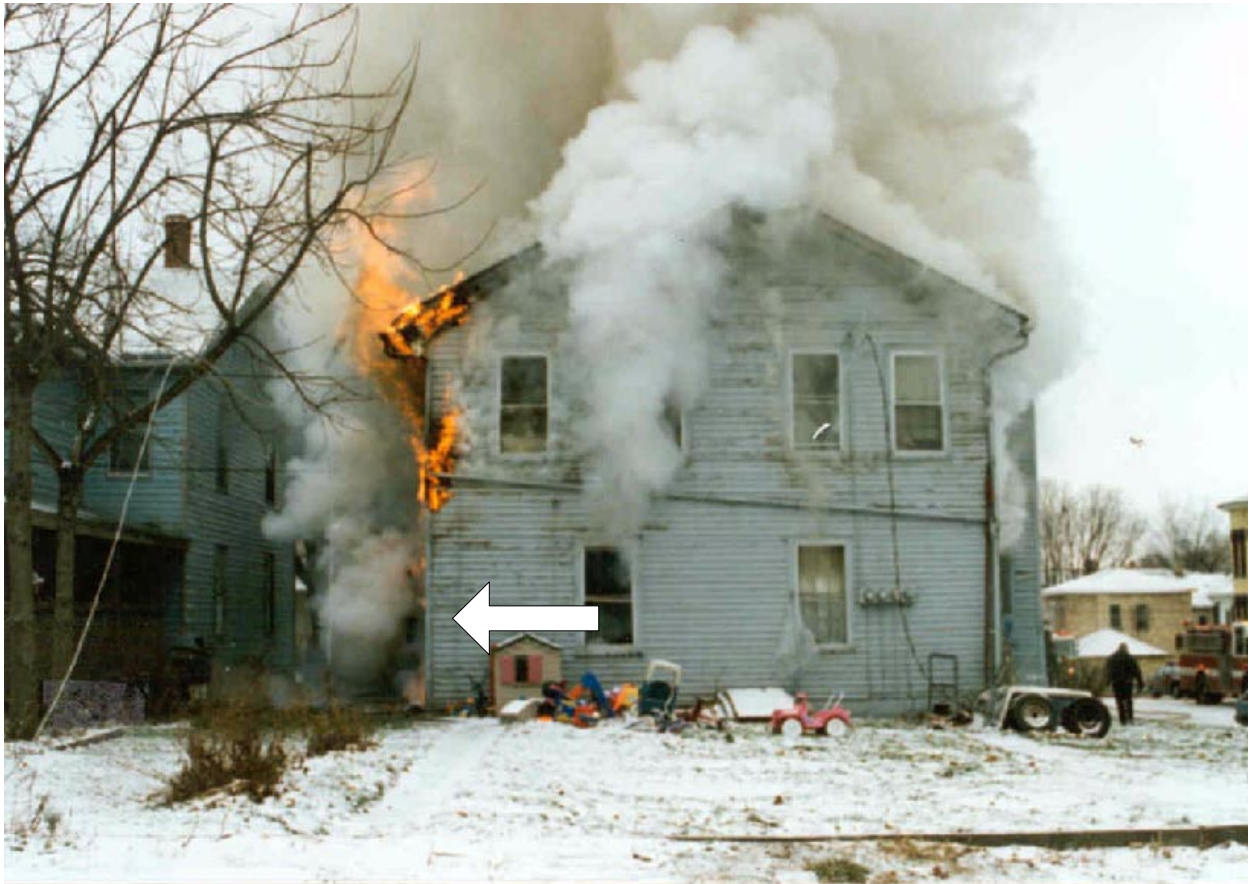
*Photo 3. Rear of Structure* Note: Arrow indicates origin of the fire.

Due to the extreme heat inside the structure, the IC made the call to switch from a search-and-rescue operation to a defensive attack. The IC assigned Assistant Chief #1 the responsibility of keeping fire fighters out of the structure until it was deemed safe. At this time three additional fire fighters (Fire Fighters #5, #6, and #7) were transported to the scene by a police officer. Fire Fighter #7 was assigned to the rear of the structure with the Lieutenant from Engine 6 and Fire Fighter #2, to control the fire extension from the rear of the structure (Photo 3). Fire Fighter #5 was
