## **A Captain and a Fire Fighter Die From Injuries in a Tanker Rollover - Indiana**

### **SUMMARY**

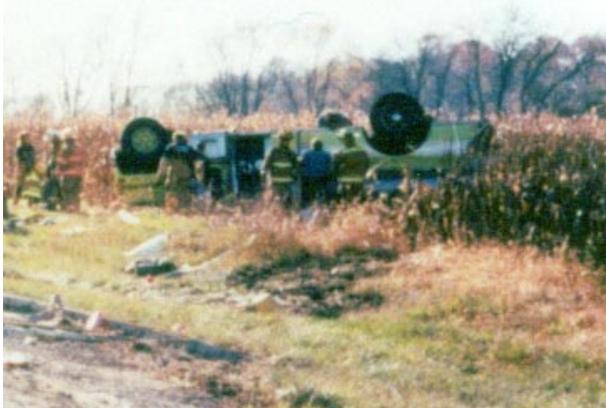
*Incident Scene*

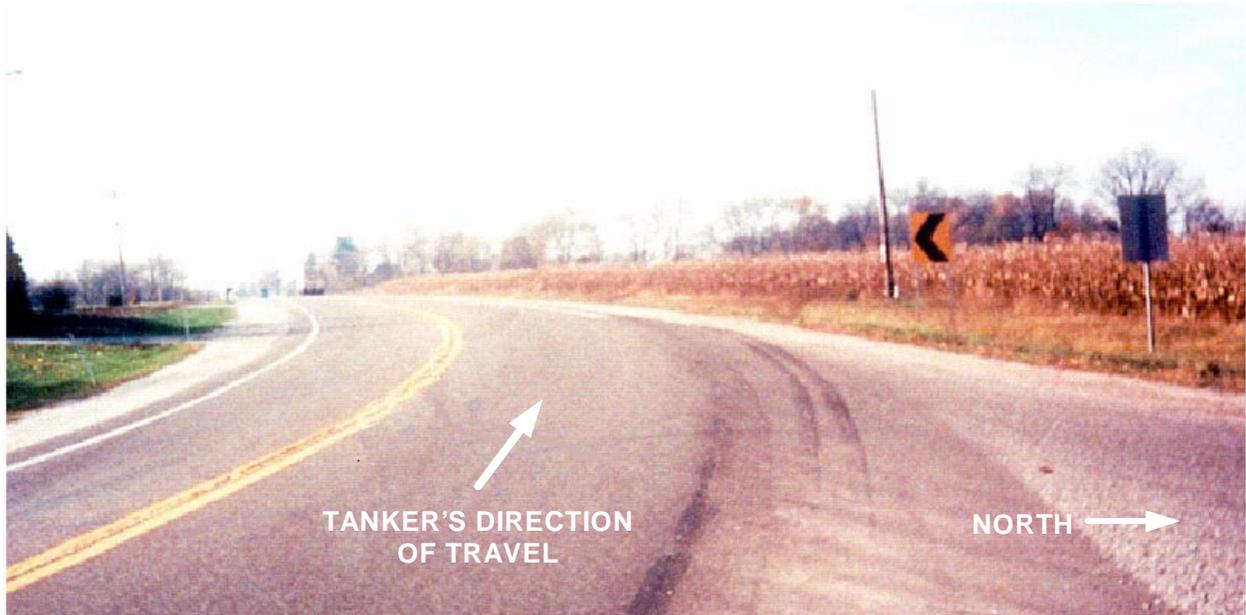
*Photo 1. View of Curve Traveling West Where Tanker Veered Off Road and Rolled Over*

On October 28, 1999, central dispatch received a call about a grass fire that was threatening structures. At 1354 hours Tanker 3 responded as mutual aid with a Captain (Victim #1) riding in the officer seat, and a fire fighter/driver (Victim #2). The tanker was traveling west on a two-lane state road, approximately 2 miles from the fire station (Photo #1). The posted speed limit was 55 miles per hour (mph) with a posted caution speed of 40 mph at the curve. The weather conditions were clear, sunny and approximately 79° F. As the tanker approached the curve, the driver (Victim #2) lost control of the tanker and it skidded off the road, and rolled into a

corn field. *Note: The sheriff's department estimated that the tanker rolled several times. The speed of the tanker could not be determined. However the speed was estimated by the investigating county sheriff patrolman to be approximately 55mph, which was above the posted caution speed of 40 mph for the curve.* The incident was witnessed by a civilian motorist, who was stopped at a crossroad. The witness saw the tanker, traveling westbound with flashing lights on, drift to the outside (northern) edge of the road until the right front tire hit the graveled shoulder of the road. The driver (Victim #2) then tried to correct the tanker's direction of travel, but the tanker continued to drift north off the road past the curve, and the tanker rolled over on the passenger (Victim #1's) side into a corn field (Photo #2). Victim #2 was ejected, and it is believed he exited the tanker through the driver's side window. *Note: The driver's side window was believed to be in the down position at the time of the incident.* The witness called 911 to report the incident. Central dispatched the call at 1412 hours to the county sheriff's department, as a motor vehicle incident with property damage and no injuries. Once on the scene a patrolman from the county sheriff's office did a quick survey of the scene and observed the fire department tanker upside down in a corn field approximately 34 feet from the hard-graveled shoulder of the road. The patrolman also observed an unconscious fire fighter (Victim #2) lying on his back with no visual injuries. Victim #2 was approximately 9 feet from the hard shoulder of the road in a ditch along the road, approximately 35 feet from the tanker. A civilian bystander, who was a nurse and already on the scene, told the patrolman that there was a fire fighter trapped in the tanker. The patrolman asked the civilian nurse to remain with the ejected fire fighter (Victim #2). The patrolman then went over to check on the fire fighter (Victim #1) in the tanker. The patrolman made verbal contact with Victim #1, trapped in the tanker. Victim #1 was conscious and

Discussion: At all times the vehicle's operator should be in control of the vehicle and take into consideration the speed of the vehicle while responding to an emergency incident. Operating and controlling the vehicle at a speed from which the vehicle could be safely slowed or stopped could decrease the potential for a skid and loss of control. The most common causes for skids are driving too fast for road conditions, failing to properly appreciate weight shifts of heavy emergency vehicles/apparatus, and failing to anticipate obstacles. If the vehicle goes into a skid, the proper response is to release the brakes, allowing the wheels to rotate freely. The steering wheel should be turned so that the front wheels face in the direction of the skid, and to let up on the accelerator gradually. If using a standard transmission, the clutch should not be released until the vehicle is under control. Another key factor for skid prevention is proper maintenance of tire air pressure and adequate tread for tires. The tanker in this incident was estimated to be going the posted speed limit of 55 mph. However, the tanker may have been traveling at an excessive speed given the weight shifting of the 1,800 gallons of baffled water and the posted caution speed of 40 mph for the curve.

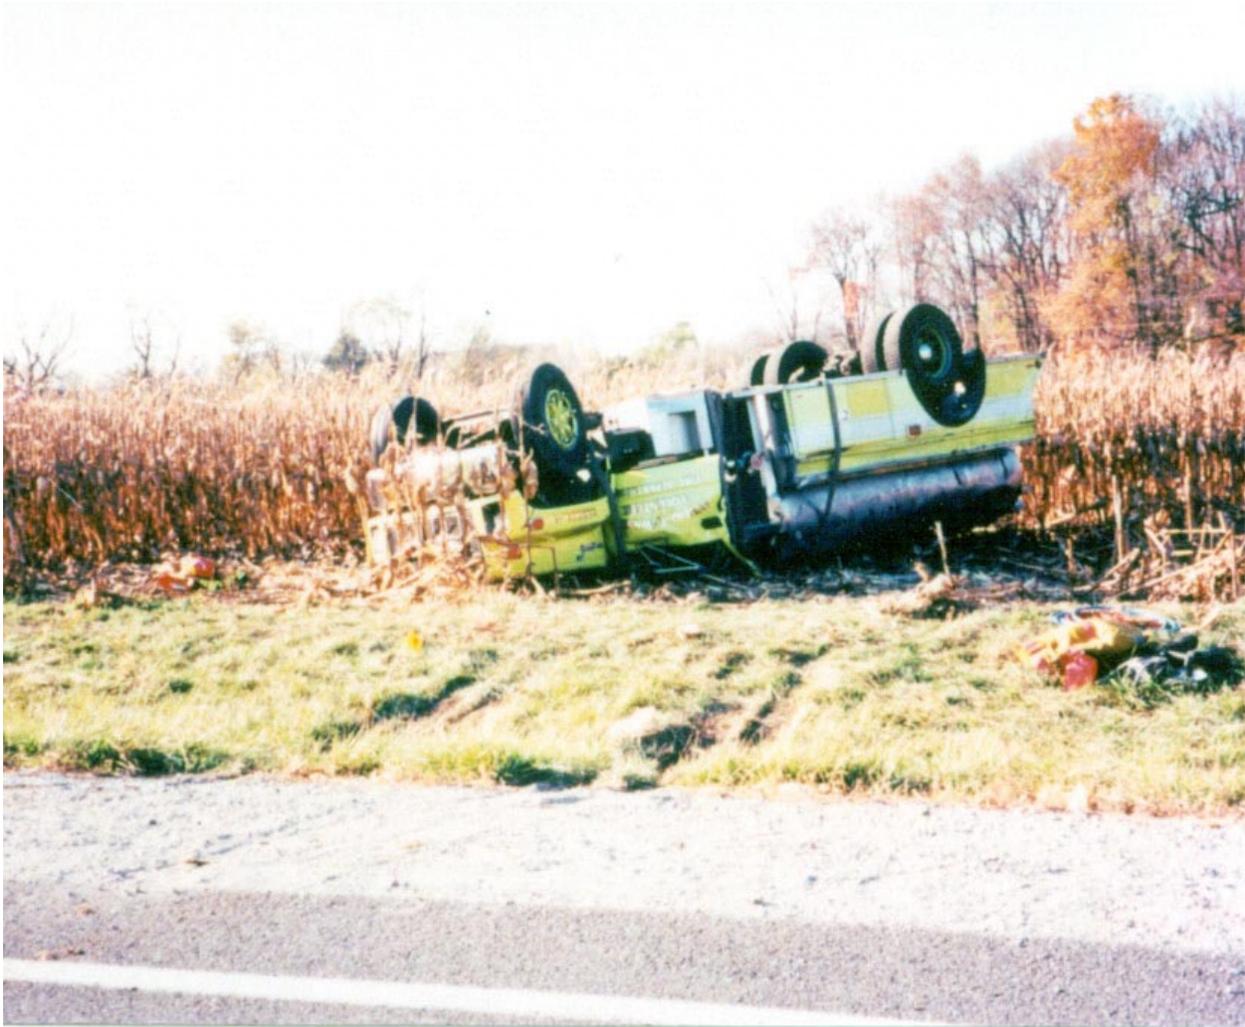
*Photo 2. Tanker Involved in This Incident*

Discussion: Fire fighters make many life-and-death decisions during a tour of duty, and one of the most important is snapping on a seat belt after climbing aboard an emergency apparatus that has been called to respond. The fire department involved in this incident had no written or enforced policy on the use of seat belts at the time of the incident. Victim #2 was not wearing a seat belt and was ejected from the tanker. The Chief of the department involved in this incident was told by Victim #1 that he had his seat belt on. After further evaluation, it is undetermined whether Victim #1 was wearing a seat belt. However, it is believed that Victim #1 was not wearing a seat belt due his position in the cab of the tanker after the rollover, in which he was lying across the tanker's front seat, face down on the driver's side with his right arm pinned behind the seat. Additionally, none of the responders remembered removing Victim #1's seat belt, and photos taken after the incident of the interior of the tanker's cab show the passenger seat belt to be fully intact and in the original retractable position.

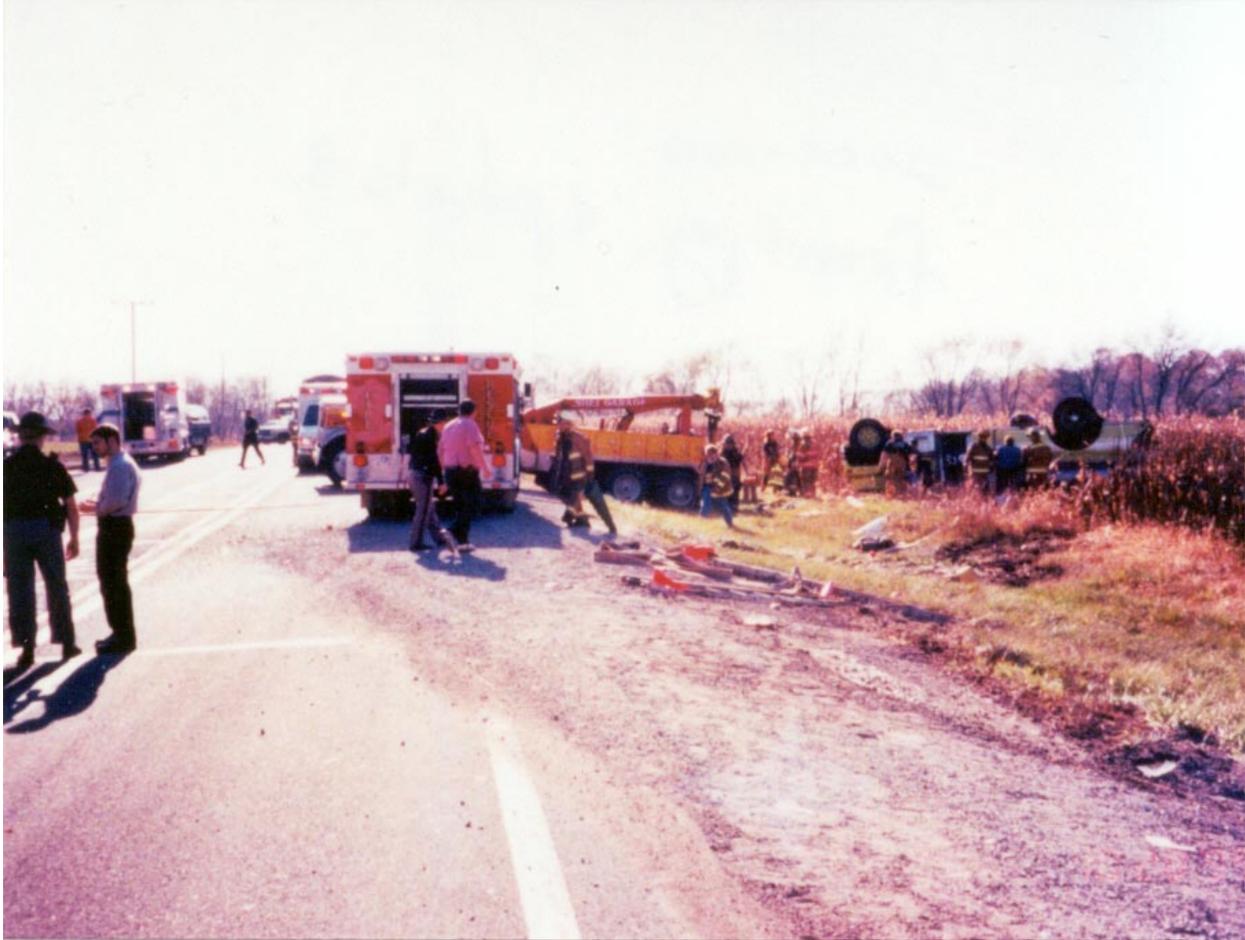
*Photo 3. Incident Scene*
