Arson Fire Claims the Life of One Volunteer Fire Fighter and One Civilian and Severely Injures Another Volunteer Fire Fighter—Michigan

Fatality Assessment and Control Evaluation Investigative Report #F2000-16

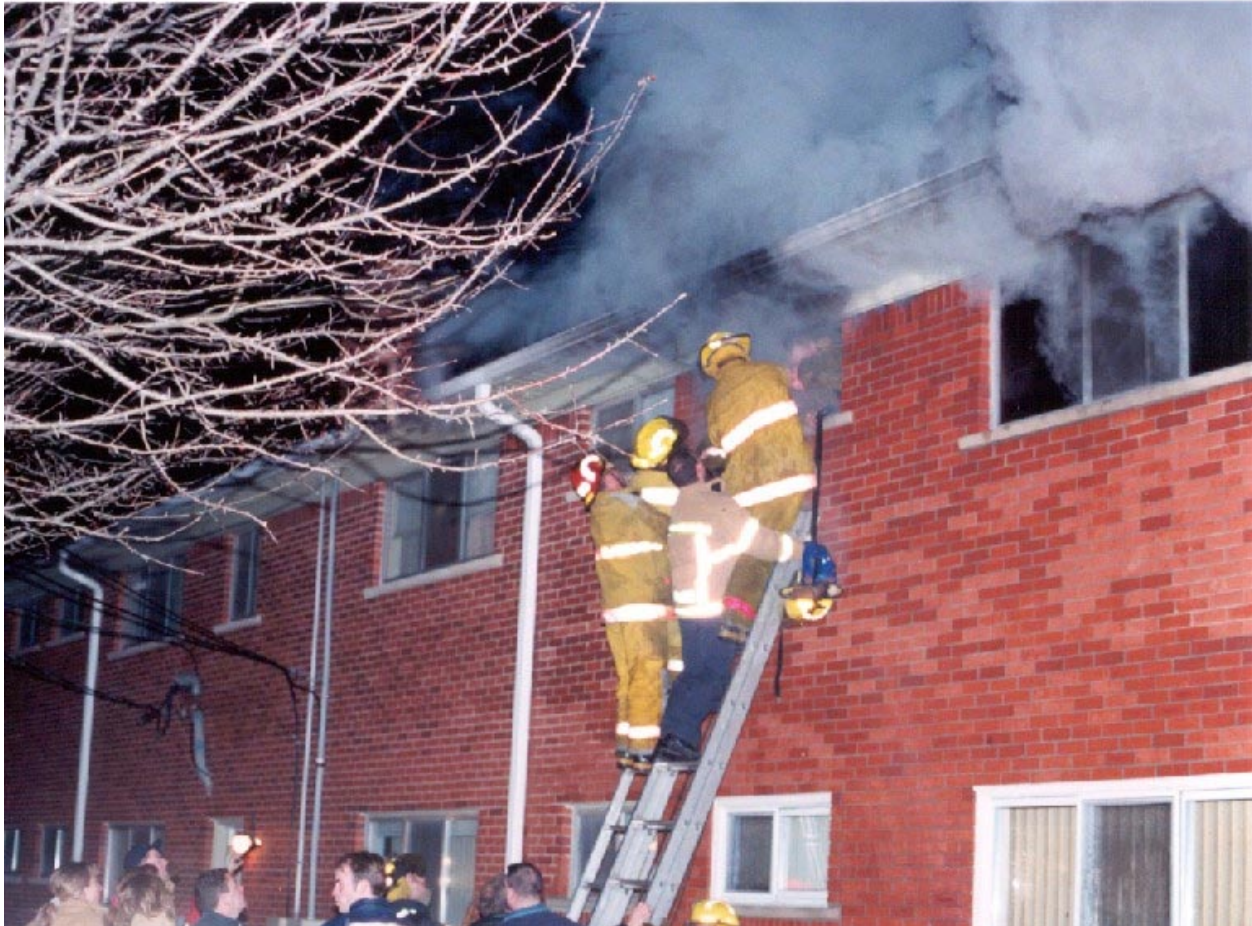
Photo 3. Fire Fighter #1 Being Removed From Bathroom Window

hospital where he was pronounced dead upon arrival. At 0525 hours, personnel on the fireground of the second fire realized they had a second fire fighter trapped in the upstairs bathroom. Two fire fighters entered through the bathroom window and rescued Fire Fighter #1 who was then transported to a nearby hospital. Fire Fighter #1 suffered from smoke inhalation and third-degree burns to 30% of his upper body. The trapped female civilian was fatally injured in this fire. NIOSH investigators concluded that, to minimize the risk of similar occurrences, fire departments should
