A Volunteer Fire Fighter/Driver Was Killed and Another Volunteer Fire Fighter was Injured While Responding to a Motor Vehicle Incident with Injuries—California

Fatality Assessment and Control Evaluation Investigative Report #F2000-17

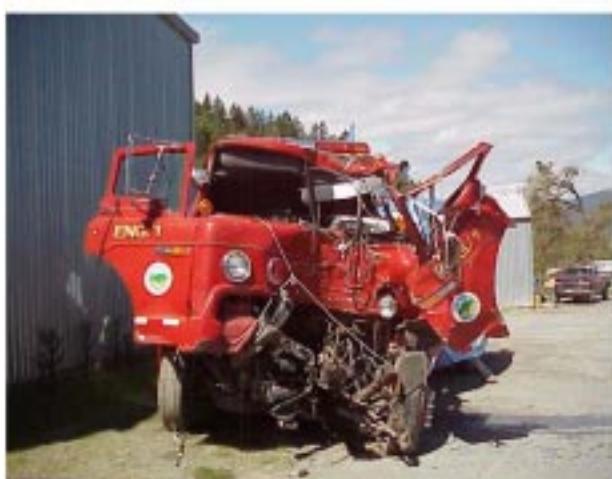
Engine Involved in this Incident

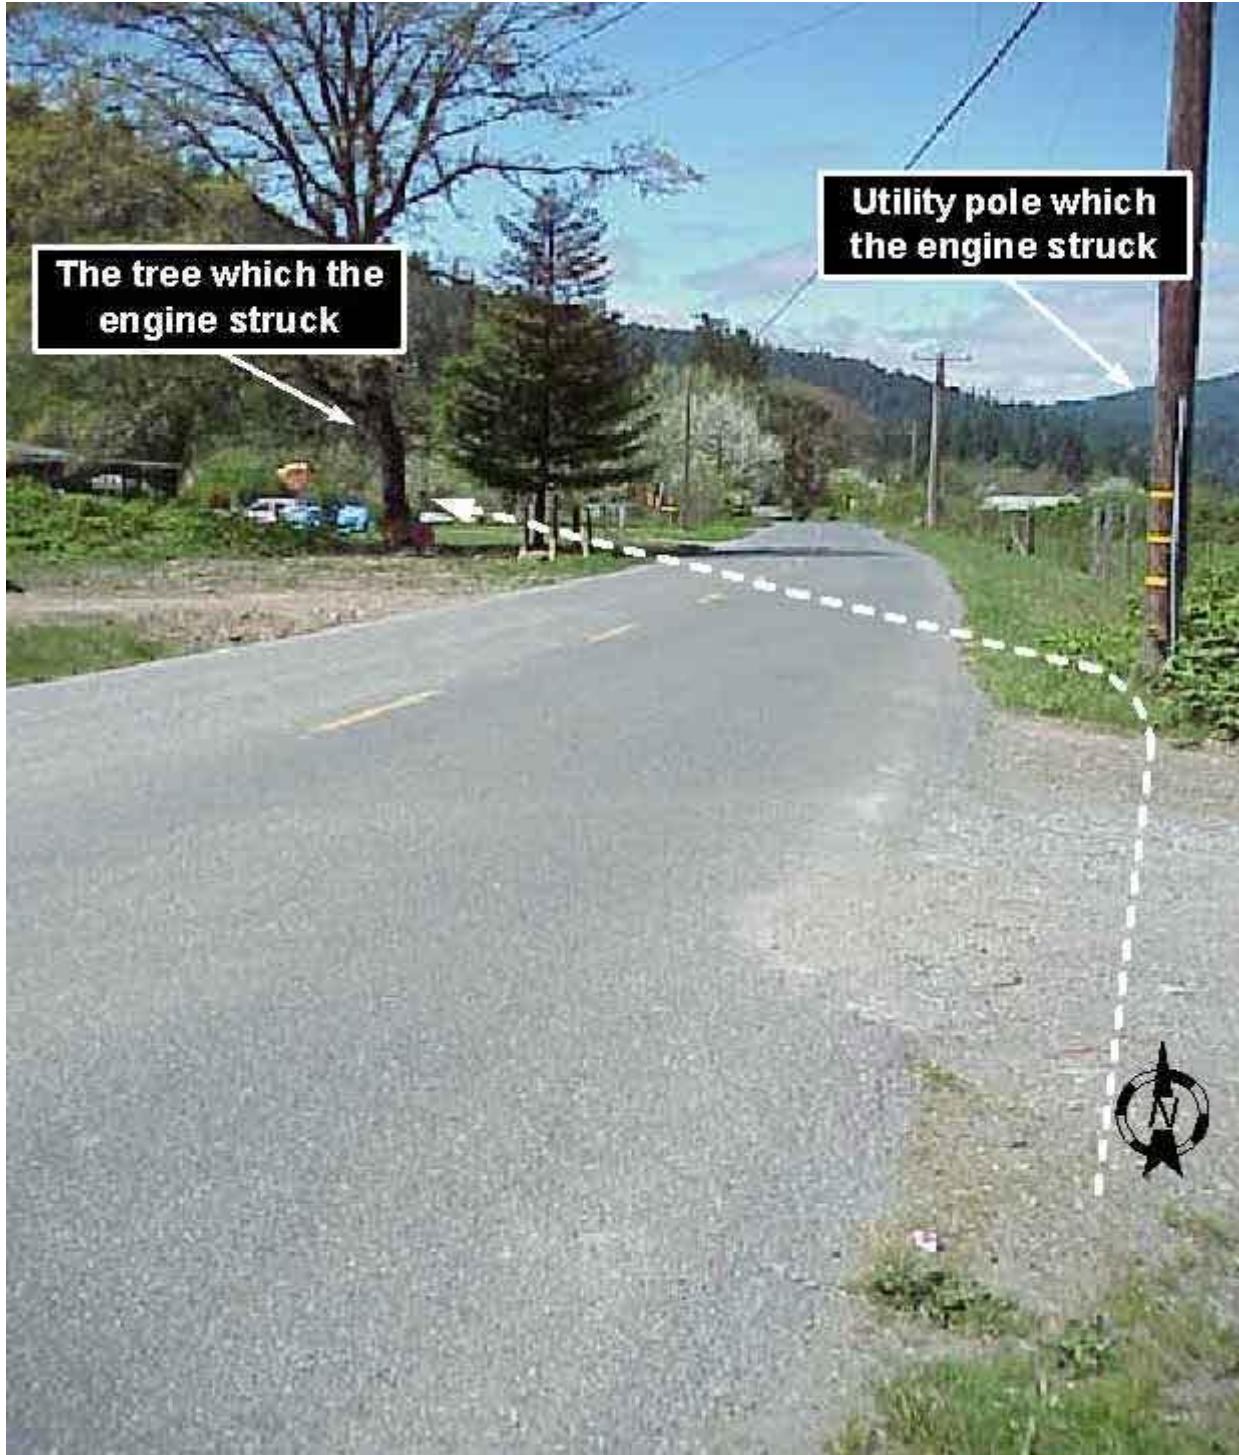
Photo 1. The Road Which the Engine Was Traveling. Note: The dashed arrow indicates the approximate path the engine traveled.

of the road. When the vehicle and the engine were approximately 50 feet apart, the victim pulled the engine to the right, partway onto the soft shoulder. The injured fire fighter recalled the engine fishtailing as it traveled on the soft shoulder toward a utility pole. The distance from the location where the engine’s right tires left the roadway to the utility pole is approximately 230 feet. To avoid striking the pole, the victim steered the engine sharply to the left; however, the top-mounted lights on the engine grazed the pole. In pulling the engine back onto the road, the victim overcompensated. The engine crossed the road diagonally and struck a large tree. The distance from the utility pole to the tree was approximately 80 feet (see Photo 1). The posted speed limit on this section of road is 35 mph. The injured fire fighter estimates that the engine was traveling approximately 35 mph. *Note: The State Highway Patrol estimated the engine traveling between 35 and 50 mph. This estimate was taken from several witness statements.*

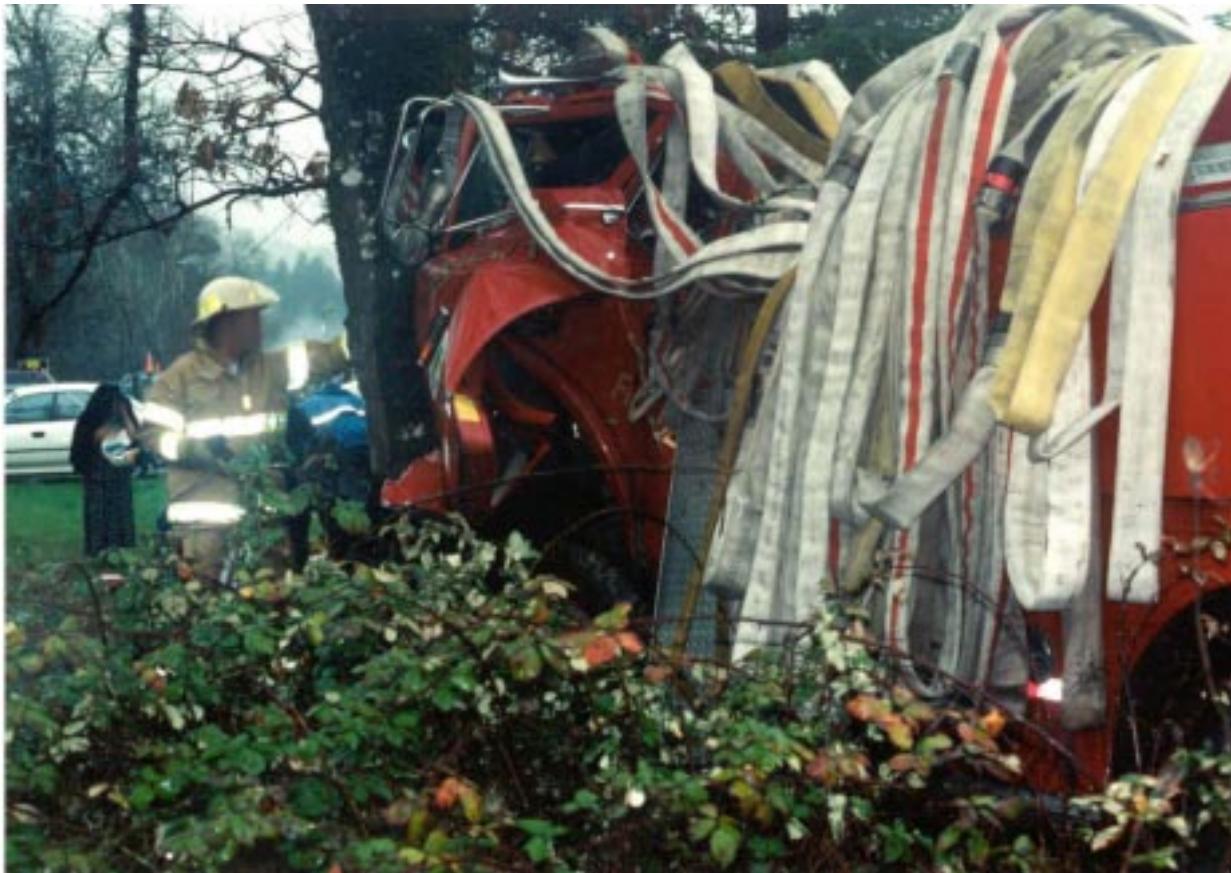
Since the driver’s side of the engine was heading directly toward the tree, the victim lunged toward the passenger side to try to avoid direct impact. The engine struck the tree, which pushed the cab inward approximately 3 feet (see Photo 2). The victim was in the middle of the bench seat with the gear shift between his legs, and he was leaning at the waist toward the passenger side. He was pinned by the gear shift and the dashboard, and he was bleeding profusely and calling for help. The passenger was thrown through the windshield and landed approximately 30 feet from the engine in the yard of a residence. The resident called Central Dispatch at 1536 hours to report the incident. A civilian following approximately $\frac{1}{4}$ mile behind the engine stopped to provide assistance to the victim and injured fire fighter. The civilian immediately ran to the victim inside the crushed cab. When a second civilian arrived on the scene,

Photo 2. The Engine Involved in This Incident

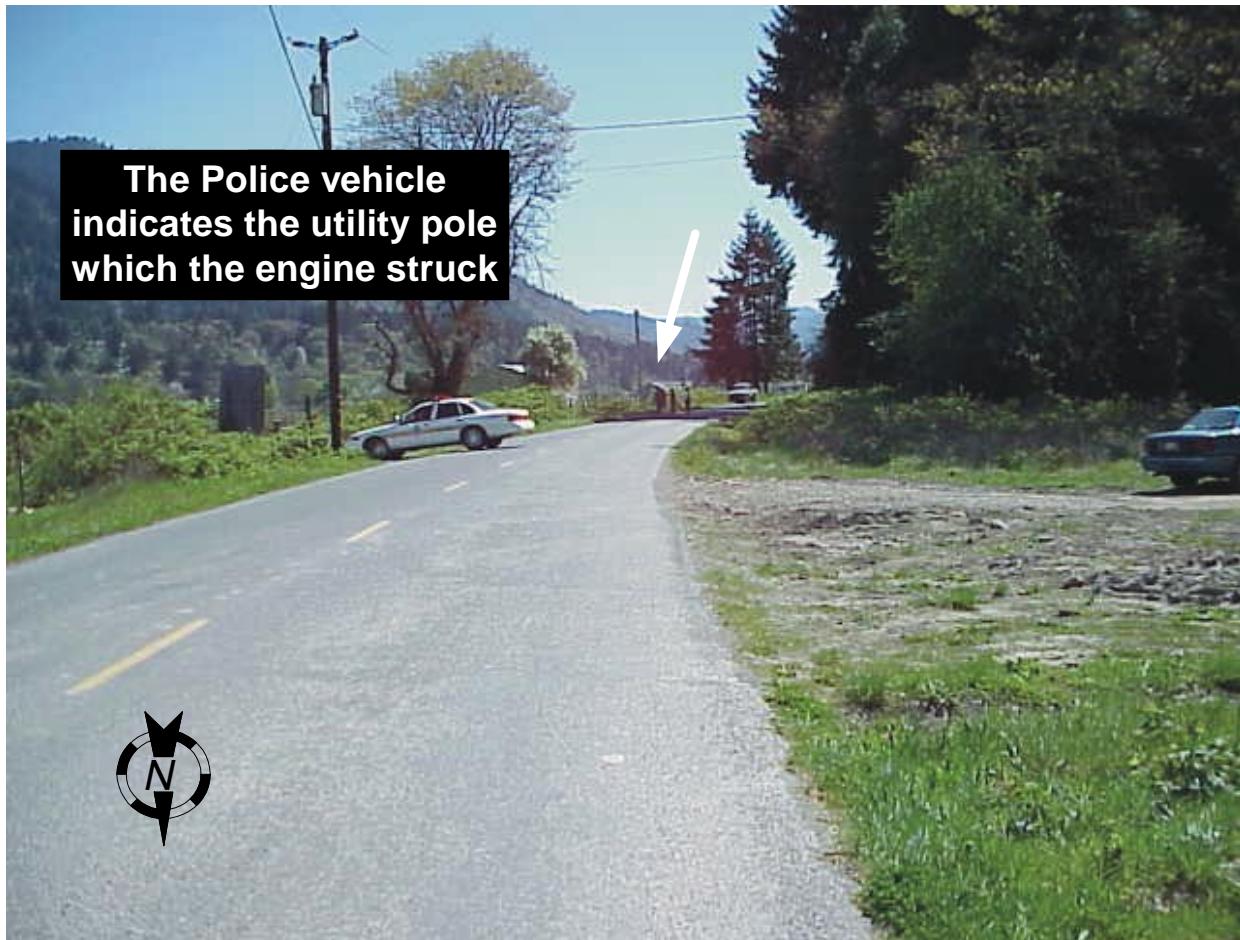
Photo 3. *The Road Which the Engine Was Traveling.* Note: This photo depicts the opposite direction of travel with the engine coming toward the police vehicle. The arrow indicates the approximate location which the engine left the roadway.
