Residential House Fire Claims the Life of One Career Fire Fighter— Florida

Incident Site: Single-Story Residential Home

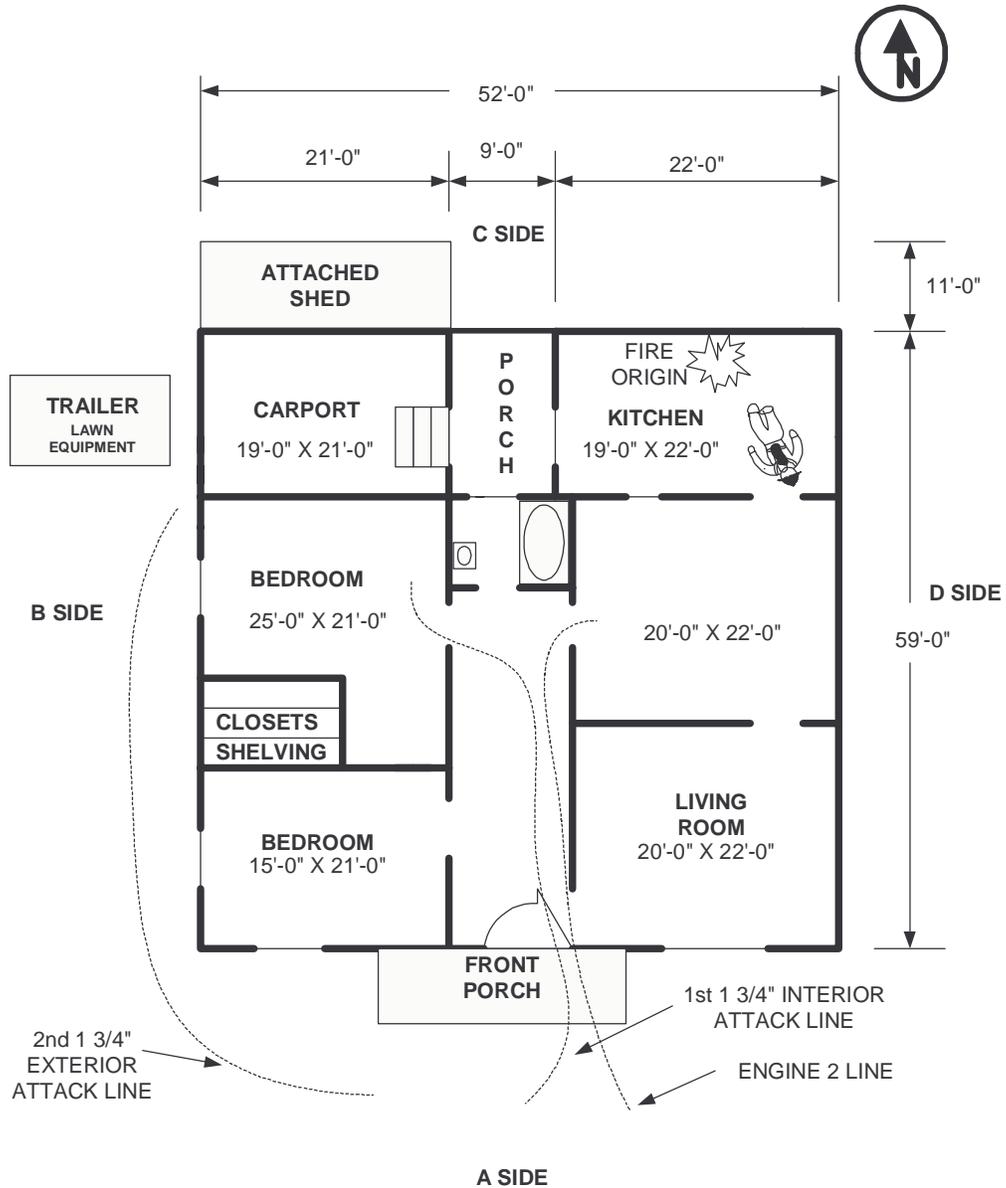
Diagram. Floor Plan

The structure involved in this incident was a single-story residential home (Photo 1). The structure measured approximately 52 feet by 59 feet. The structure had an attached roof on side C, measuring approximately 19 feet by 21 feet, which served as a carport. The fire's origin was determined to be in the kitchen (see Diagram). The fire was declared as accidental due to cooking.

The search crew (the victim and the Captain and Lieutenant from Rescue 32) advanced their handline through the front door and down the cluttered hallway toward the rear of the structure (Photo 3 and Diagram). *Note: Fire fighters stated that there was debris and furniture throughout the hallway.* The Captain and Lieutenant from Ladder 11 positioned the PPV fan in front of the

that they encountered fire in a room near the kitchen (Diagram). They hit the fire three times with a fog stream and stated that the fire was quickly knocked down, but not completely extinguished. Given the information that the victim was in a room off to their left, they retreated and entered the doorway of the room on their left and recalled seeing a small fire. They opened their line on this fire and the Lieutenant's low-air alarm sounded. Noticing that all fire fighters on the scene were occupied, the IC radioed dispatch at 0150 hours requesting a second ambulance, Engine 6, and Rescue 36. Engine 3 arrived on the scene at 0152 hours and was ordered to pull a handline from their engine and protect the D exposure.

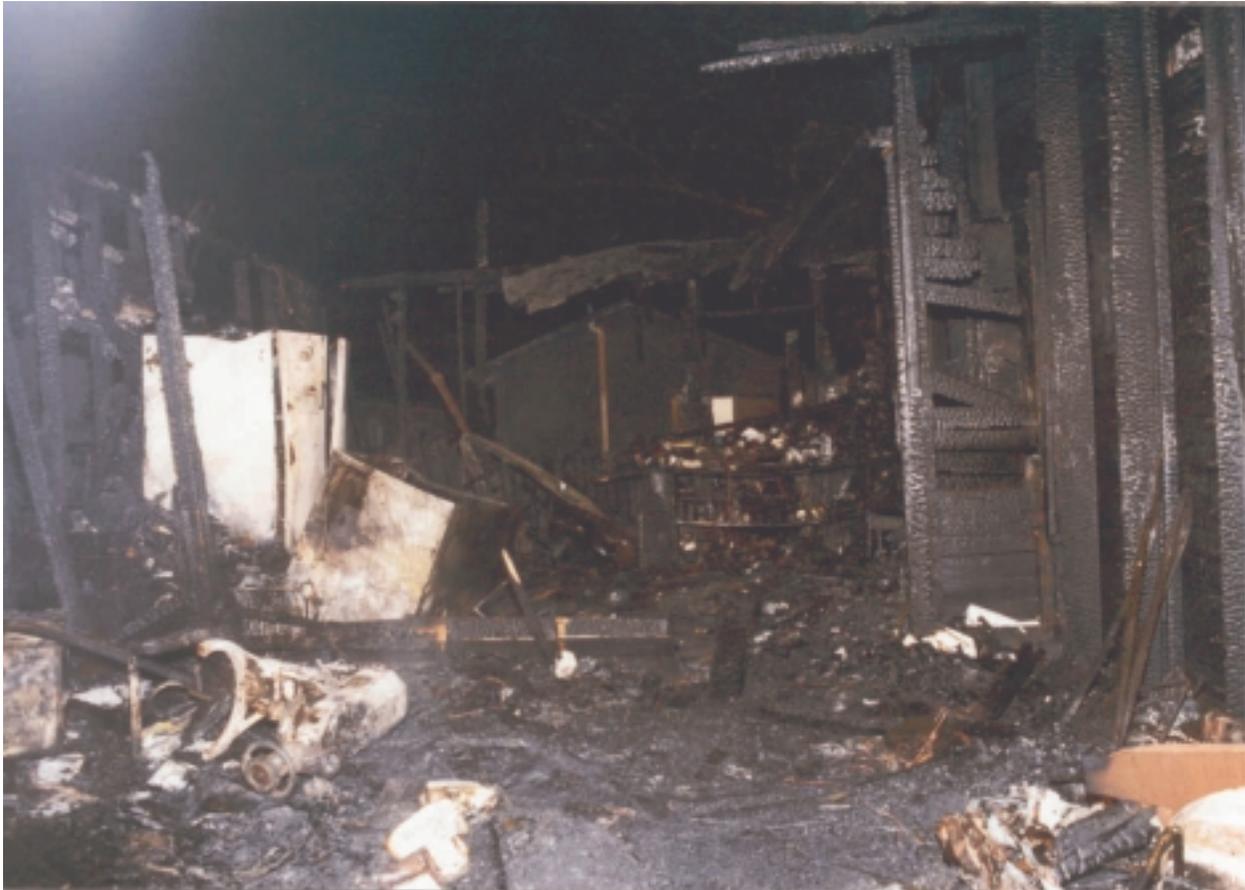
Photo 4. Carport/Kitchen Area on B/C Corner

The Lieutenant and the fire fighter from Engine 1 opened their line up on a trailer with lawn equipment, which was burning in the rear. After knocking down most of the lawn equipment fire, they opened up a straight stream and applied it to the heavy fire emitting from the eaves of the partially collapsed carport (B/C corner) (Photo 4). *Note: The Lieutenant stated that he never received a direct order of operation and was unaware that any fire fighters were inside the structure at this time.* Shortly thereafter, the Lieutenant and the fire fighter from Engine 1 turned their hoseline to a small, burning shed, to the left of the covered carport. The Captain and Lieutenant from Rescue 32 stated that the victim, who was on the nozzle, entered a bedroom near the rear of the structure (Photo 5 and Diagram). The Lieutenant stood at the door of the room as the Captain remained in the hallway. The Captain and the Lieutenant stated that at this time the PPV fan was clearing up the heavy smoke conditions. The Captain from Rescue 32 stated that he looked into a room toward the D side of the structure (a room in front of the kitchen where the fire started) and saw a large amount of fire through the kitchen doorway. He yelled at the Lieutenant from Rescue 32, requesting the nozzle in fear that the room would flashover. The Lieutenant responded to the Captain's request stating that they could not locate the nozzle. With the heat intensifying, the Captain ordered the victim and Lieutenant to exit the structure immediately. At this point, the Lieutenant and fire fighter from Engine 1, who were on the B/C corner, recalled seeing the roof over the kitchen begin to collapse. The Captain from Rescue 32 stated that the Lieutenant turned and went in front of him toward the front door

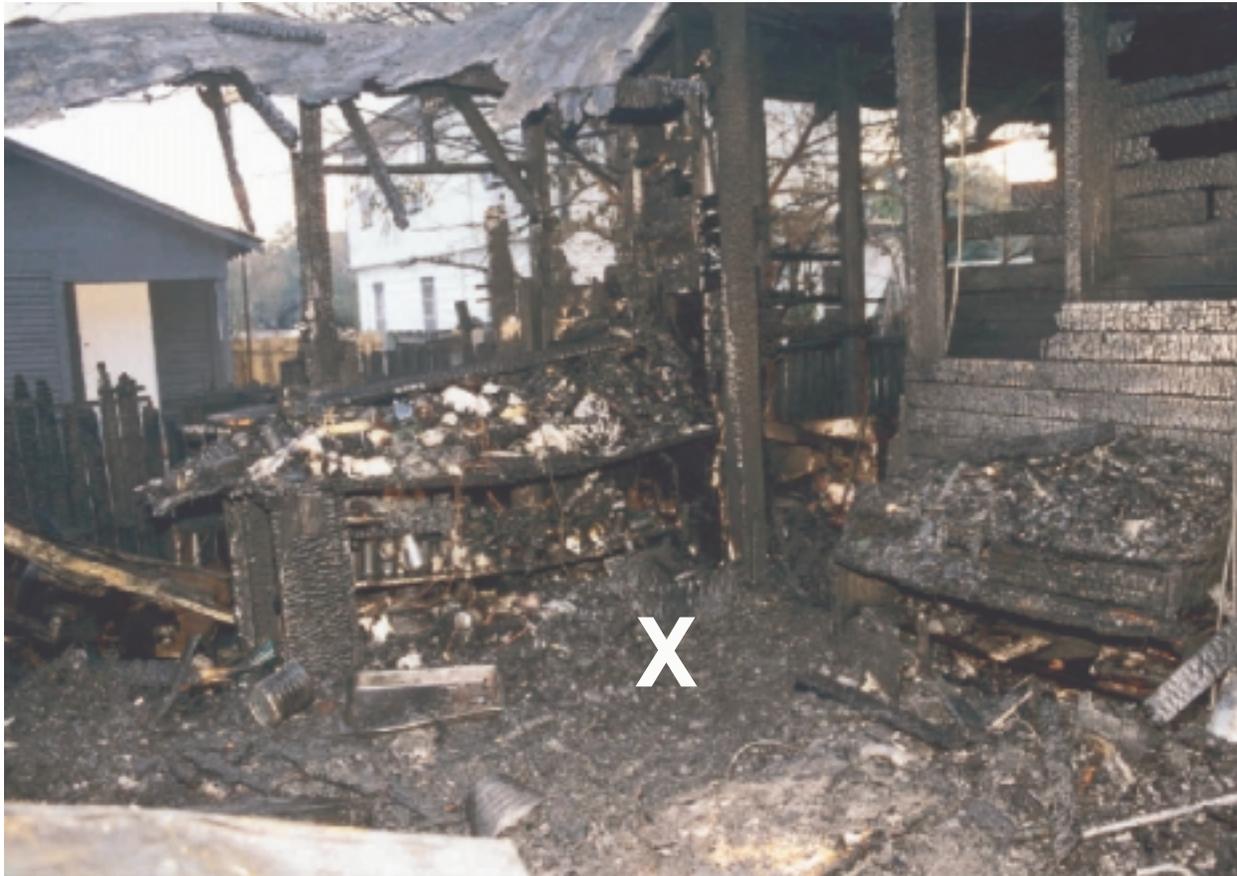
Photo 6. Victim's Position

Over the next 40 minutes, several fire fighters took part in the search, which consisted of following the initial hoseline taken inside by the search crew. The fire fighters stated that they had reached the nozzle and the victim was not near it. The fire fighters stated that the search was hampered by a large amount of debris, clothing, and furniture, which was throughout the structure (Photo 5). The fire fighters continued the search for the victim, thinking that he could have been under some of the debris. At 0234 hours, the crew from Engine 1, along with a Captain reported to be in the rear (C side), stated that a section of the roof near the kitchen was down, and they were attempting to knock down some hot spots and search that area. As the crew from Engine 1 hit the hot spots, the Captain searched through the burned-out debris in the rear, C side. At 0245 hours, the Captain was searching in the kitchen, near the doorway which led into the room off of the kitchen, and located the victim (Photo 6 and Diagram). The victim was found in his full array of personal protective equipment, lying on his left side with his head

toward the doorway and his feet toward the C side. *Note: His personal alert safety system (PASS) was severely damaged in the fire and was not sounding.* The Captain radioed the IC reporting that the victim was found and they would need a paramedic in the rear. Soon after, a paramedic arrived at the rear of the structure and pronounced the victim dead at 0250 hours.
