**NIOSH**  
Fire Fighter Fatality Investigation  
and Prevention Program

## Volunteer Fire Fighter Dies and Another Fire Fighter is Injured During Wall Collapse at Fire at Local Business--Wisconsin

## Fatality Assessment and Control Evaluation Investigative Report #F2001-09

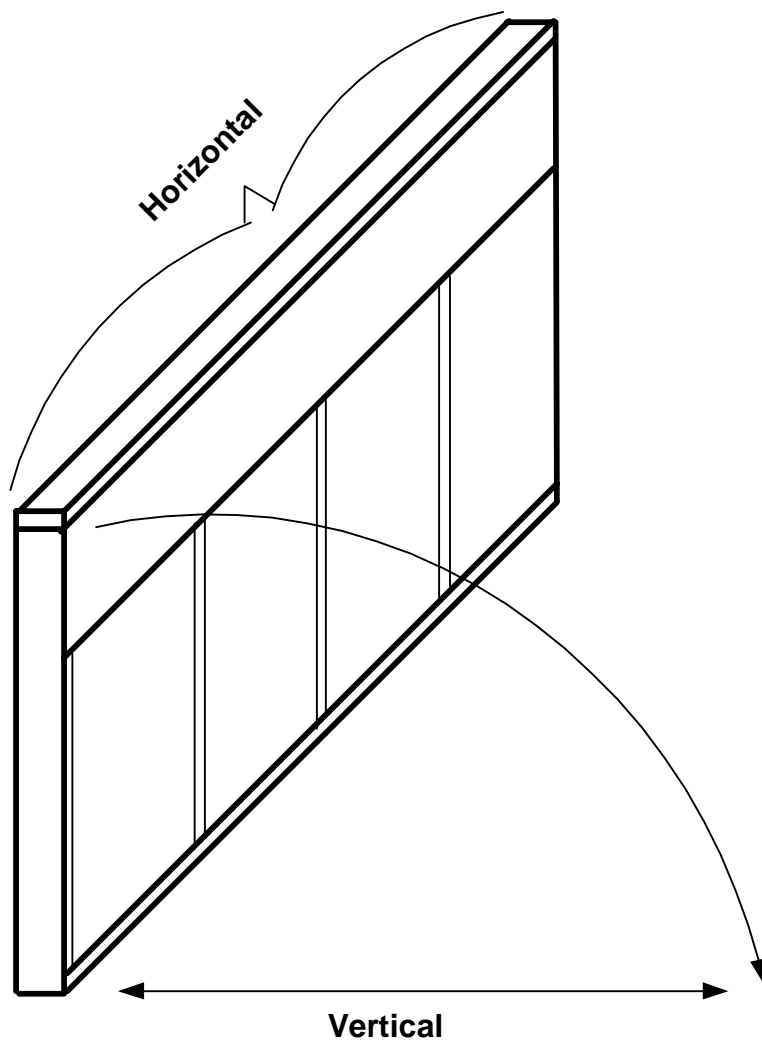
**Figure 1**  
**Zones of Danger: Collapse Danger Zone**

The zone of danger contains two types of hazards, horizontal collapse zone and vertical collapse zone

*Horizontal Collapse Zone:* “The horizontal measurement of the wall. When establishing a collapse zone, fire fighters should estimate this measurement in addition to the outward area that the wall may cover if it falls. A miscalculation of the potential horizontal length of a wall collapse could be just as deadly as a miscalculation of the outward area a falling wall will cover with masonry.”

*Vertical Collapse Zone:* “The expected ground area that a falling wall will cover when it collapses. It is generally that distance away from the wall equal to the height of the wall. In some instances, heavy stones will fall farther than this distance.” (See Figure 1)

***Recommendation #1: Fire Departments should ensure that a collapse zone is designated and monitored to ensure that no fire fighting operations take place in the danger zone.***<sup>1</sup>

Upon arrival, if structural integrity is questionable, a zone of danger needs to be established. When the department arrived on the scene, a section of the roof had already collapsed due to the conditions.

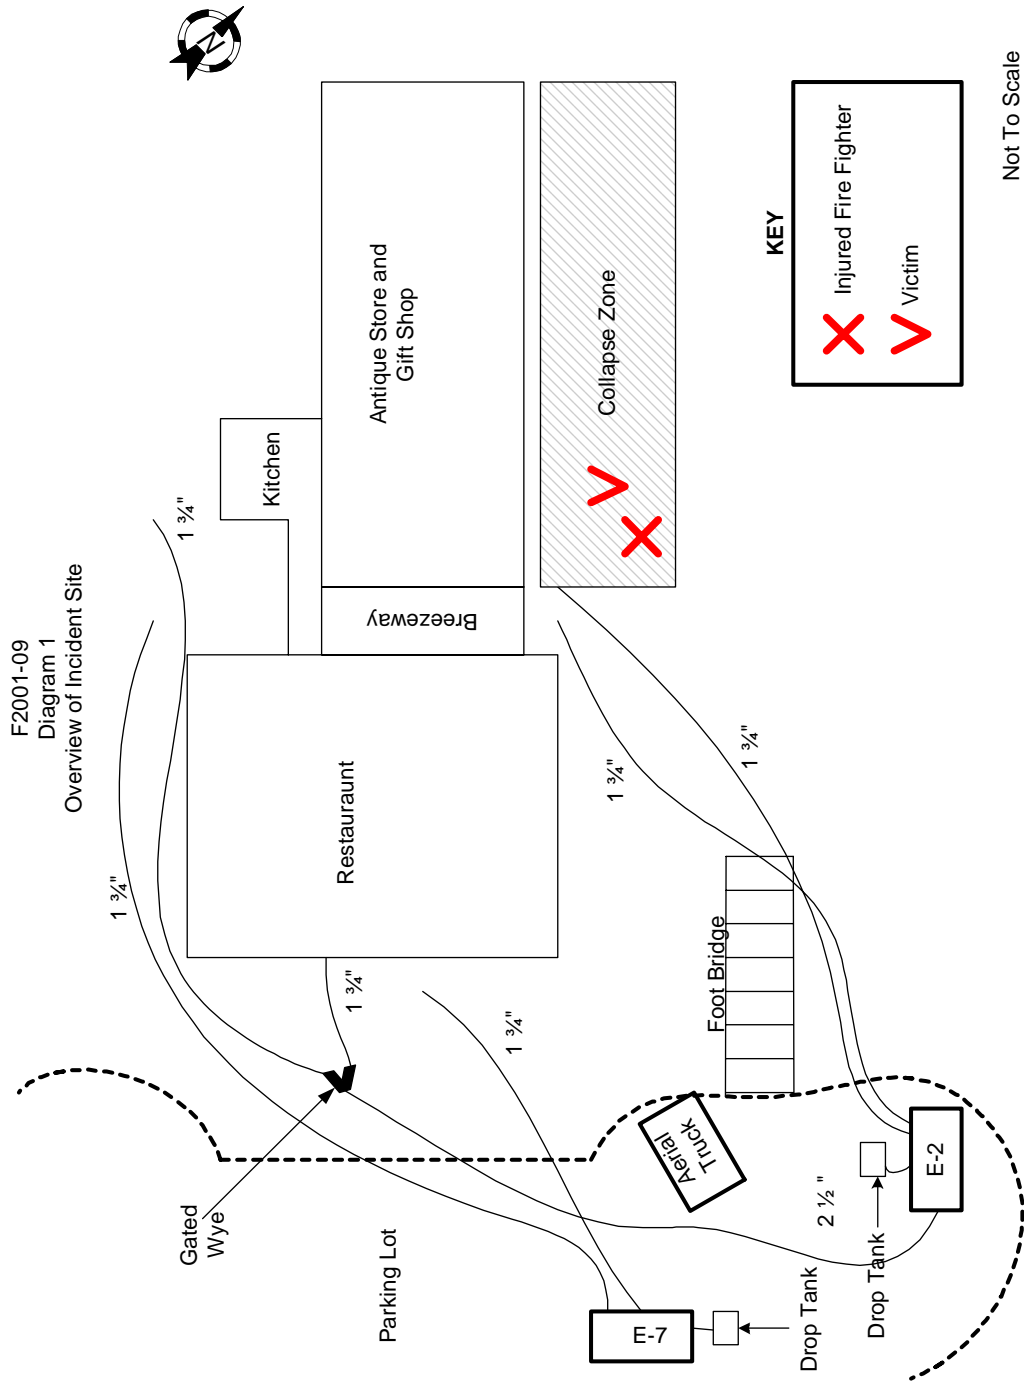
The IC then assigned crews to the west side of the structure (kitchen area), the south side of the structure, and two crews near the front of the structure to keep the fire from spreading into the antique/gift shop area (Diagram 1). Crews began to ventilate the structure by clearing windows. The IC then assisted a crew on the north side of the structure on a ladder to hit the fire through a window. The IC ordered crews to ladder the roof to try to force a door (hay loft) open to provide some vertical ventilation to assist suppression efforts. The crew could not force the door open and the IC ordered them to exit the roof. Crews on the north side forced a pedestrian door open on the northeast corner of the structure and entered to check for fire extension. Crews exited and reported that there was no extension inside
