## **Volunteer Fire Fighter Dies After Tanker Truck Is Struck by Freight Train - Kentucky**

## Fatality Assessment and Control Evaluation Investigative Report #F2002-10

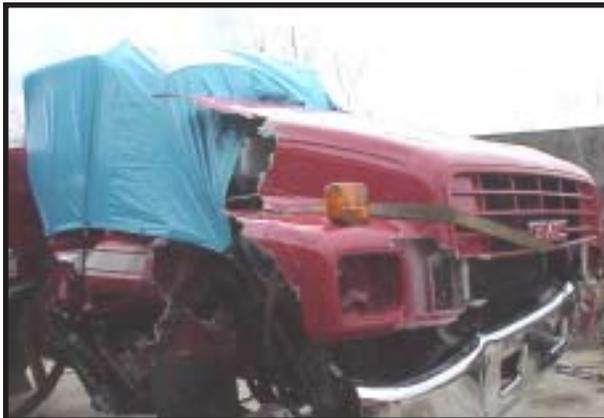
*Vehicle involved in incident*

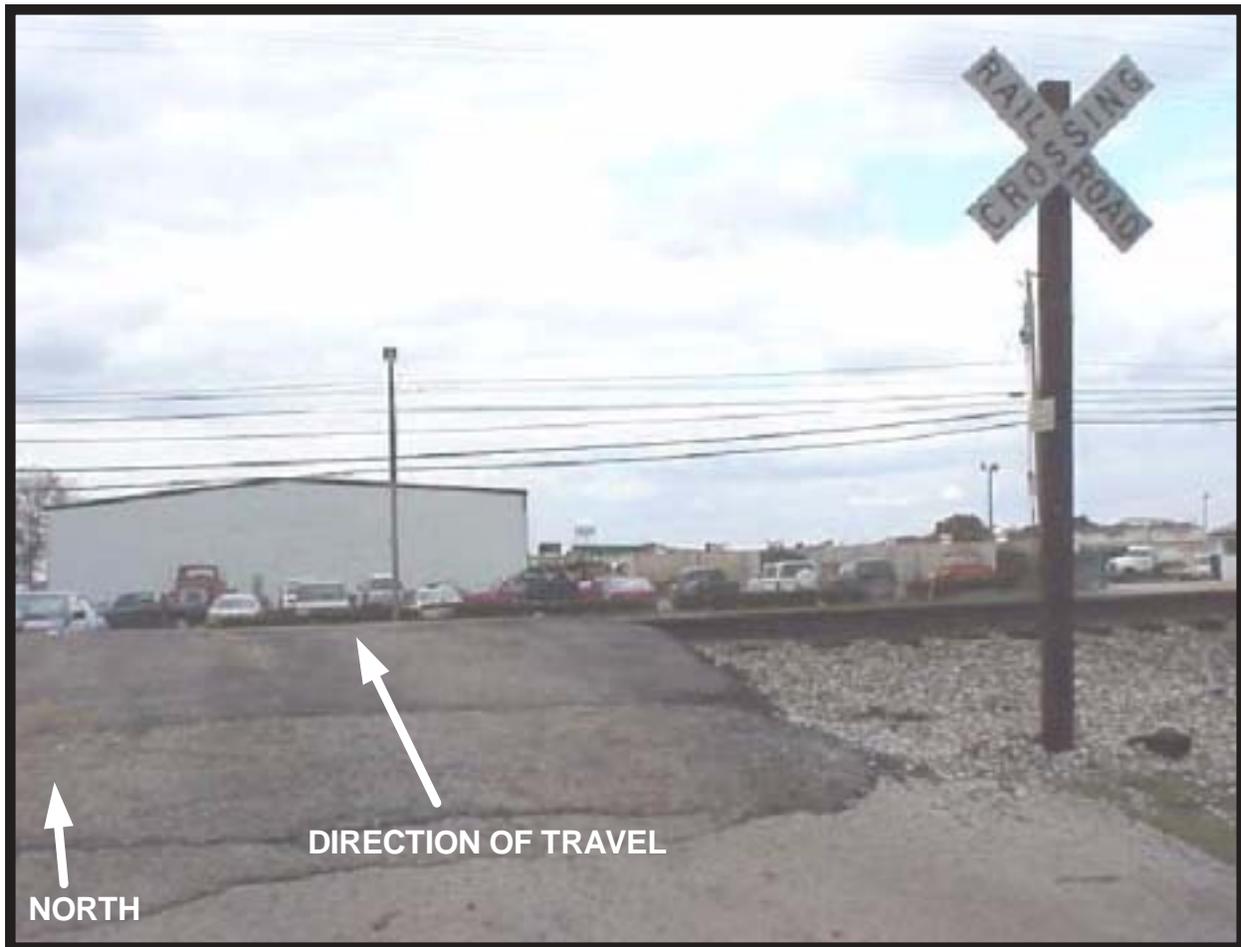
**Weather/Road Conditions.** The incident occurred at 2150 hours on a private, unguarded,<sup>b</sup> railroad crossing. The county police estimated that the slope of the private roadway the victim was driving up as he approached the tracks was approximately 17 degrees. The roadway was dry and the weather was clear and cold. A Crossbuck<sup>c</sup> sign was located on the right side of the roadway approaching the tracks (Photo). This is a high-density rail community with 30 trains per day.<sup>d</sup>

<sup>c</sup>A Crossbuck is a type of passive warning device for railroad crossings. It is a white, reflectorized sign with the words RAILROAD CROSSING in black letters (Photo).

*Photo. Northbound View of Incident.*

***Recommendation #1: Fire departments should ensure that drivers of fire department vehicles come to a complete stop at all unguarded railroad grade crossings during emergency response or nonemergency travel.***<sup>3-4,7</sup>

Discussion: Drivers of fire department vehicles should come to a complete stop at all unguarded railroad grade crossings and assure that it is safe to proceed before crossing the railroad track(s). Additionally, drivers should use caution when approaching and crossing any guarded grade railroad crossing. National Fire Protection (NFPA) 1500, § A-4-2.8 states that vehicle accidents at railroad crossings have
