A Summary of a NIOSH fire fighter fatality investigation

October 20, 2003

Parapet Wall Collapse at Auto Body Shop Claims Life of Career Captain and Injures Career Lieutenant and Emergency Medical Technician - Indiana

Fatality Assessment and Control Evaluation Investigative Report #F2002-44

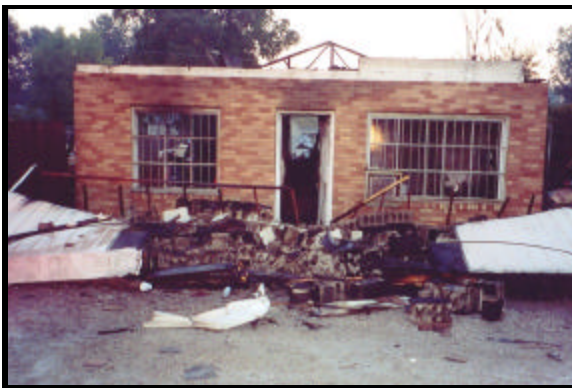
Incident site

collapsed. The parapet wall and overhanging facade fell forward, landing on top of the victim (Diagram and Photo 3). *Note: Fire fighters told NIOSH investigators that they had little to no warning of the impending collapse.* The Lieutenant from Engine 3 was knocked to the ground and suffered a broken leg and an EMT suffered a fractured wrist. The injured personnel were pulled away from the debris and received medical attention before being transported to an area hospital. Fire fighters on the scene began removing debris in an attempt to extricate the victim. The IC, who had been knocked to the ground and received minor injuries, ordered a fire fighter to call Central Dispatch for additional resources. Rescuers removed the victim from the debris and found that he did not have a pulse and was not breathing. The rescuers began cardiopulmonary resuscitation (CPR). At 0230 hours, the victim was transported to an area hospital where he was later pronounced dead at 0300 hours.
