## Volunteer Chief Dies and Two Fire Fighters Are Injured by a Collapsing Church Facade - Tennessee

***Volunteer Chief Dies and Two Fire Fighters Are Injured by a Collapsing Church Façade - Tennessee***

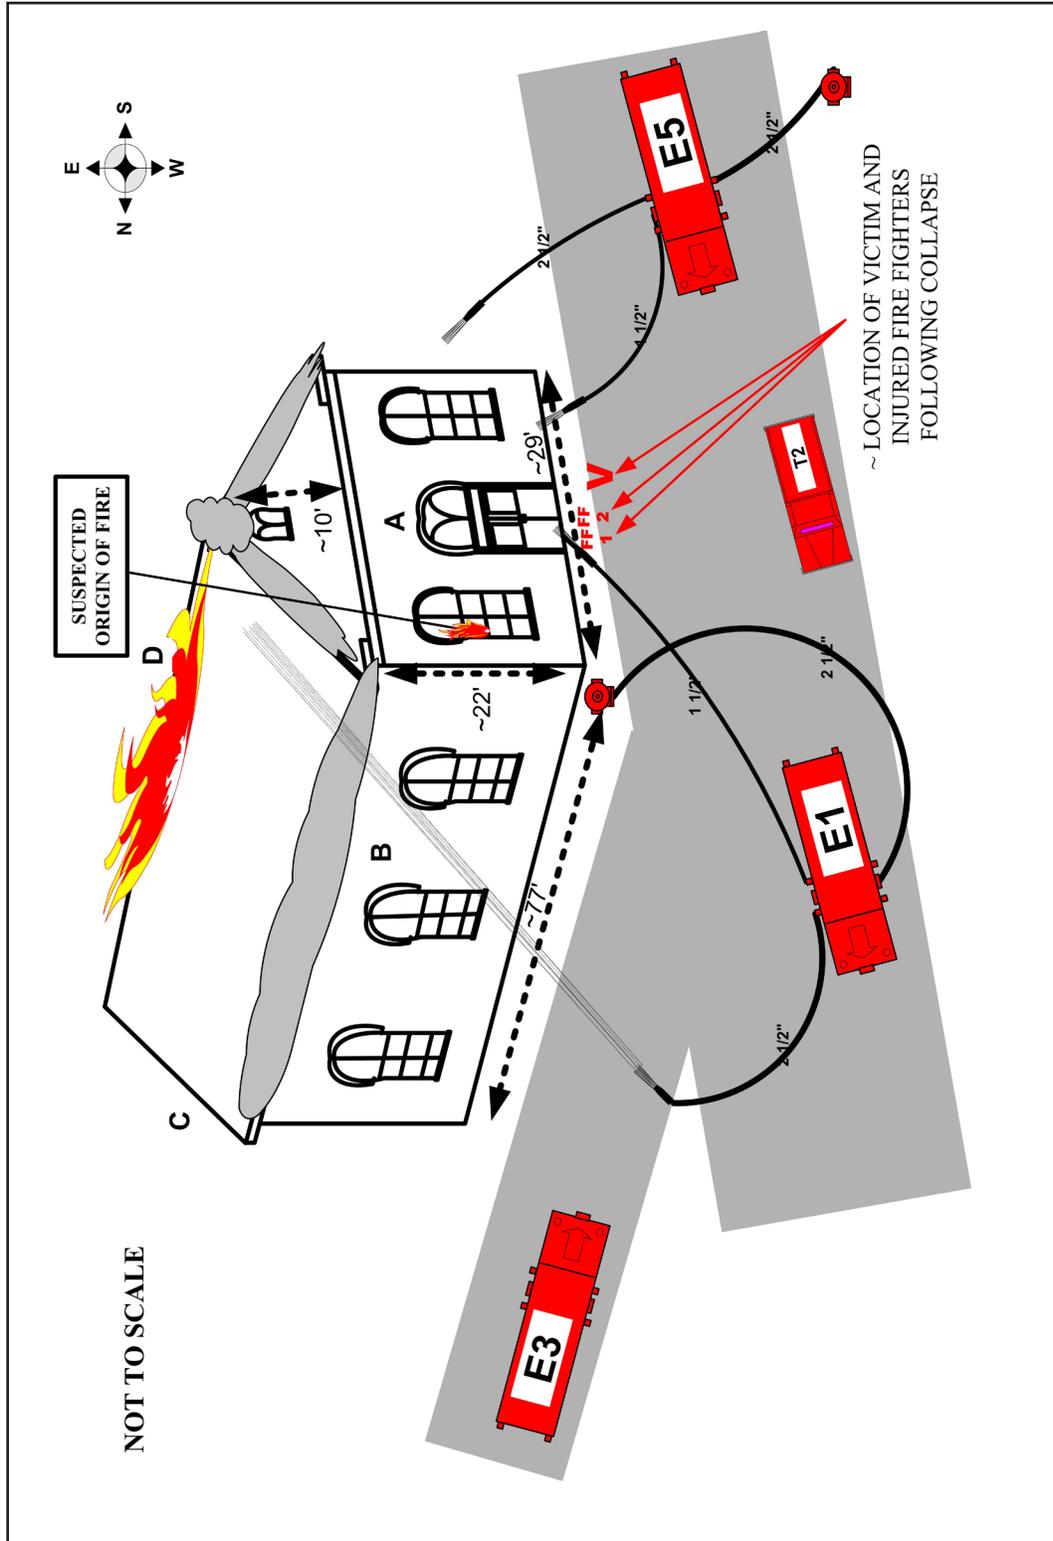
Diagram. Incident scene

carried a charged 1½" line off of E5. At 1042 hours FF1 radioed for a pike pole to pull ceiling tile in the AB corner of the vestibule and check for fire extension where it was believed the fire had originated. At approximately the same time, two fire fighters had pulled a 2½" line off of E1 and set up in the street near the AB corner of the church. The fire fighters were directing a water stream onto the AB roof corner toward the front of the structure (see Diagram).

In this incident, fire fighters set up a 2½” handline in the street to the north of the AB corner of the church. They directed the stream toward flames beginning to show near the roof apex at the A wall. During this same period of time, two fire fighters entered the front of the church with a charged 1½” line to check for fire extension in the front vestibule area. The collapse occurred approximately fifteen minutes after the first alarm and just as fire fighters were evacuating the structure.

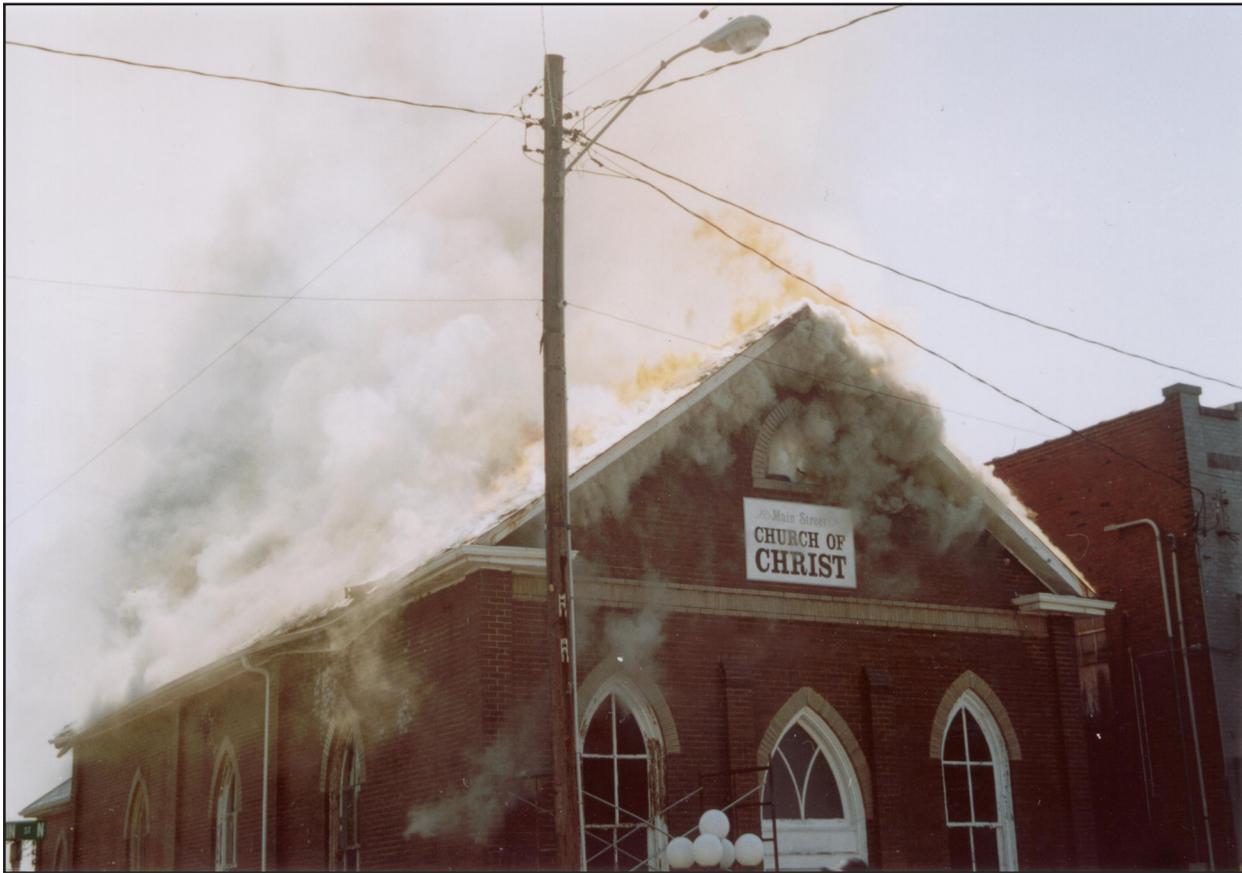
*Photo 1. Before collapse of roof and facade, photo courtesy of the fire department*

The victim had just completed a 360° walk-around of the structure. He was wearing civilian pants and shoes, but had donned his turnout coat and helmet. Very quickly, thick gray smoke began to appear near the A side roof apex, the AB corner, and out of the front upper level window. Flames were just beginning to show at the roof ridgeline and appeared to be moving toward side A (Photo 1). It is believed that the victim made the decision to evacuate the structure when he witnessed the quickly deteriorating conditions. He began walking toward the front entrance of the church while verbally calling for FF1 and FF2 to immediately come out of the structure. At approximately 1045 hours, as the two fire fighters exited the structure through the front door, the entire roof collapsed inward and the brick façade above the gutter line on the A side wall fell outward onto the street (Photo 2). The victim was in front of, and facing, the A side wall. The falling burning debris struck him and the impact caused him to fall backwards into the street. He was removed from the debris in less than a minute, but suffered burns and multiple body traumas. FF1 and FF2 were also struck by the debris as they exited the church. At the time of the collapse, both fire fighters were in, or very near, the front doorway. It is believed they were protected from more serious injuries due to their proximity to the A side wall and the protection of their turnout gear. The injured fire

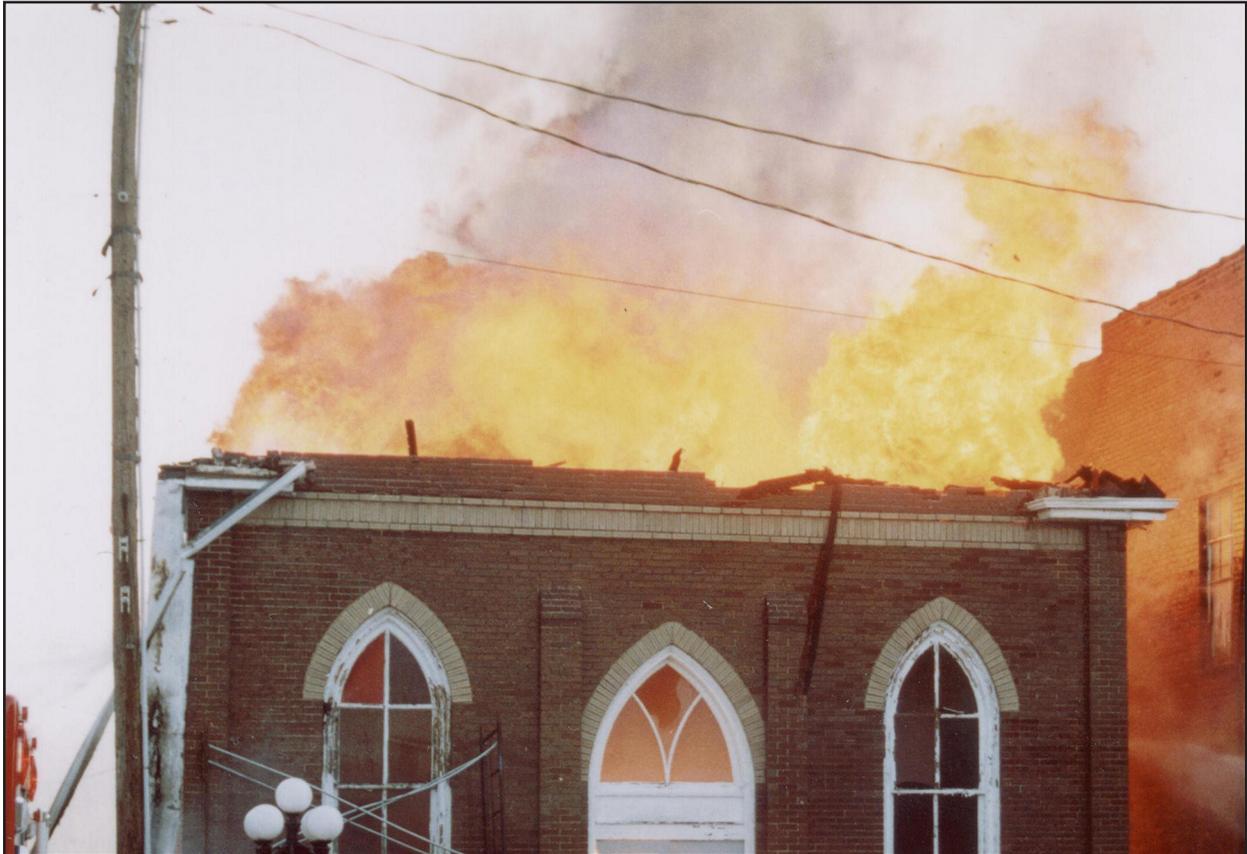
*Photo 2. After collapse of roof and facade, photo courtesy of the fire department*

It is believed the victim had recognized the quickly deteriorating conditions and the possibility of a collapse when he decided to call for the fire fighters to evacuate the church. Neither the victim nor the two fire fighters had time to escape from the collapse zone and were struck by falling debris.
