Career Fire Fighter Fatally Injured In Fall From Apparatus - Texas

SUMMARY

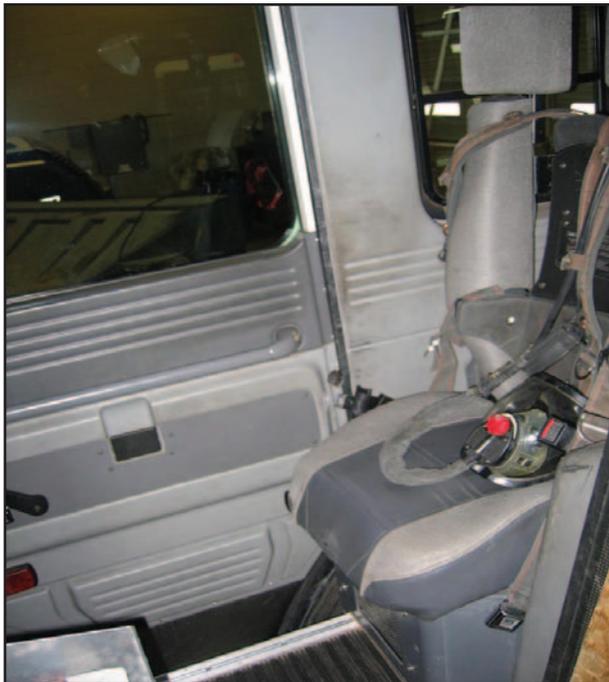
*Victim seating area and door
Photo courtesy of the State Fire Marshal*

Equipment The victim was riding in a 1998 quint with a 75 foot aerial ladder, 1500 gallon-per-minute pump, and 490 gallon water tank (Photo 1). The quint was being used as a reserve unit while the assigned truck was in the shop for maintenance. The fire department purchased the quint new in 1998. It was a custom cab with two front seats, two rear-facing crew seats, and one forward facing folding rear jump seat. The forward-facing rear seat was equipped with a three-point safety belt and the rear-facing seats had two-point lap belts.

According to the State Fire Marshal's report of the incident, the lap belt on the seat in which the victim was riding was retracted and not buckled. At the time of their investigation, the safety belt appeared to be in functional condition with no defects or other impediments to use. The quint was equipped with a safety belt monitoring system with an audible and visual alarm that would indicate if a safety belt was not fastened in an occupied crew seat. The monitoring system was not functioning and at least one seat sensor had been disabled.²

The quint in this incident had a history of the passenger doors not latching securely and coming open while the apparatus was moving. Maintenance records reveal that department personnel reported the issue to the manufacturer, and records show that the quint was taken out of service because of the door latch failure on numerous occasions dating back to 1998 when it was purchased new. However, many attempts to conclusively resolve the issue were unsuccessful.

Recommendation #3: Manufacturers should ensure that fire apparatus design incorporates all applicable safety standards and that passenger doors are constructed to remain securely latched under conditions of normal and expected use.

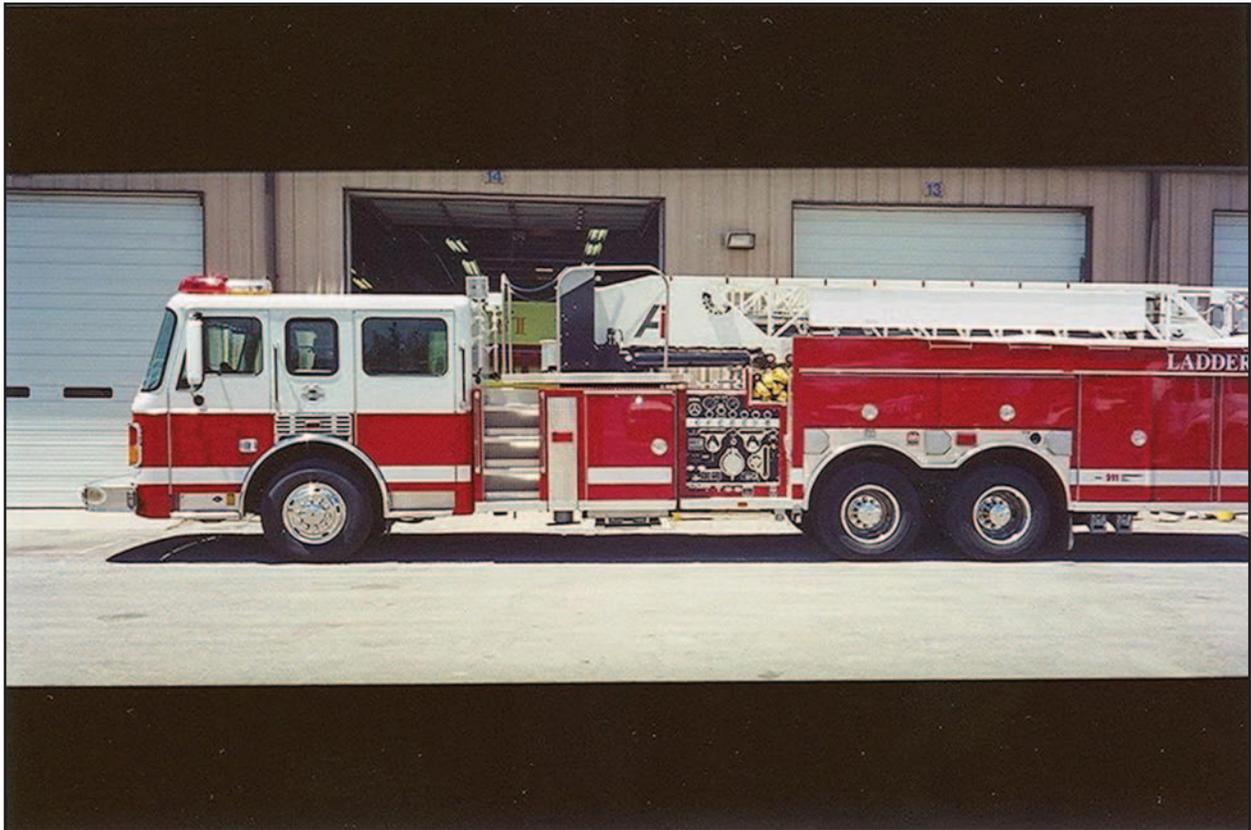
*Photo 1. Type of quint involved in the incident
Photo courtesy of the State Fire Marshal*

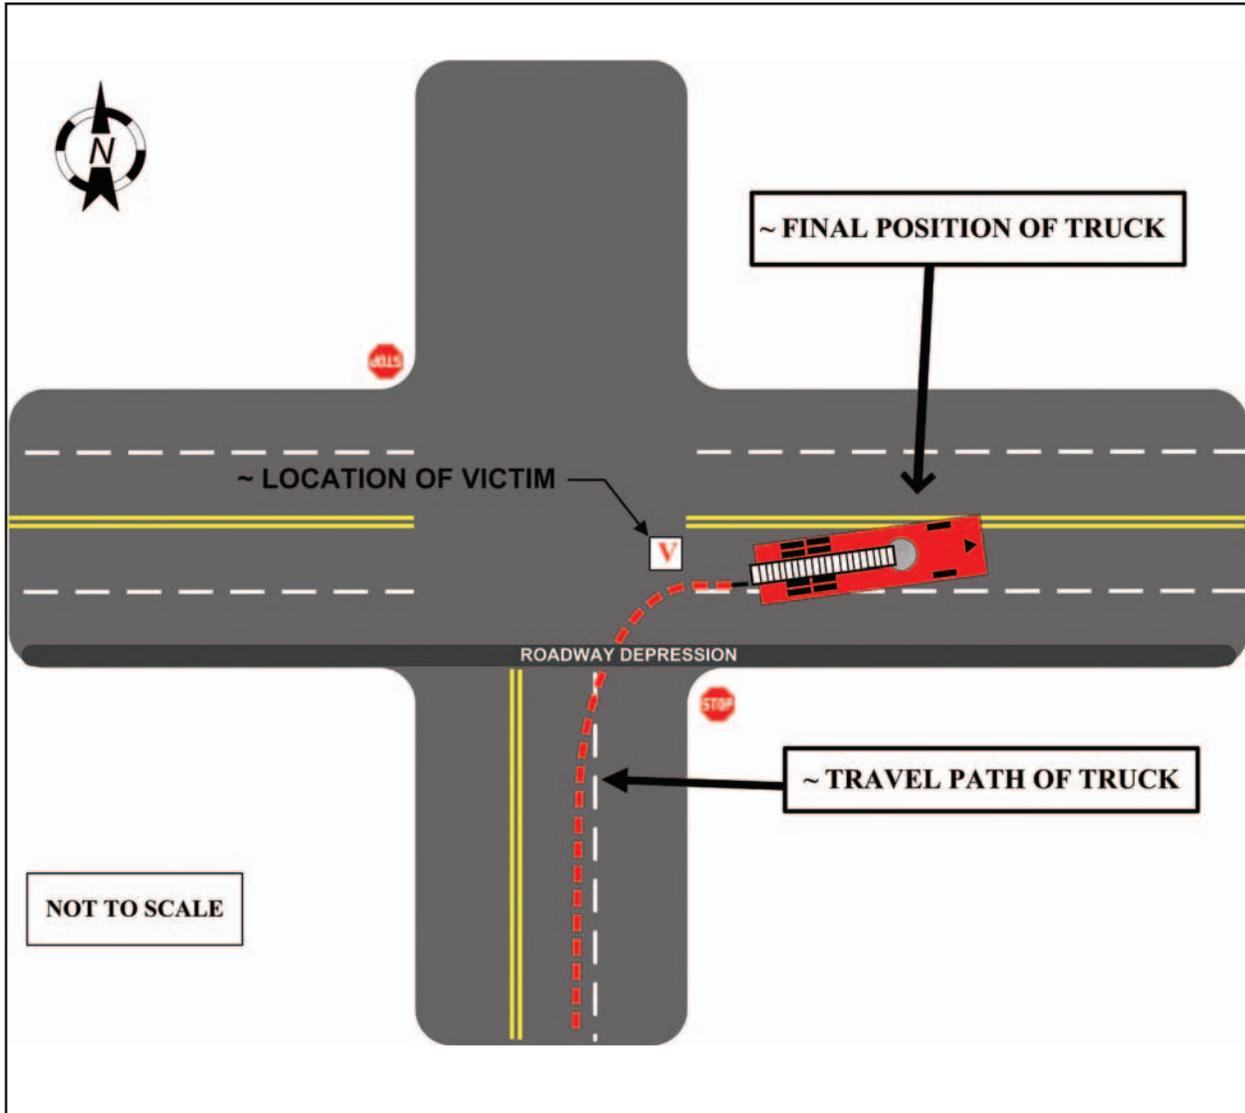
Diagram. Incident Scene

Road / Weather Conditions The incident occurred at approximately 2203 hours at an intersection of two city streets (Diagram). The asphalt road surface was clear and dry, and was illuminated by street lights. The apparatus made a right turn at the intersection, crossing a roadway depression

that is designed to direct rainwater runoff toward the roadway perimeter. At the time the incident occurred civilian traffic was light. The temperature was approximately 48° F with a wind blowing from the southeast at approximately 16 miles per hour (mph).

Upon leaving the station, the driver made a left turn at the end of the apron and traveled approximately 100 yards where he made a right turn and headed eastbound into a four lane city street (see Diagram). The fire fighter who was seated adjacent to the victim reported that the victim was in a semi-standing position and was possibly attempting to retrieve his air pack strap when the truck began the right turn. As the apparatus entered into the turn and dipped slightly due to the roadway depression, the rear passenger door came open. It appeared to the adjacent fire fighter that the victim reached to pull the door closed and lost his balance. The victim fell out of the truck and landed in the street striking his head on the pavement. In the side-view mirror, the driver saw the cab door open and heard the fire fighter who was seated behind the officer shout for him to stop the truck. He immediately stopped and all personnel on board rushed to the victim to begin emergency care.
