## ***Volunteer Fire Fighter Dies After Being Struck by a Shackle on a Recoiling Tow Rope – South Dakota***

### **SUMMARY**

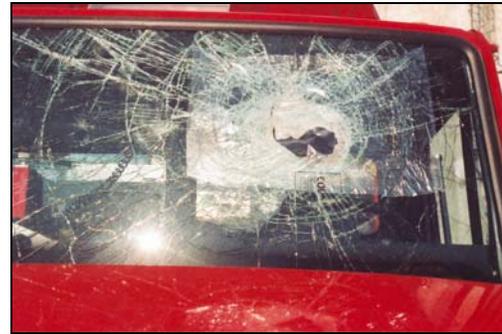
**Windshield of the engine involved  
in incident**

The second farmer began to move the tractor forward, putting tension on the tow rope. Within seconds, the small shackle on the draw bar broke, and the tow rope, with its shackle still attached, recoiled toward the engine. The victim, who had driven the engine into the field, was sitting in the driver's seat. Another fire fighter was sitting next to him in the passenger's seat. The shackle, still attached to the end of the tow rope, crashed through the windshield, struck the victim on the forehead, and exited through the back window.

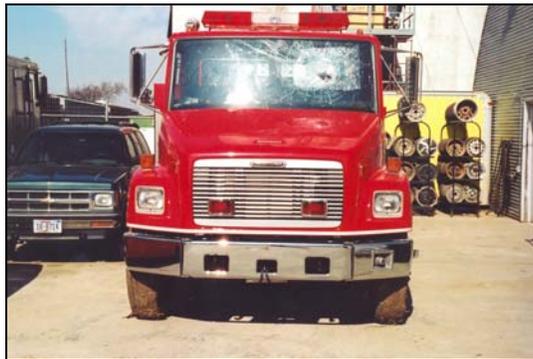
**Photo 1. Engine involved in incident.**  
*(Photo courtesy of County Sheriff's office.)*

Engine #34, 1999 model, 35,000 lbs gross vehicle weight rating(GVWR), equipped with a 1,250 gallon tank (Photo 1).

The engine was driven down into a soybean stubble field in proximity to the burning field and fire fighting activities commenced. After a short time, the fire was extinguished and fire fighters and apparatus started departing the scene. The engine, at that time with an approximate weight of 42,780 pounds (35,000 lbs GVWR of engine + about 7,780 lbs of water [3/4 tank of water]), was being driven out of the soybean field and became stuck in mud in a low, wet spot.

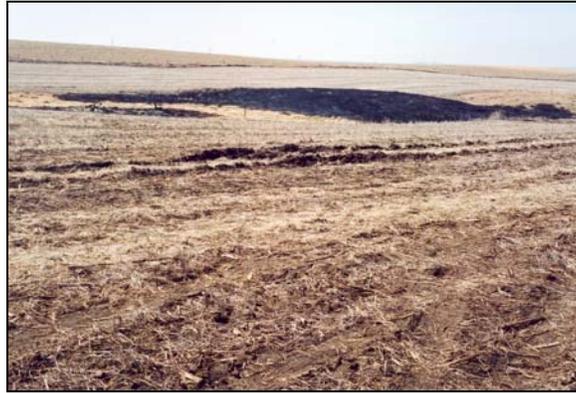
**Photo 2. Incident site.**  
*(Photo courtesy of County Sheriff's office.)*

The incident site was a soybean stubble field with a slight incline. Wet spots existed in the low areas (Photo 2).

Discussion: Fighting wildland fire often requires that apparatus travel off the roadway to reach the fire. Weight, low ground clearance, and larger turning radius make some structural fire apparatus unsuited for off-road use. Even with apparatus specifically designed for off-road use, apparatus operators must know the capabilities and limitations of the apparatus they are operating and use them accordingly. Even on level terrain, an apparatus can become mired in soft ground, sand, or mud leaving it vulnerable to being overrun by a fire.<sup>6</sup> In this case, the engine was not in danger of being overrun by fire because the fire had been contained, but the engine was driven into an area that was low and muddy and eventually became stuck in the mud. This situation resulted in the fire fighters trying to pull it out with the aid of a farmer's tractor which ultimately led to a fire fighter's death. Given the engine's weight of 42,780 pounds (35,000 pounds GVWR + about 7,780 pounds of water [3/4 tank of water]), slope of field and wet low spots, perhaps the engine could have been positioned on higher, flatter ground and may not have become stuck in the mud.

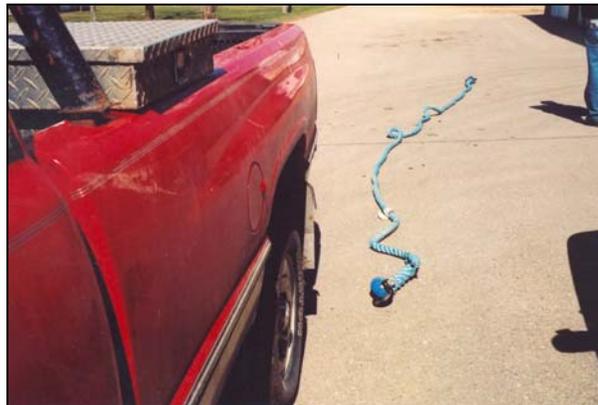
**Photo 3. Polyethylene tow rope.**  
*(Photo courtesy of County Sheriff's office.)*

Polyethylene tow rope, 27 ½' long, 1 ½" diameter, rated to 37,500 lbs (Photo 3).

A farmer, who was watching the activities, saw that the engine had become stuck and offered to pull it out of the mud. The engine was emptied of water, and a fire department tow rope with shackles attached to either end was retrieved. *Note: The tow rope was rated to 37,500 lbs, but the shackles were only rated to 8 ½ tons (17,000 lbs) capacity each.*

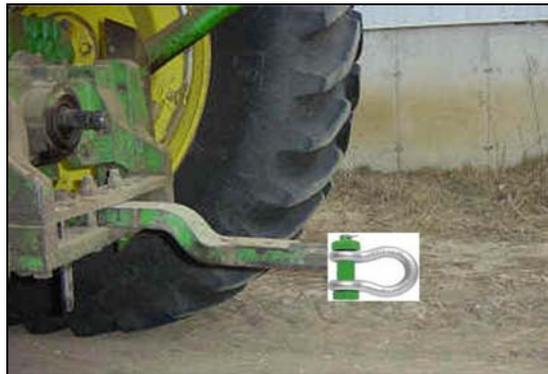
**Photo 4. Shackle attached to draw bar on larger tractor (representation only).**

Farm tractor with small shackle (about 1/2 the size of the shackle attached to tow rope - witness account) attached to draw bar of tractor (Photo 4). *Note: The broken shackle was lost prior to the investigators arrival, and the photo is a representation only.*

draw bar of the tractor used in this incident, according to witness statements, appeared to be about half the size of the shackles attached to the tow rope, and its rating is assumed to be less than the 17,000 lb rating of the larger shackles. Theoretically, the shackle (1/2" diameter) on the draw bar could have had an approximate WLL of only 4,000 lbs. Once tension was applied to the tow rope with shackles attached, the undersized shackle on the draw bar of the tractor broke, allowing the tow rope and it's shackle to recoil through the windshield, striking the victim.

Cables, chains and other hardware will have similar corresponding safe work load ratings. In this incident, the broken shackle could not be located, but, witness statements disclosed that the shackle that failed appeared to be "half the size" of the shackles (1" diameter) on the ends of the tow rope. Using the common sizes and safe working load limits provided above, the small shackle (1/2" diameter) may have had a capacity of around 4,000 lbs. Since the stuck vehicle had a gross vehicle weight of 35,000 pounds, all hardware used in the rigging should have been rated for a safe working load above this weight.

When rigging an object for towing/pulling, only appropriate sized connecting hardware should be used. Screw-pin type shackles (farm clevises) should be stamped with their safe working load limit (in tons) somewhere on the body of the clevis. For example, some common sizes and safe working limits for drop forged steel screw pin shackles are:<sup>1</sup>

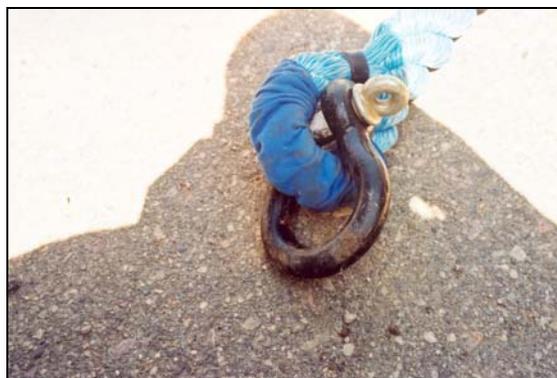
**Photo 5. Screw pin shackle (also known as Farm Clevis).** *(Photo courtesy of County Sheriff's office.)*

Shackles (also known as Screw Pin Shackle and Farm Clevis), attached to either end of the tow rope with a working load limit (WLL) of 17,000 lbs (8 ½ tons) each (Photo 5).

Discussion: Towing/pulling jobs are occasionally performed by fire departments using tow ropes, shackles, tow hooks and other rigging fixtures. Fire departments and fire fighters need to know equipment limitations and follow safety instructions supplied by the equipment manufacturer, such as the warning tag affixed to the tow rope and the working load limit stamped on the shackles. The warning tag on the tow rope used in this incident read – "When attaching the rope to a vehicle that is going to be pulled or to a vehicle that is to pull it, never attach the rope to a hook, clevis, chain, cable or other metal object that is weaker than the rated strength of this rope that is on the attachment." In this case the engine had a gross vehicle weight rating of 35,000 lbs. The polyethylene tow rope used was rated to 37,500 lbs; however, the shackles (1" diameter) attached to the ends of the tow rope had a working load limit (WLL) of only 17,000 lbs each. Additionally, a smaller shackle attached to the

3/8"	2,000 lbs or 1 Ton	1 1/8"	18,500 lbs or 9.5 Tons
1/2"	4,000 lbs or 2 Tons	1 1/4"	24,000 lbs or 12 Tons
5/8"	6,500 lbs or 3.25 Tons	1 3/8"	27,000 lbs or 13.5 Tons
3/4"	9,500 lbs or 4.75 Tons	1 1/2"	34,000 lbs or 17 Tons
7/8"	13,000 lbs or 6.5 Tons	1 3/4"	50,000 lbs or 25 Tons
1"	17,000 lbs or 8.5 Tons	2"	70,000 lbs or 35 Tons
