Career Fire Fighter Dies and Captain is Injured During a Civilian Rescue Attempt at a Residential Structure Fire – Georgia

SUMMARY

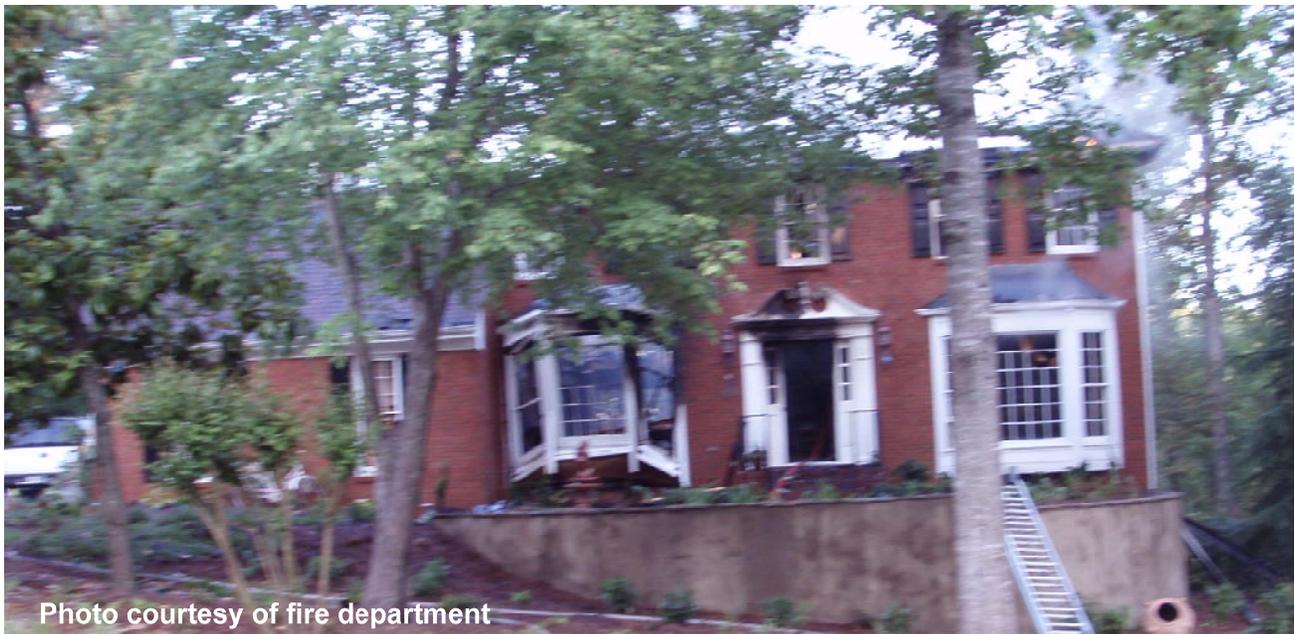
Incident Site

Photo courtesy of fire department

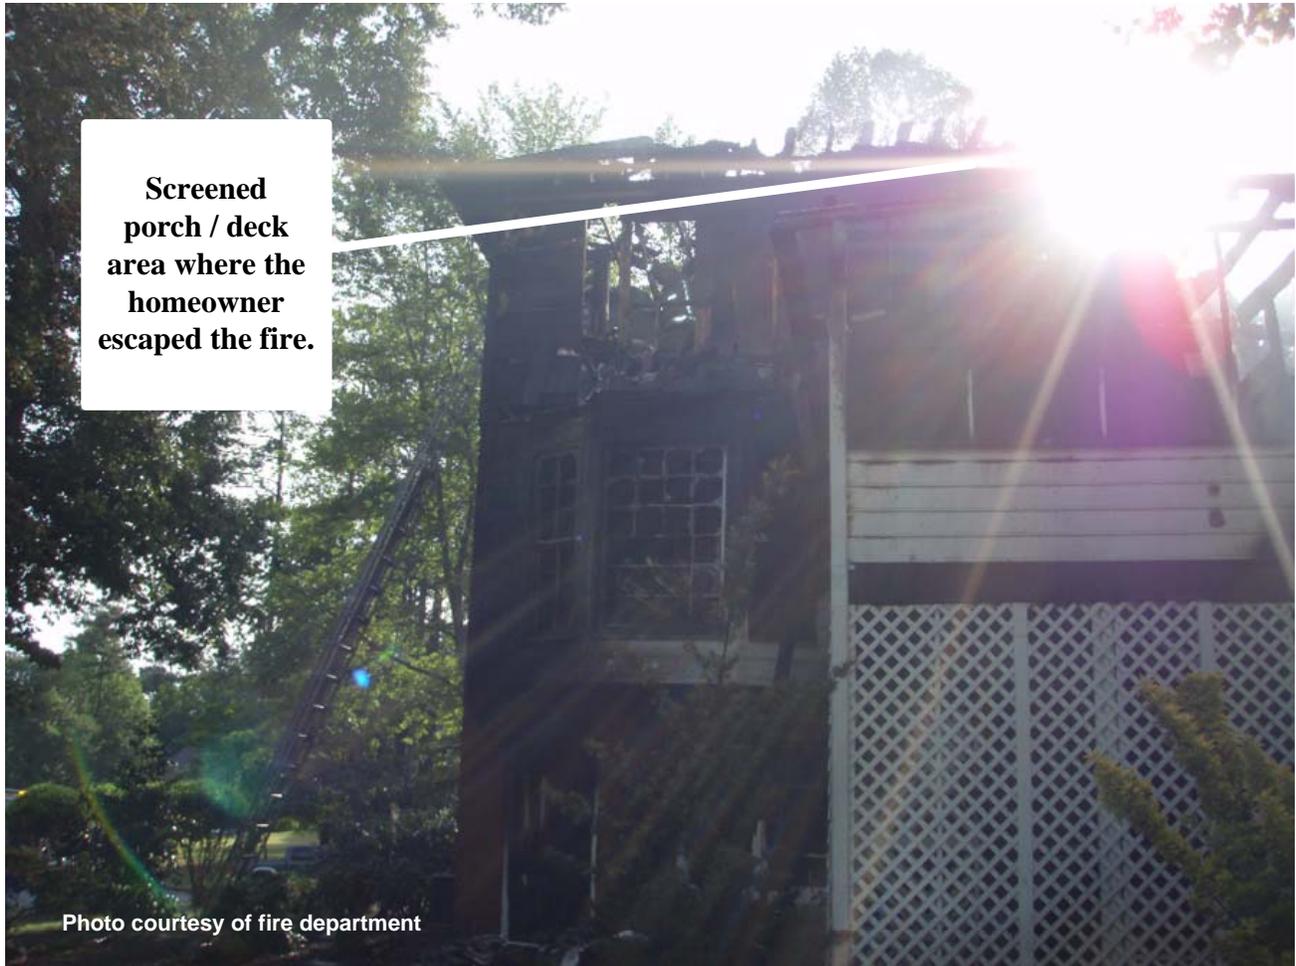
Photo 1. C/D Corner of the House

window and onto the deck at the C side of the house. (Photo 1; Diagram 1) The owner told investigators that she was awakened by the civilian victim who was alarmed when he heard the dogs, that were in a room on the first floor of the house, barking. She went to her bedroom door and could hear the dogs barking and the smoke alarm sounding. She opened her bedroom door and saw dark smoke in the hallway. She closed the door and tried to wet a towel to place under the door but there was no water. She then tried to call 911 from the bedroom phone, and was unable because the phone line was dead. She went to the back of the house (C side) to exit from a bathroom window next to the master bedroom where she could get onto the roof of a screened porch and then onto a deck. She found herself in an adjacent bedroom where she exited from the window onto the roof of a first floor box-bay window then onto the deck. She believed that she saw the other occupant as he leaned out of the bathroom window that was adjacent to the master bedroom. She called to him, he disappeared from the window and she thought he was following her. After jumping onto the deck, she realized that he was not behind her so she ran to a neighbor's house to call 911. While the neighbor called 911 the owner and another neighbor returned to the deck area where they believed they would find the trapped occupant trying to exit. However, they could not see him and did not hear any response when they called his name. The neighbor then attempted to use a garden hose to extinguish a small flame that was showing adjacent to the house near the corner of the deck, but there was no water.^a The owner and neighbor then went to the front (A side) of the house. A bystander told them that he had seen the other occupant in the master bedroom window near the A/D corner and called for him to jump; but he did not jump out of the window and disappeared from view. Bystanders used a sledge hammer to break open the front door and a ladder to break open an upstairs window in the master bedroom. The homeowner and the neighbor tried to enter through the front door but were forced back by thick smoke. They then went to the garage on the B side where the owner was able to open the garage door by using the outside keypad. They took a ladder from the garage to the A side of the house and used it to break out a window above the front entrance. They were able to break out the front bay window near the door and rescue the family pets that were in a room directly behind the window. Once again she and the neighbors called out to the trapped civilian. It was later reported that bystanders heard the trapped civilian call out from above the garage area, but this information was never relayed to the fire fighters.

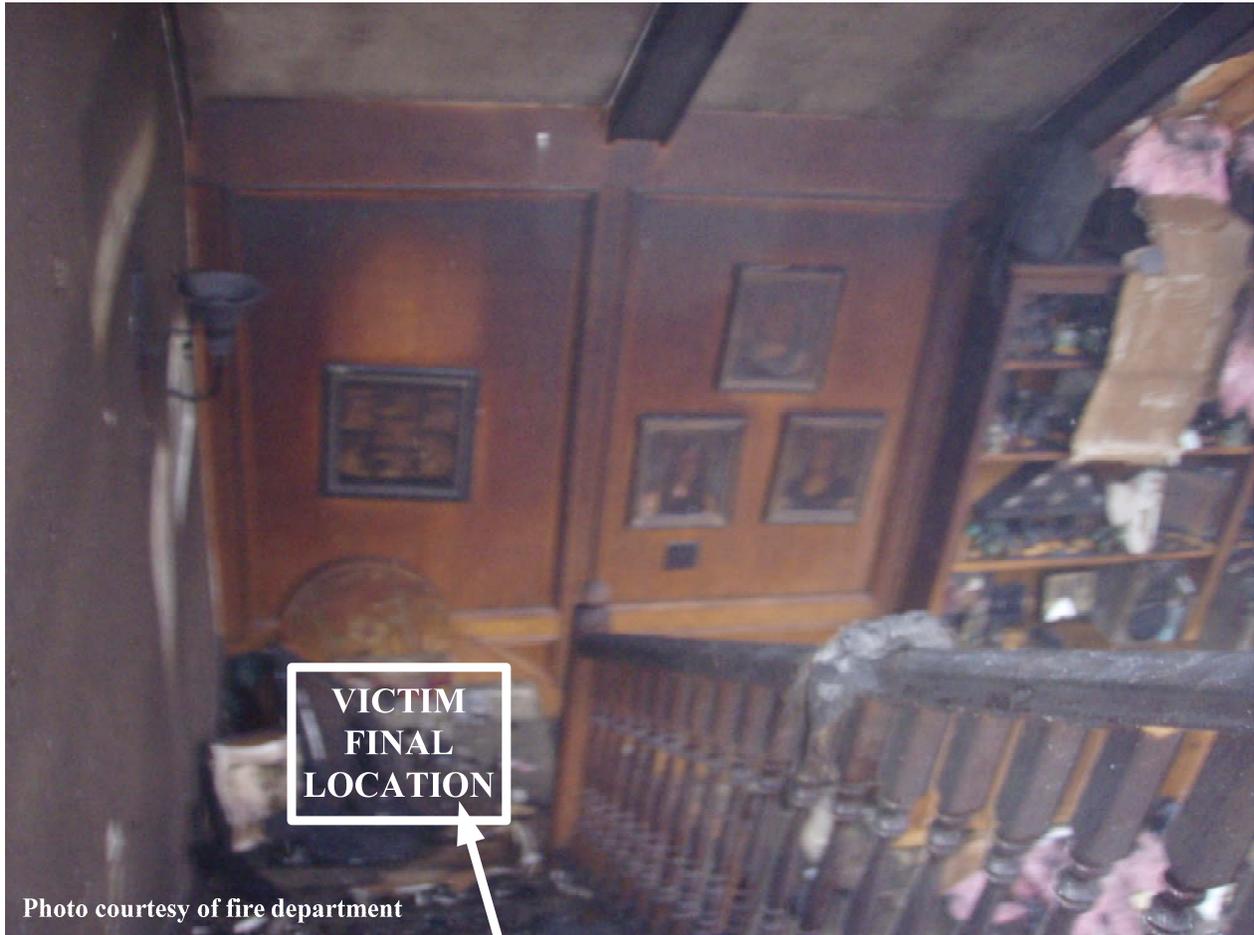
Photo 2. Stairway to landing where victim and officer fell

The heat and fire were intensifying on the lower level by the time the officer and victim exited the bedroom. With the victim going first on the line and the officer behind him, they turned to the right into a hallway and began to crawl toward an open walkway above the first floor family room that led to the B side of the structure near a room above the garage. (Diagram 2) They had just begun to crawl through the hallway when the victim discharged a short burst of water from the line and suddenly stood up. He appeared to be in some sort of distress, pulled his face mask loose and started to run toward the walkway. The officer ran after the victim and while trying to grab hold of him, they both fell down stairs that they were unable to see due to the thick smoke and possibly debris from the partial collapse of the first floor that was occurring at approximately the same time. The stairs they fell down led to a first floor family room. The victim fell unconscious onto the stair landing. (Photo 2) The officer could not find his radio so he removed his gloves to find and key his mic to call “man down.” He radioed that they were in the basement because he believed that the stairs they had just fallen down went to the basement level. He crawled around trying to find a way out, but when he felt his hand go through the floor he returned to the victim who’s Personal Alert Safety System (PASS) had activated. At that point, the officer’s SCBA low air alarm began to vibrate so he activated his own PASS alarm, stayed close to the victim, and waited for rescue.

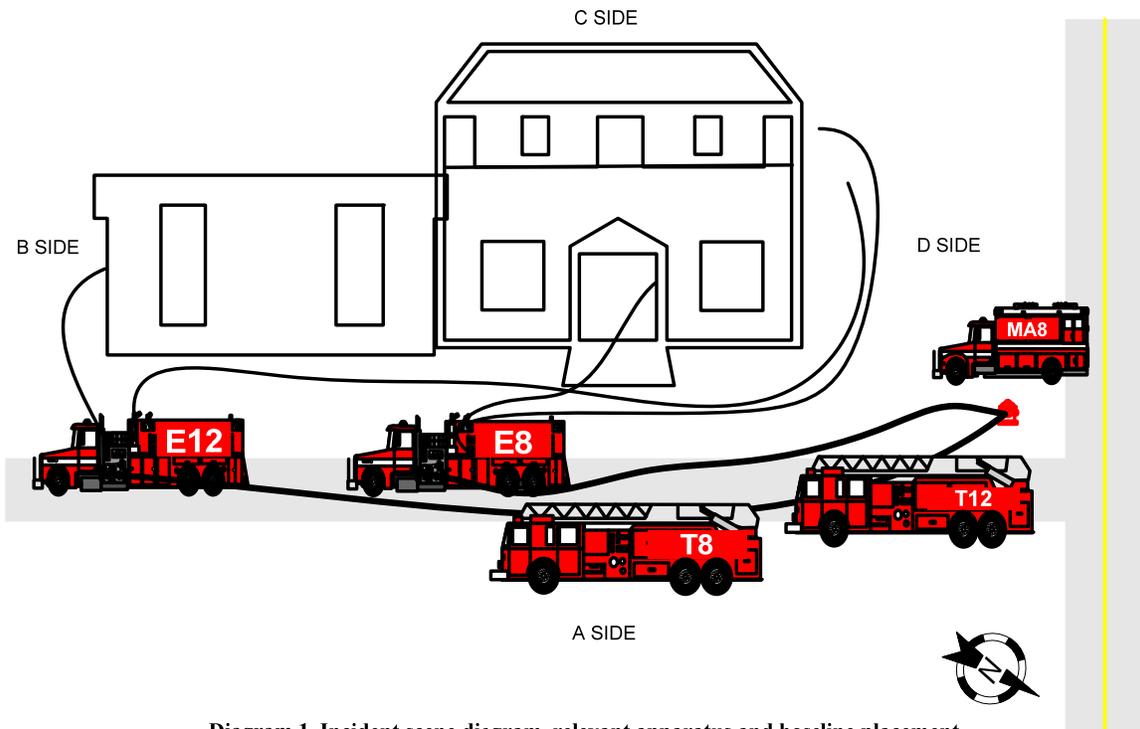
Diagram 1. Incident scene diagram, relevant apparatus and hoseline placement.

At 0459 hours Engine 8 (E8) with an officer, driver, and the victim arrived on the scene, parked at the A side of the house (Diagram 1) and reported to dispatch that there was heavy smoke coming from the structure. Truck 8 (T8) with an officer and driver/operator, and Battalion 4 (BC4), arrived at 0500 hours. BC4 assumed incident command. Bystanders told the first arriving fire fighters that the trapped civilian was last seen in the master bedroom window located at the A/D corner of the second floor. They said that they tried to encourage him to jump but he seemed disoriented and had disappeared from view.

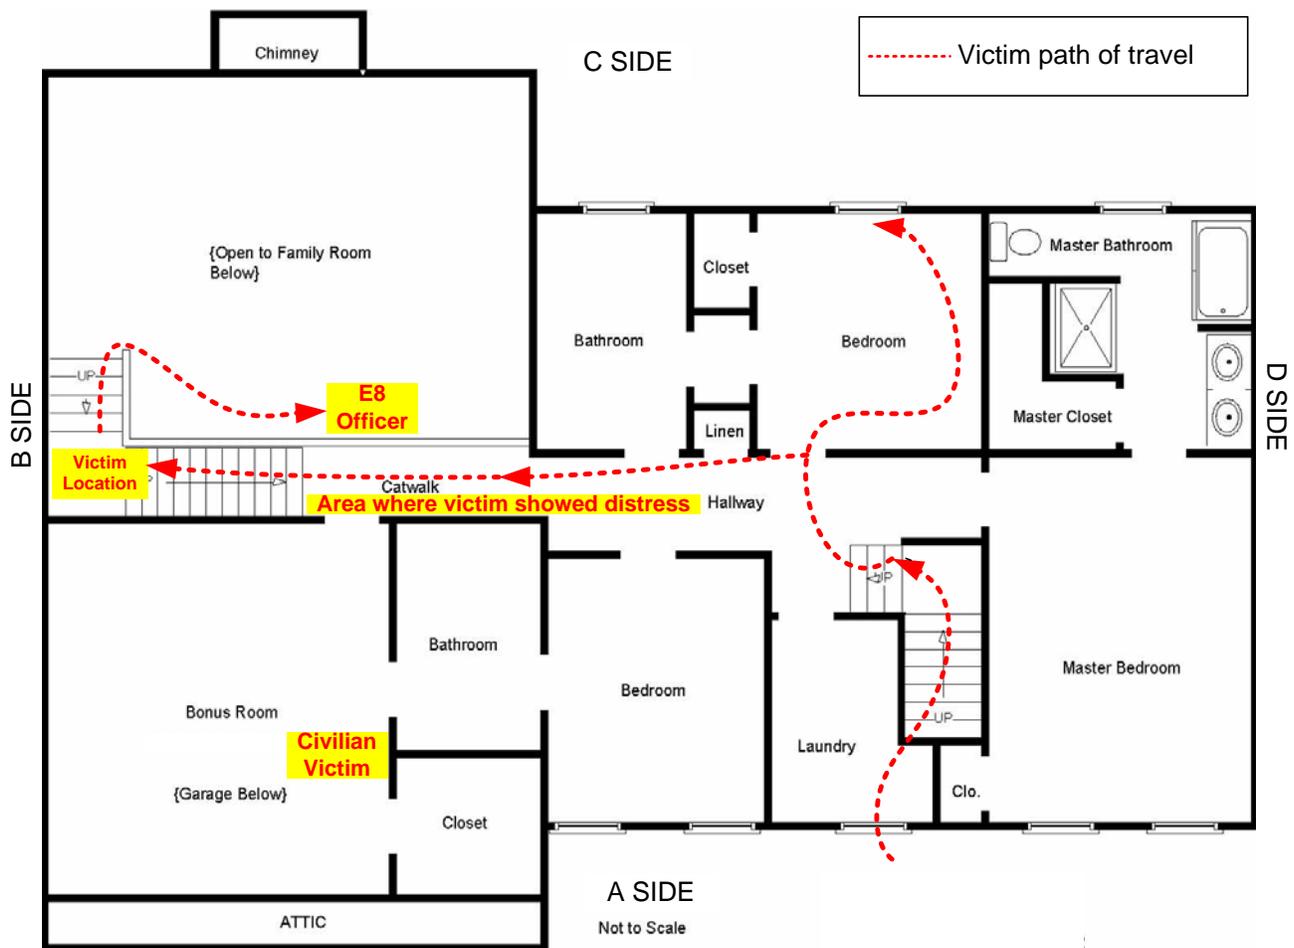
Diagram 2. Victim path of travel and civilian victim location.
Second Floor

The victim and the officer from E8 stretched a 200 foot 1¾” cross-lay pre-connect from E8 and entered the structure through the front door to search for the trapped civilian. The driver/operator of E8 hooked up to the hydrant located near the northwest corner of the roadway and cul-de-sac intersection and then assisted pulling the line. He then pulled a second line off of the truck from the back skid load and began pump operations. The victim and officer ascended the stairs from the first floor foyer reaching a landing then making a sharp left turn followed by several additional steps before reaching the second floor. (Diagram 2) There was heavy smoke but no fire. They decided to do a quick search for the civilian since the truck crew had not yet entered the structure. Since they were told he was last seen in the master bedroom at the A/D corner, the victim and officer made a right turn at the top of the stairs and began to search a room which they believed to be the master bedroom. They had actually entered a smaller bedroom that was next to the master bathroom. The victim who was on the nozzle began a right hand search. The officer went to the left and quickly realized that the room was too small to be a master bedroom. He called out to the victim to return to the door.

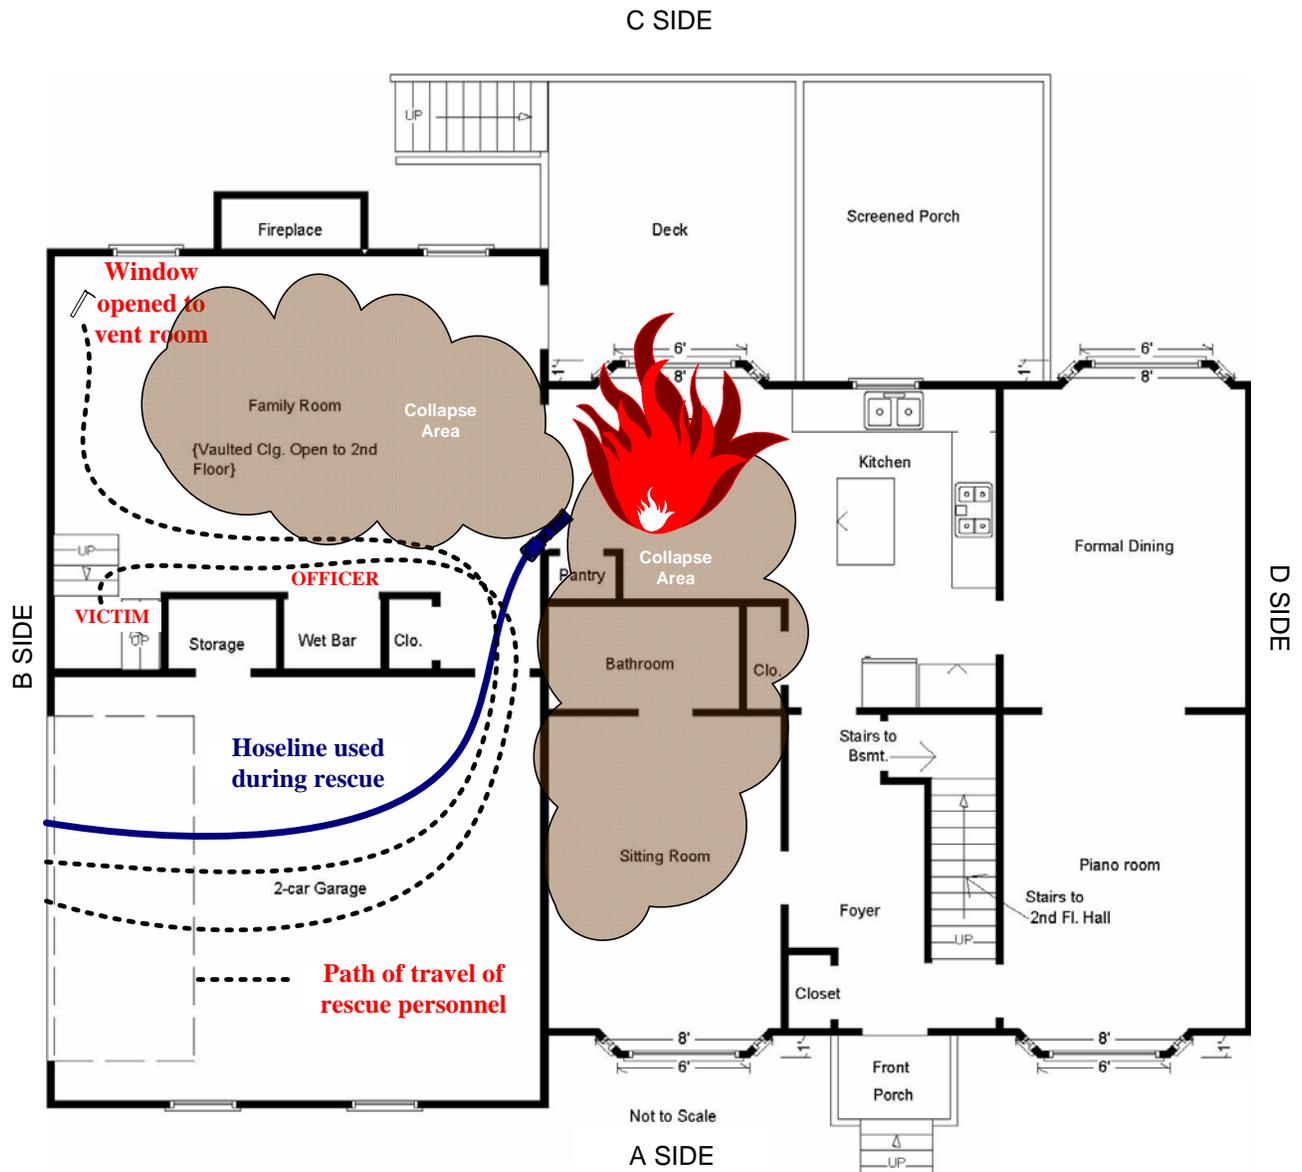
Diagram 3. Victim rescue efforts.
First Floor

The garage door was open so the officer from T12 entered. (Diagram 3) He opened the interior door on the left side of the garage after feeling the door to check for heat. The door led into the family room. There were no flames in the immediate area but visibility was zero due to heavy smoke. Just

then he heard a second mayday transmission both over the radio and audibly. He entered through the door toward the direction where he believed he heard the voice of the E8 officer calling for help. The officer from T12 entered the area and went to the left. He quickly located the E8 officer along the wall that adjoined the garage and family room. He found him upright on his knees but when the officer tried to help him out of the area he said that the victim was right beside him and he would not leave without him. The T12 officer could feel the E8 officer's low air alarm sounding and the area was starting to heat up due to the flames that were showing in the kitchen area toward the D side. He went back to the garage and told a fire fighter from E12 that he needed a hoseline brought into the family room and to direct the stream toward the D side to cool the area and keep the flames off of him while he tried to extricate the E8 officer.
