Career Fire Fighter Dies in Fall from Roof at Apartment Building Fire – New York

Fatality Assessment and Control Evaluation Investigation Report # F2007-19

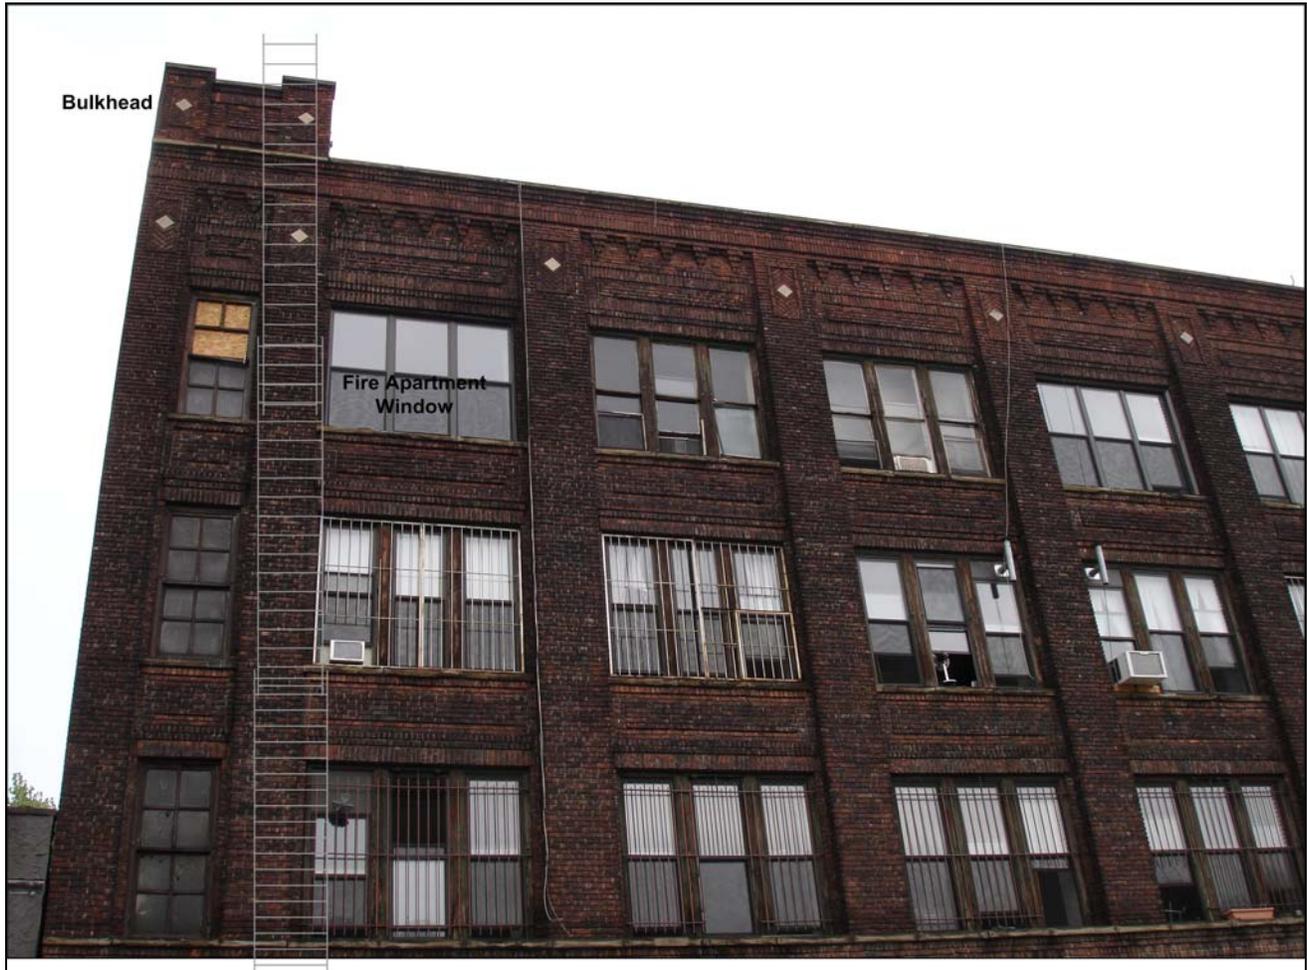
Photo 1. Incident Structure.
(Ladder image is for reference purposes only)
(NIOSH photo)

The structure involved in this incident was a four-story industrial brick building of class III construction, originally built in the 1920s (see Photo 1). The building was originally a sewing machine factory and had been illegally converted into residential loft apartments in 2000. The building was 75 feet wide by 100 feet long and was equipped with sprinklers, some of which were blocked because of the illegal conversions. Each floor had four apartments and interior construction was drywall over metal studs. Exterior construction was solid brick with a flat tar and asphalt roof.

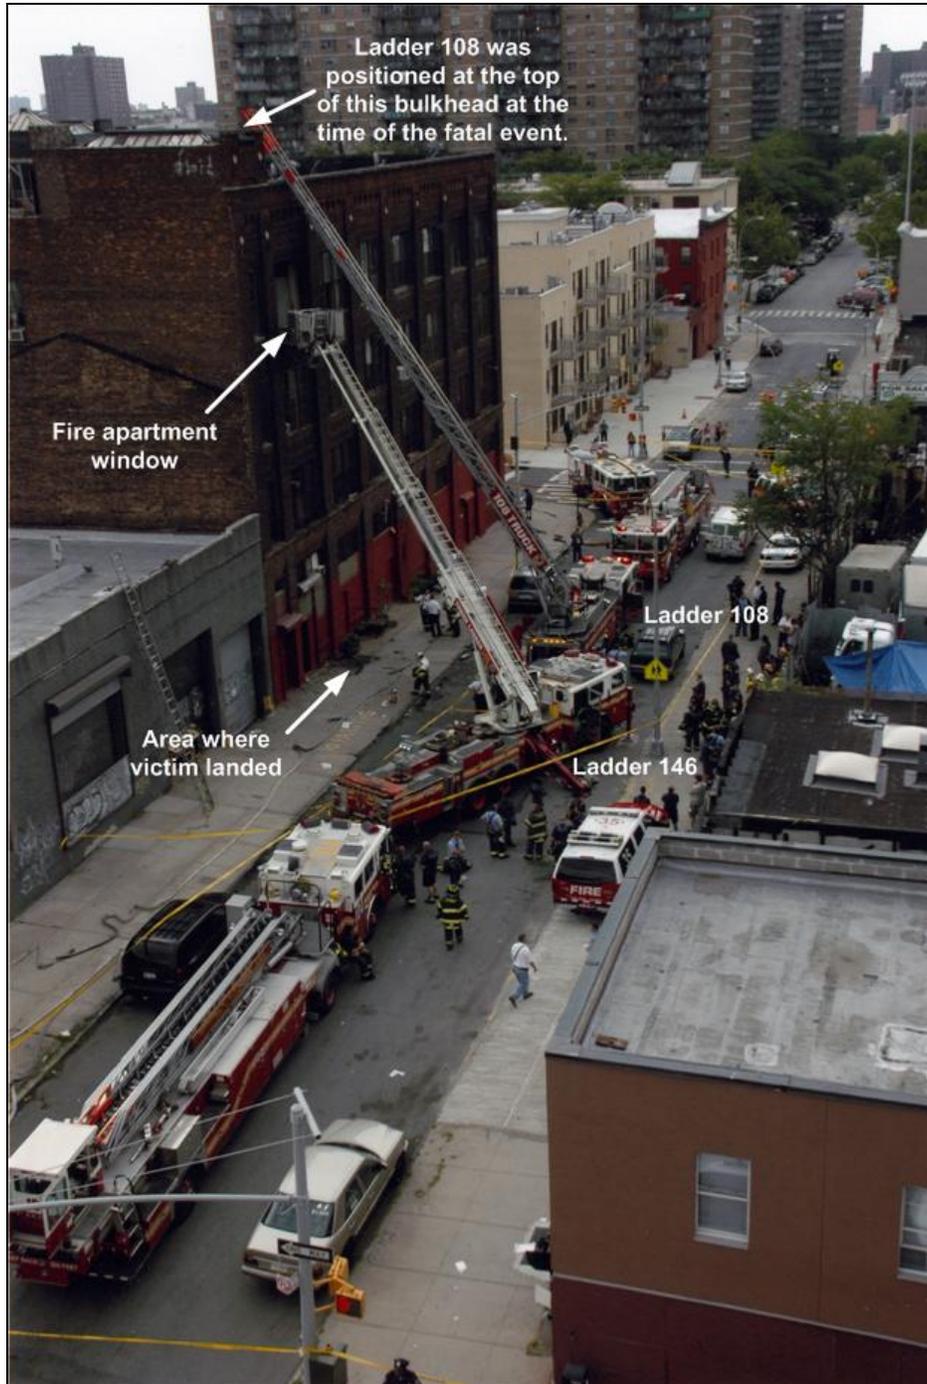
Photo 2. Aerial View of Incident Scene.
(Photo Courtesy of Fire Department)

Ladder 108 (L108), the 1st due truck company, arrived at 1657 hours. After positioning in front of the building, the L108 roof fire fighter raised and placed the aerial ladder to the roof at the center of the bulk head (see Photo 2). (*Note: A roof fire fighter is responsible for ventilating the roof if necessary and checking all sides of a building for trapped residents*). The victim (another roof fire fighter) arrived on scene in Ladder 146 at 1658 hours. He dismounted the apparatus, grabbed his tools and went to Ladder 108 to access the roof.

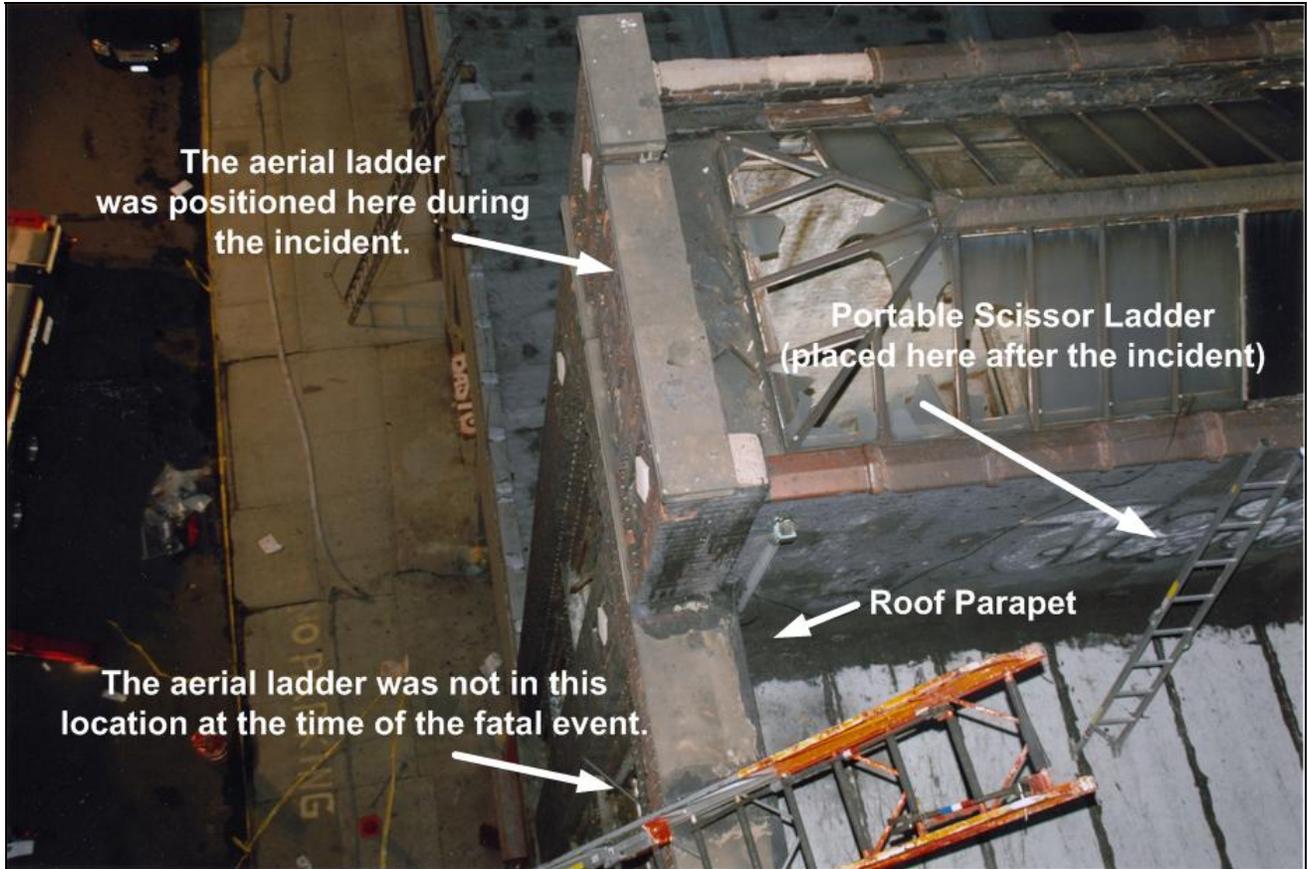
Photo 3. Aerial View of the Bulkhead on the Roof of the Incident Structure.
(Photo Courtesy of Fire Department)

Discussion: During this incident, the aerial ladder was initially placed at a bulkhead on the roof. This bulkhead measured approximately 9 feet above the roof. The first fire fighter lowered himself over the side of the bulkhead and then dropped to the roof without incident. The second fire fighter (the victim) attempted to lower himself to the adjacent roof parapet wall 5.5 feet below and fell to his death. The aerial apparatus had a portable scissor ladder mounted at the tip of the aerial. Using the

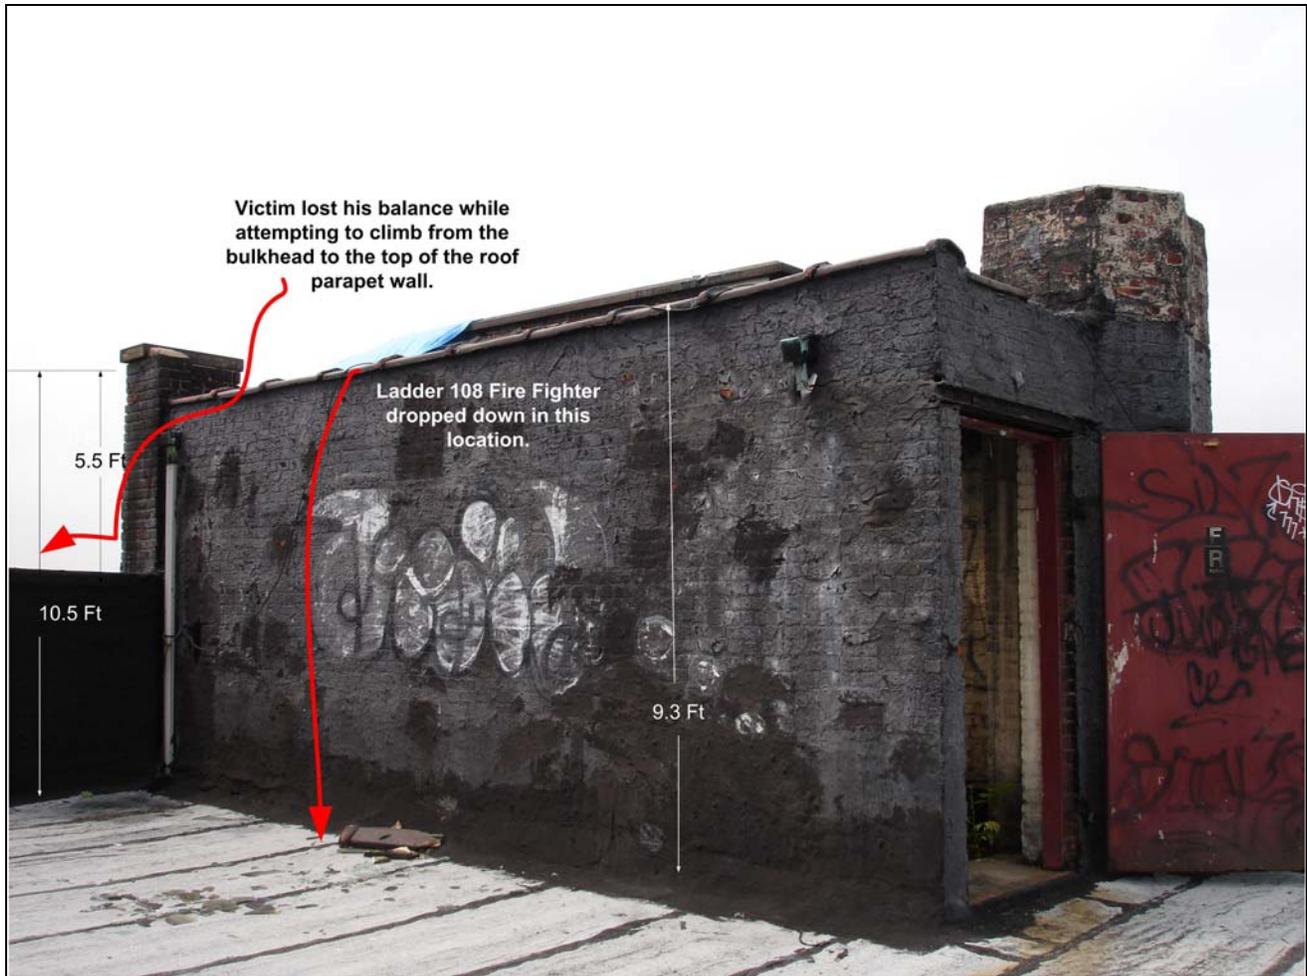
hand tool in each hand. (Note: It was 5’6” feet from the top of the bulkhead coping to the top of the roof parapet wall). The chauffeur of Ladder 108 observed that the roof saw (slung over the victim’s shoulder) shifted during the climb down from the bulkhead and the victim lost his balance. The victim fell to the ground and landed on his side and upper torso and sustained massive trauma to his head, torso, and extremities. (Note: Besides the weight shift from the saw, a loss of grip or footing could have contributed to the fall).

Photo 4. Bulkhead on Roof of Incident Structure.
(NIOSH photo)

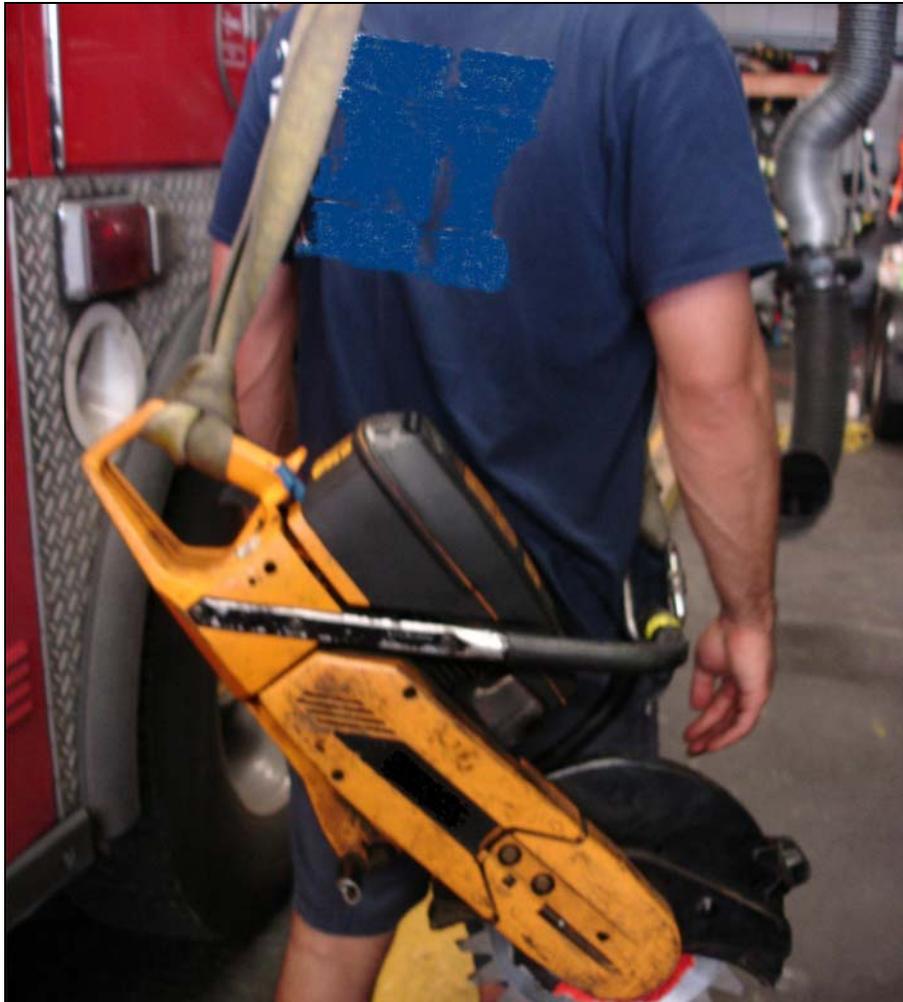
Discussion: This fire department uses a strap/sling made from a section of nylon webbing.¹ This allows for a roof saw to be carried over the fire fighter's gear to permit the use of both hands while climbing a ladder (see Photo 5). This practice is taught at their fire academy.¹ Their training included proper attachment of a 50 inch sling to each end of the saw and donning of it.¹ While the victim was trying to descend to the roof parapet from the bulkhead his roof saw shifted, throwing him off balance, causing him to fall. In lieu of having fire fighters sling the saw over their body, they could possibly hoist it up to the roof with rope or if an aerial ladder has attachments for securing tools at the tip, these attachments could be used to elevate the tools for roof operations.

Photo 5. Roof Saw with Sling.
(Photo taken for demonstration purposes only)
(NIOSH photo)

Discussion: During this incident, a ventilation saw was outfitted by the fire department with an aftermarket carrying sling/waist strap harness. It was placed in the same manner as the manufacturers', but served a dual purpose as a carrying sling and safety harness while cutting. It was observed that while the victim was climbing down from the bulkhead, the saw shifted, throwing him off balance. Manufacturers should consider working with the fire service to develop different sized slings for variations in saw size and fire fighter stature. The goal is to keep the saw as close to the body as possible, thus limiting movement which can effect a fire fighter's balance.
