Volunteer Lieutenant and a Fire Fighter Die While Combating a Mobile Home Fire - West Virginia

SUMMARY

On February 19, 2009, a 49-year-old male volunteer lieutenant (Victim #1) and a 26-year-old male fire fighter (Victim #2) were fatally injured while combating a mobile home fire. They arrived on scene to find a camper fully involved with fire and flames impinging on an adjacent mobile home.

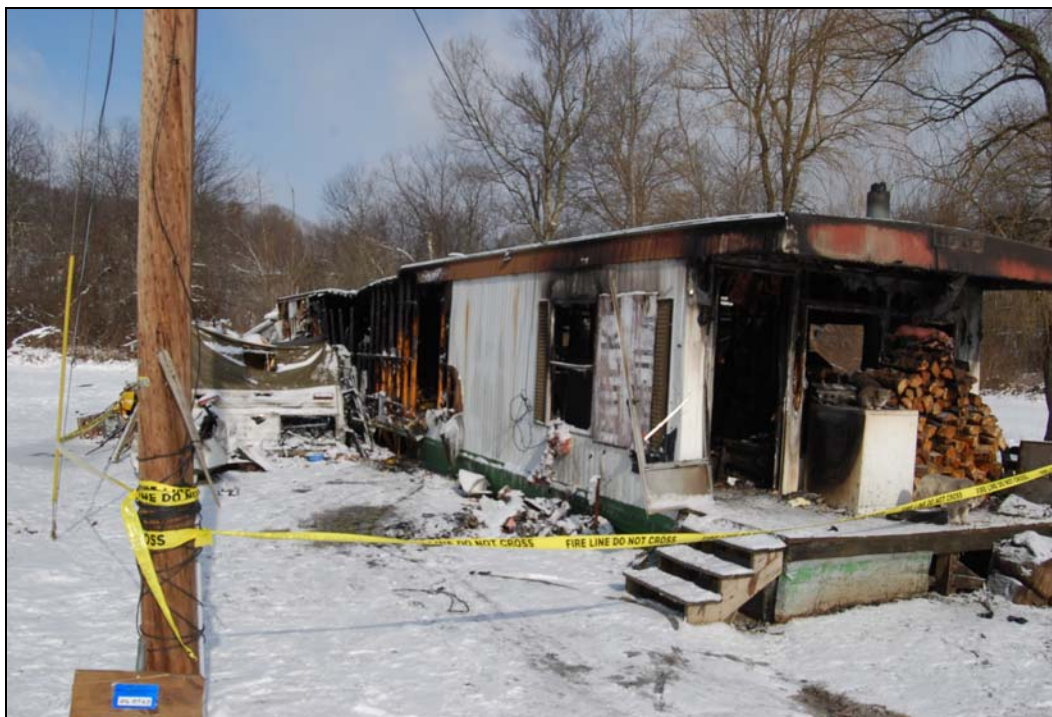
*Incident Scene
(Photo courtesy of fire marshal)*

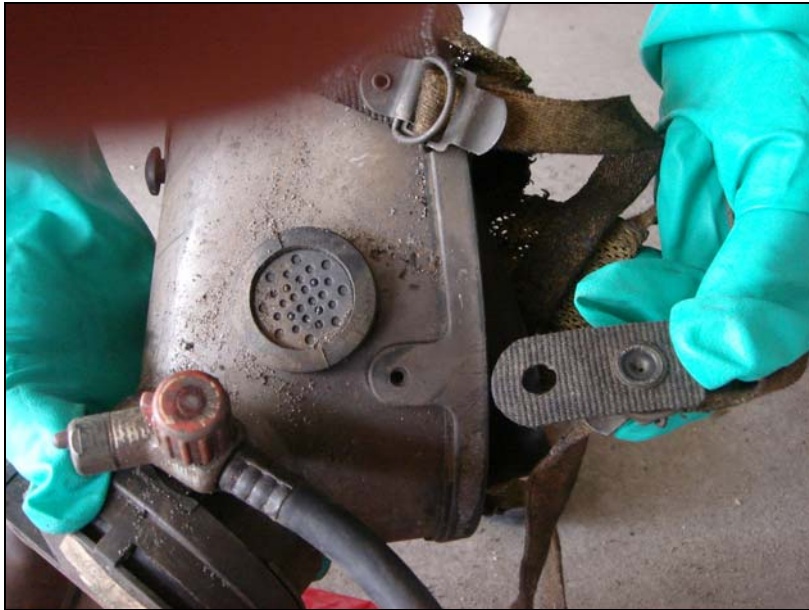
Photo 1. Facepiece missing a harness fastener.
(NIOSH photo)

The victims' facepieces had not been flow tested since 2002, and the SCBAs did not meet the current edition of NFPA 1981. The face piece used by victim #2 was missing a harness anchor screw which could affect the seal of the mask. Also, the victims' air packs did not contain an integrated or stand-alone PASS device. Fire fighters need to know and officers need to reinforce that a SCBA is an integral part of fire fighters' protective clothing, and without it they cannot safely enter hazardous environments requiring respiratory protection. Preventative maintenance programs are designed to extend the life of a product and catch potentially life-threatening problems.

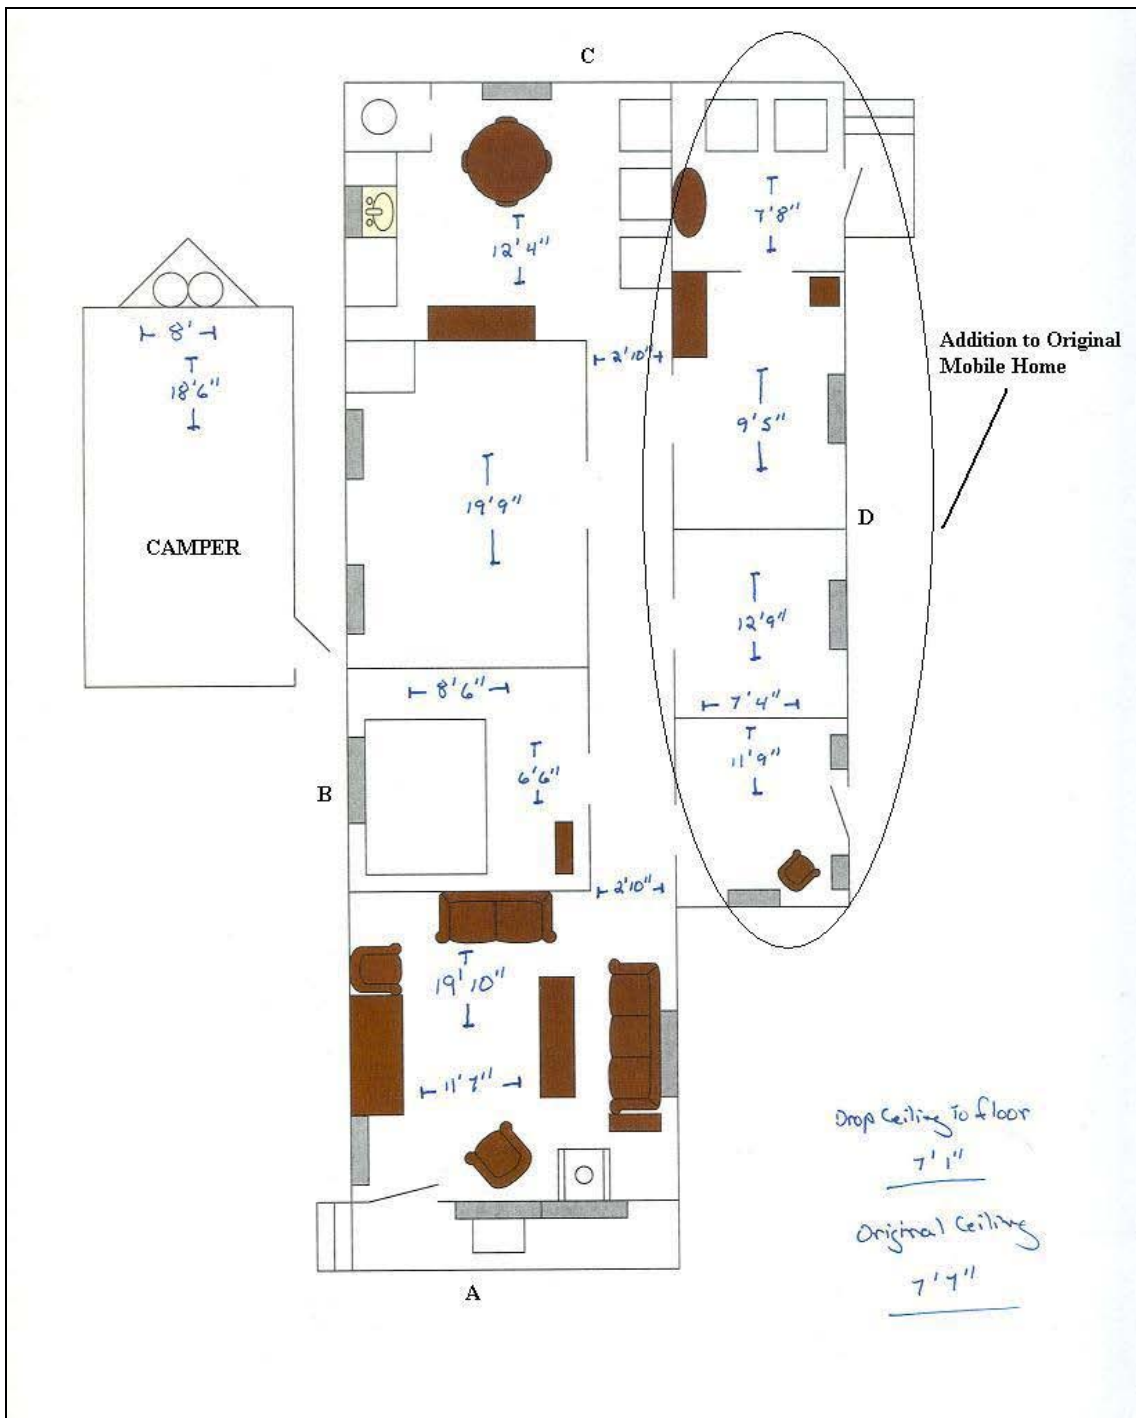
Diagram 1. Approximate dimensions of mobile home.
(Diagram courtesy of fire marshal; with added labels)

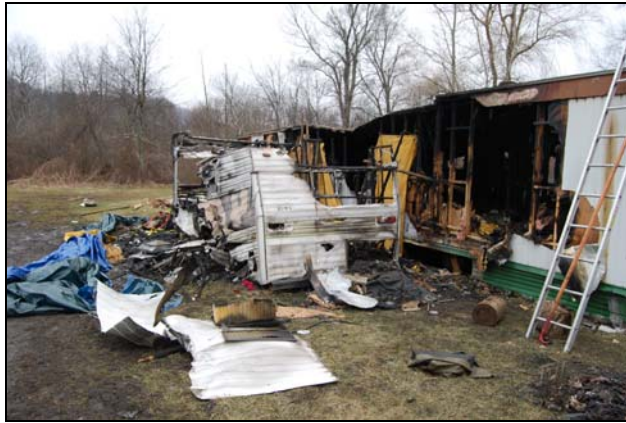
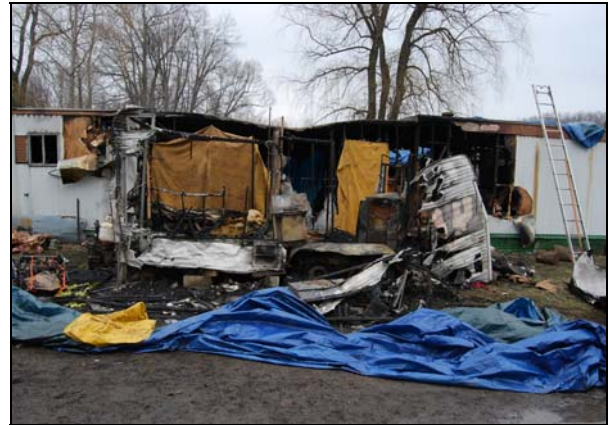
The fire originated from an occupied camper that was parked near the B-side of the mobile home, approximately four feet away (see Photos 2 and 3). The camper measured 18 ft 6 in x 8 ft and was completely destroyed during the fire. It is believed the camper fire directly impinged on the B-side of the structure causing a window to fail, allowing the fire to ignite the B-side wall and bedroom materials inside the mobile home.

**Photos 2 and 3. Camper located on the B-side of the structure.
Photos taken after snow had melted.
(Photos courtesy of fire marshal)**

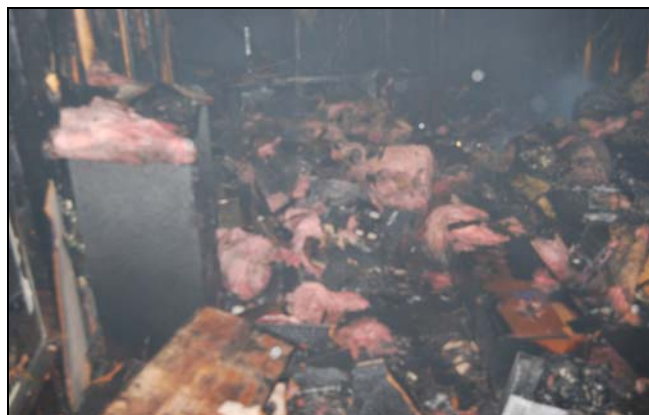
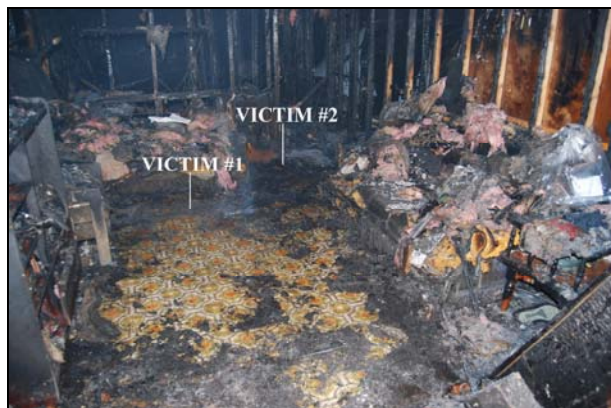
FF2 (from Station 3) and FF 4 entered through the A-side front door. FF4 recalls seeing no fire conditions in the front room and the gray/black smoke was being blown around them. He was able to walk around the front room and remembers walking on a lot of debris. The suspended ceiling had fallen allowing the fiberglass insulation to fall, covering the living room floor and the victims (see Photos 4 and 5).

Photos 4 and 5. Front room of mobile home before and after debris and victims were removed.
(Photos courtesy of fire marshal)

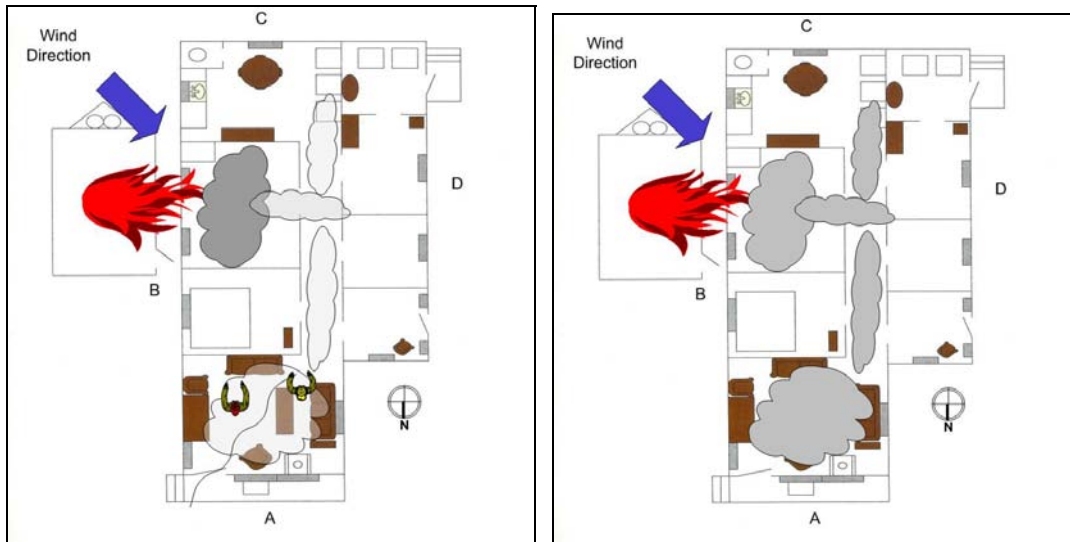
State fire marshal and NIOSH investigators have not been able to determine what happened in the mobile home causing the deaths of the two fire fighters. According to the medical examiner, both victims had lethal doses of carbon monoxide and cyanide in their systems, thermal burns to their tracheas, and soot in their lungs. NIOSH investigators believe that the victims may have entered the structure without being on air because there was no evidence of fire within the mobile home, only light smoke. *Note: Fire fighters interviewed stated if no fire was present and smoke conditions were light, then the department fire fighters may not have initially been on air.* It is believed that while advancing the hoseline into the front room, the camper fire continued to directly impinge on the mobile home, causing materials to heat up and off-gas until they reached their ignition temperature; fire from the camper also breached into the interior of the mobile home through a B-side window. The windy conditions and the mobile home acting as a horizontal chimney may have contributed to the movement of products of combustion, smoke toxins, and hot fire gases through the mobile home, which could have quickly overcome the victims (see Diagrams 3 and 4).

Diagrams 3 and 4. Diagram on left depicts smoke and visibility conditions when fire fighters entered into the mobile home, with the gray cloud indicating heavy smoke and products of combustion and the transparent clouds indicating lighter smoke conditions and good visibility. NIOSH investigators believe that smoke and visibility conditions quickly changed engulfing the fire fighters in an oxygen-deficient atmosphere and exposing them to fire-produced toxins, with the gray clouds indicating increased smoke conditions and products of combustion (Diagram on right).

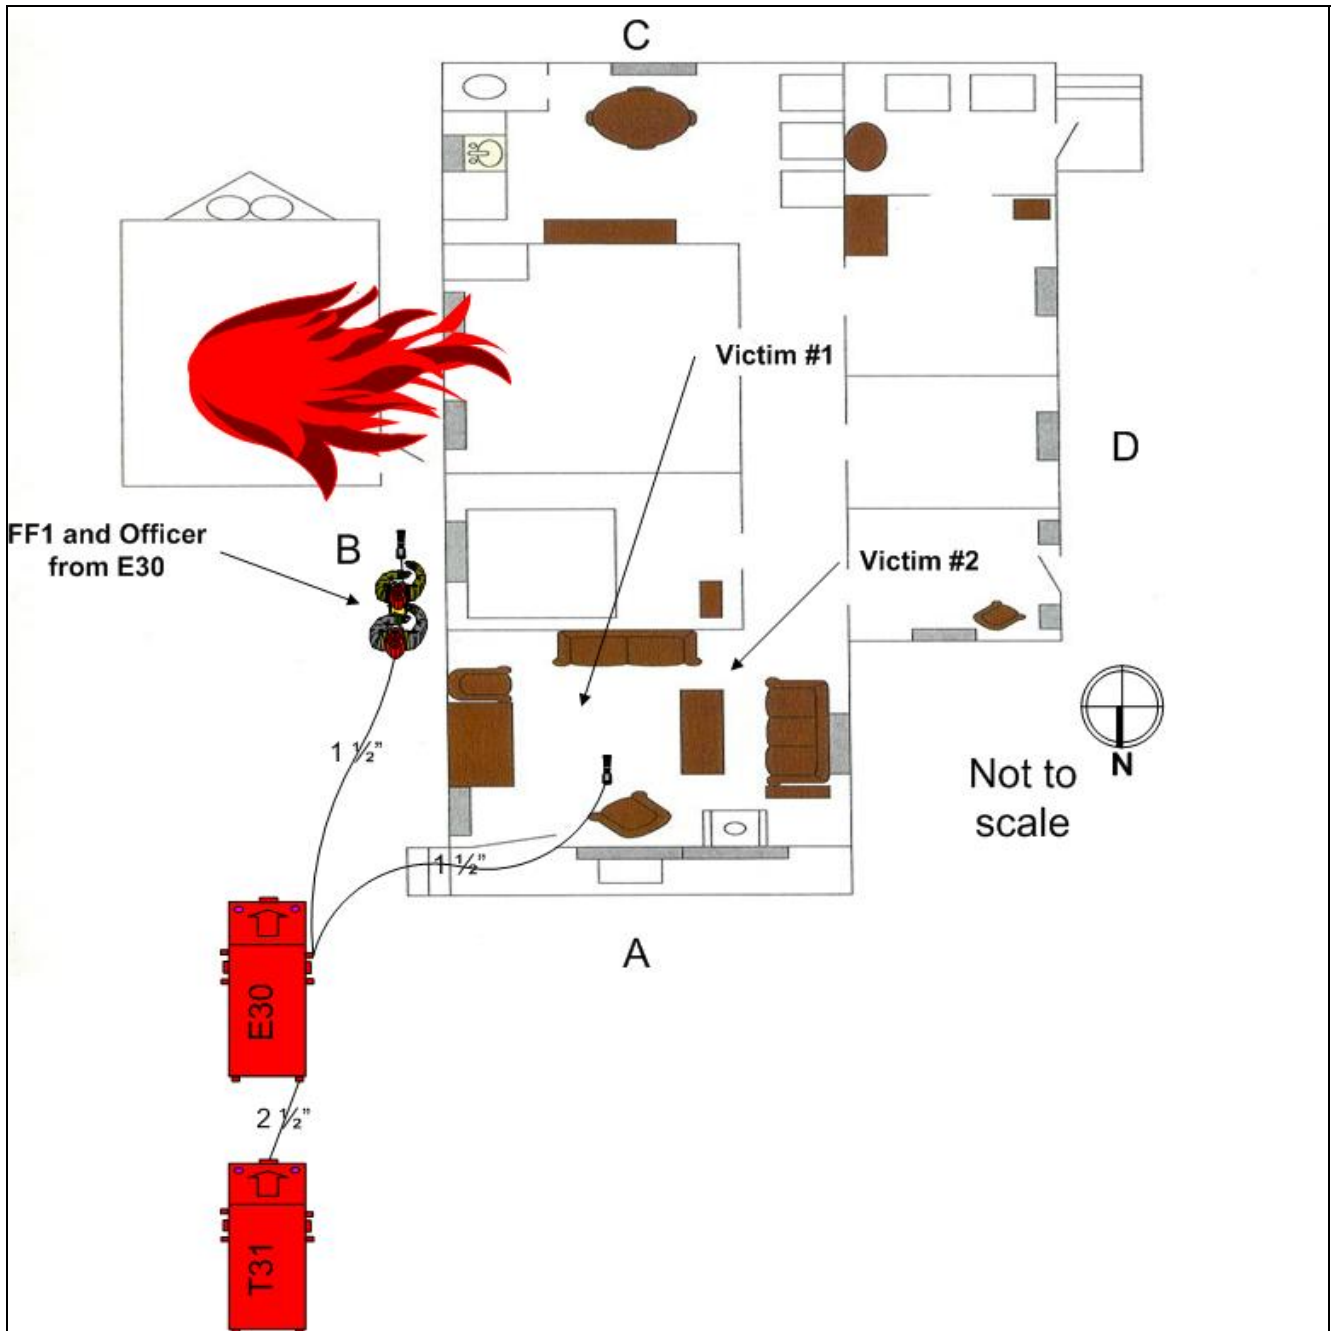
Victim #1 was found 9 ft 10 in and Victim #2 was found 15 ft 11 in from the A-side door they entered through. *Note: These measurements were taken from the doorway to the victims' closest extremities.* Victim #1 was face down with his arms by his side and legs straight. His regulator was connected to his facepiece and was discovered under him at waist level. His body was positioned toward the C-side of the mobile home. His helmet was found sitting upright on a couch several feet away from him as if he had taken it off and laid it on the couch. Victim #2 was found 1 ft 10 in ahead of Victim #1, also face down. His left leg was bent under his right leg, right arm under his body, and left arm facing up. His regulator and facepiece were also connected and discovered under his body at waist level. His body was also pointing toward the C-side of the mobile home. Both victims had their Nomex® hoods rolled down on their necks. Also, both victims were found without an integrated or stand-alone PASS device.

Diagram 2. Incident scene when evacuation alarm sounded and location of victims when found.
