## **One Fire Fighter Dies and Another is Severely Injured in a Single Vehicle Rollover Crash—Georgia**

## Fatality Assessment and Control Evaluation Investigation Report # F2009-08

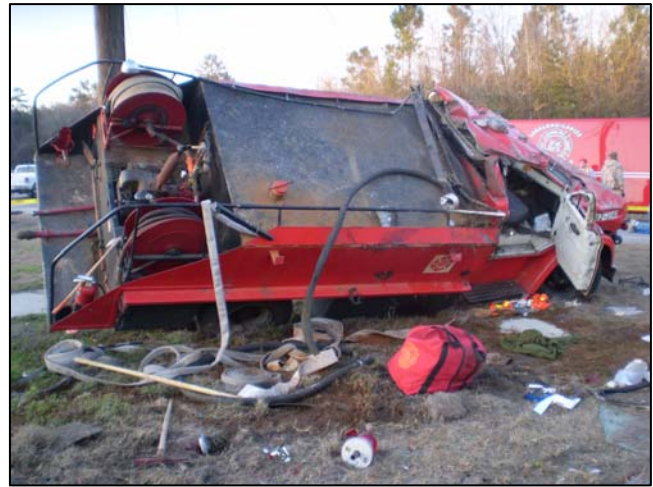
**Crash Scene Photo.**  
*(Photo courtesy of fire department)*

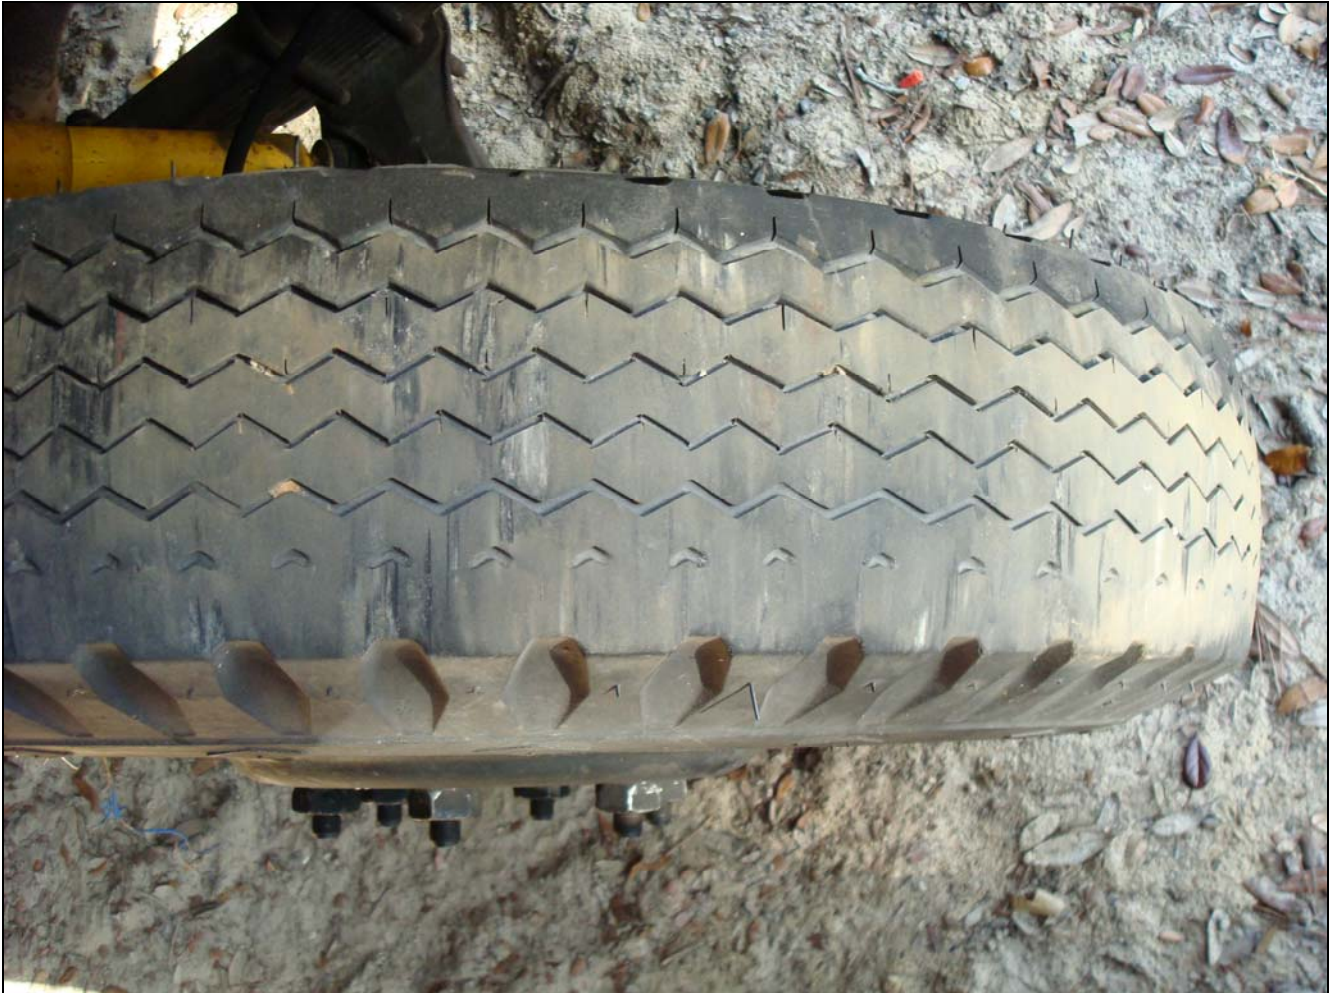
The driver of the apparatus reported brake failure just prior to the crash. The reported brake failure involved the brake pedal going completely to the floor with no resistance. Georgia state police investigators determined that the master brake cylinder was empty of hydraulic brake fluid after the crash, but did not determine if or where the brake fluid leaked from. The driver reported that steering the truck was difficult due to the front end shaking considerably. The driver had experienced this difficulty in steering the truck on previous occasions and had attributed this shaking to flat spots on the tires from the truck sitting for extended periods.

**Photo 1. Right front tire tread indicating needed maintenance of steering system and replacement of the tires.**  
*(NIOSH photo)*

Discussion: NFPA 1911, *Standard for the Inspection, Maintenance, Testing, and Retirement of In-Service Automotive Fire Apparatus*, states that fire apparatus should be serviced and maintained to keep them in safe operating condition and ready for response at all times.<sup>8</sup> Maintenance schedules should be established and recorded as an integral part of a well-planned maintenance program. The maintenance program should include daily, weekly, and periodic maintenance service checks. The maintenance checks should be based on the manufacturer’s service manuals, the tire manufacturer’s recommendations, local experience, and operating conditions.

The state of Georgia does not require annual vehicle safety inspections for fire apparatus, and the fire department did not have a program for vehicle inspections. Complaints regarding vehicle performance or concerns regarding maintenance items in this department were supposed to be forwarded verbally to the county district chief who would arrange for repair. A comprehensive vehicle inspection, maintenance, and testing program should also include a formal method to place apparatus out of service and notify any potential responders of the unit's status.

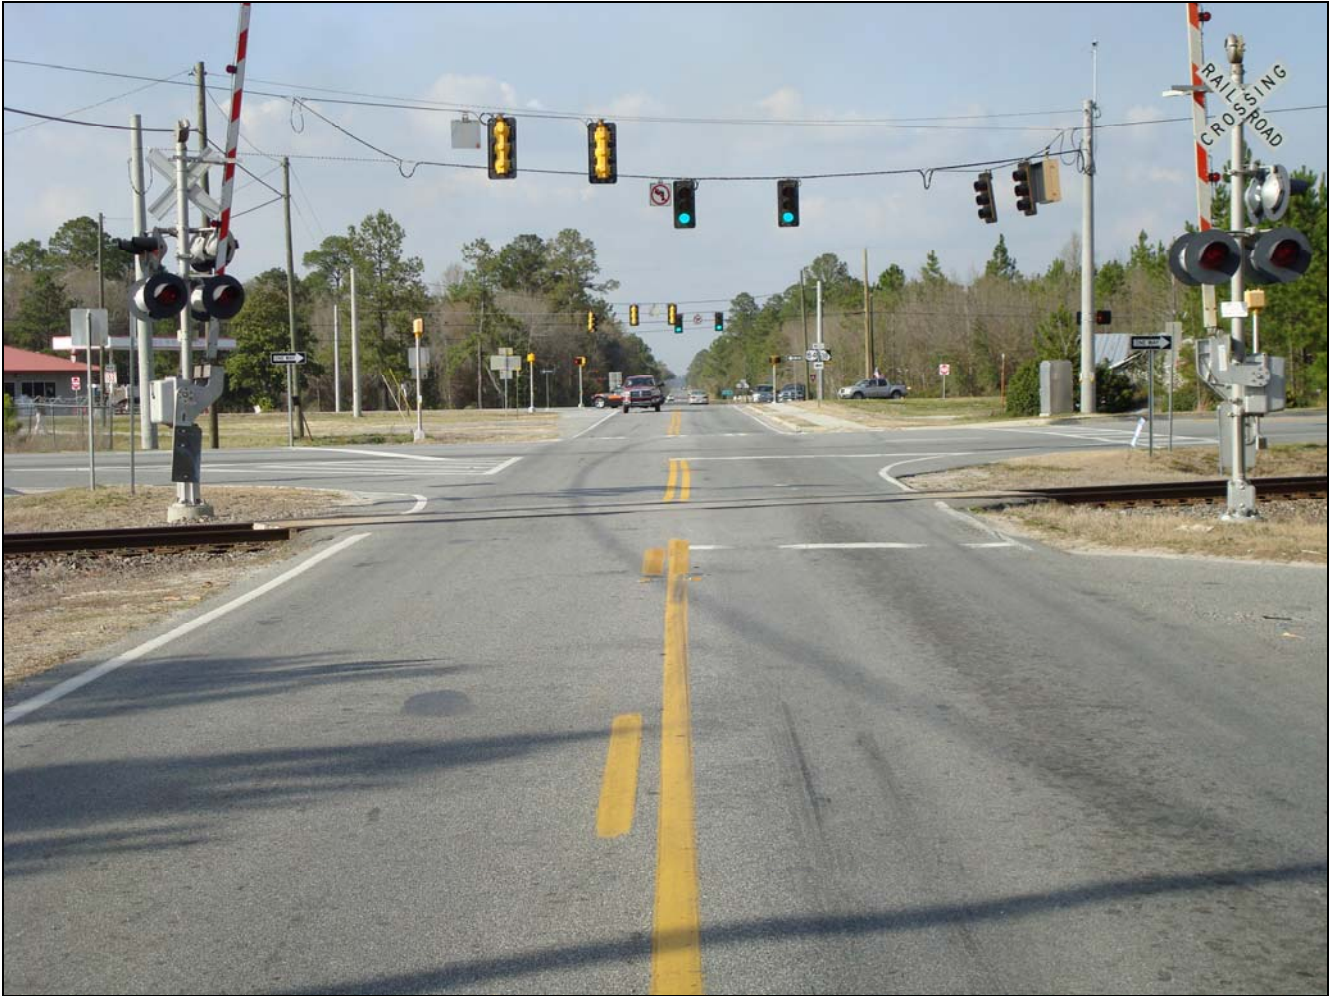
The engine was traveling on a two-lane blacktop state highway with a posted speed limit of 55 mph. The incident occurred at an intersection with a railroad crossing and a divided four-lane highway with two traffic signals (see Photo 2). The road surface was asphalt in good condition and was dry. At the time of the crash it was daylight, the skies were clear, visibility was 10 miles, and the temperature was 55°F. Winds were 7 mph, from the north.<sup>1</sup>

**Photo 2. Driver's view of roadway at the railroad crossing where E-4's brakes failed entering the intersection. Traffic began to enter the 2<sup>nd</sup> intersection from the right after E-4 passed through the 1<sup>st</sup> traffic light.  
(NIOSH photo)**

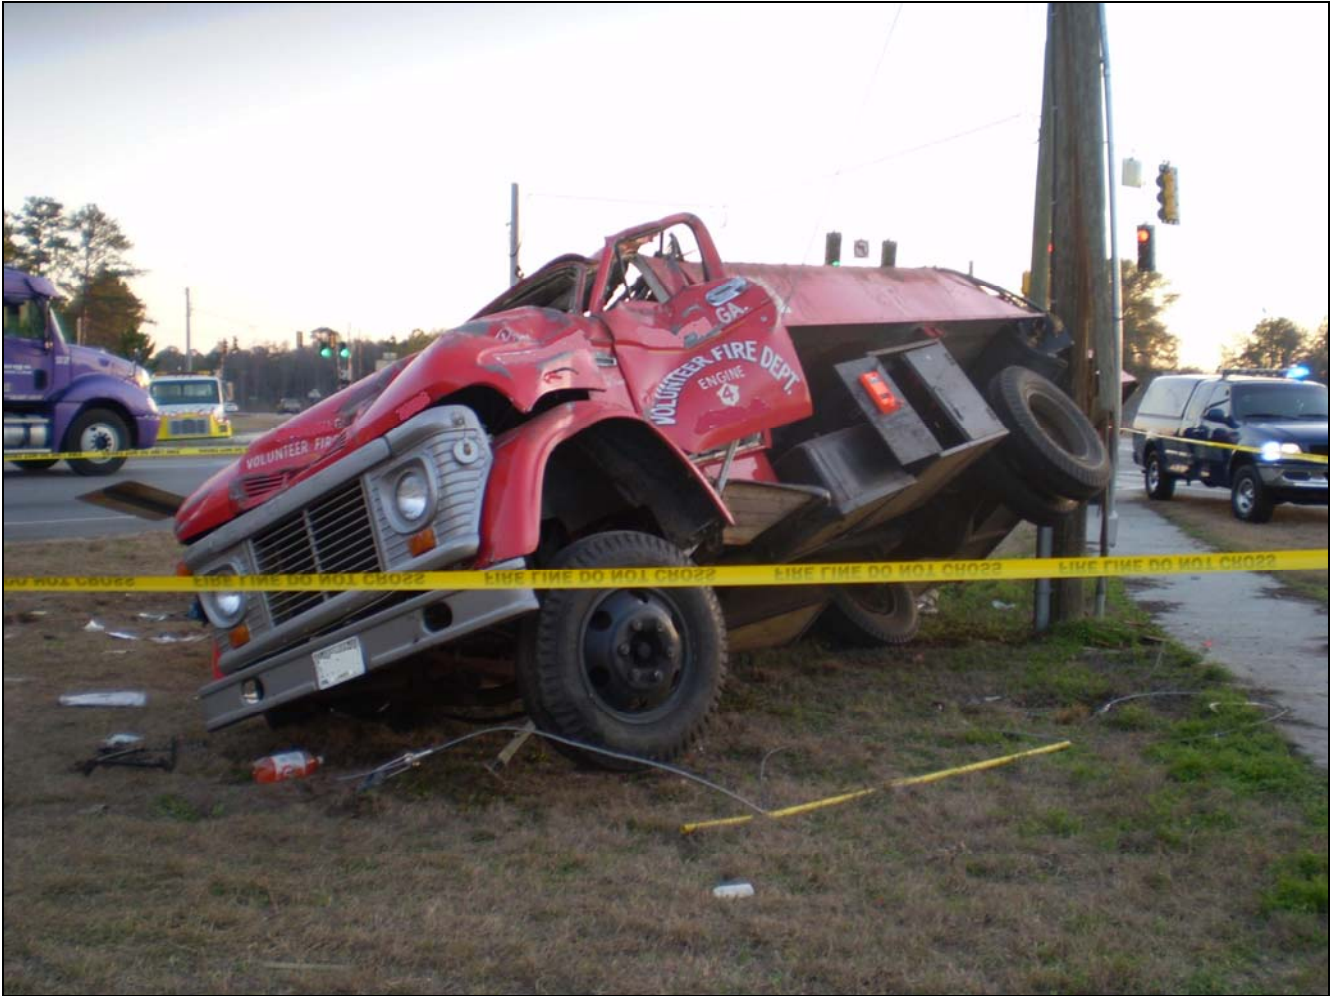
The driver stated during interviews that the truck was traveling approximately 45 mph when they approached the intersection. E-4 was responding code 3 (lights and siren) and had traveled 1½ miles when the driver attempted to apply the brakes, pushing the brake pedal all the way to the floor of the truck with no resistance. The driver told the victim that he didn’t have any brakes and the victim replied “do what you have to do” and took over activating the siren. The driver attempted to activate the brakes without success by pumping the brake pedal. He also attempted to slow the truck by down-shifting the transmission but was unable to shift into a lower gear. The driver reported that the two sets of traffic lights were turning from yellow to red in his direction. E-4 made it through the first set of lights at the crossing (see Photo 2) and noticed traffic at the next set of lights starting to move into the intersection. The driver swerved to the right of the traffic, lost control of the truck, and overturned into a utility pole (see Photos 3, 4 and Diagram).

**Photo 3. E-4 against utility pole.**  
*(Photo courtesy of fire department)*

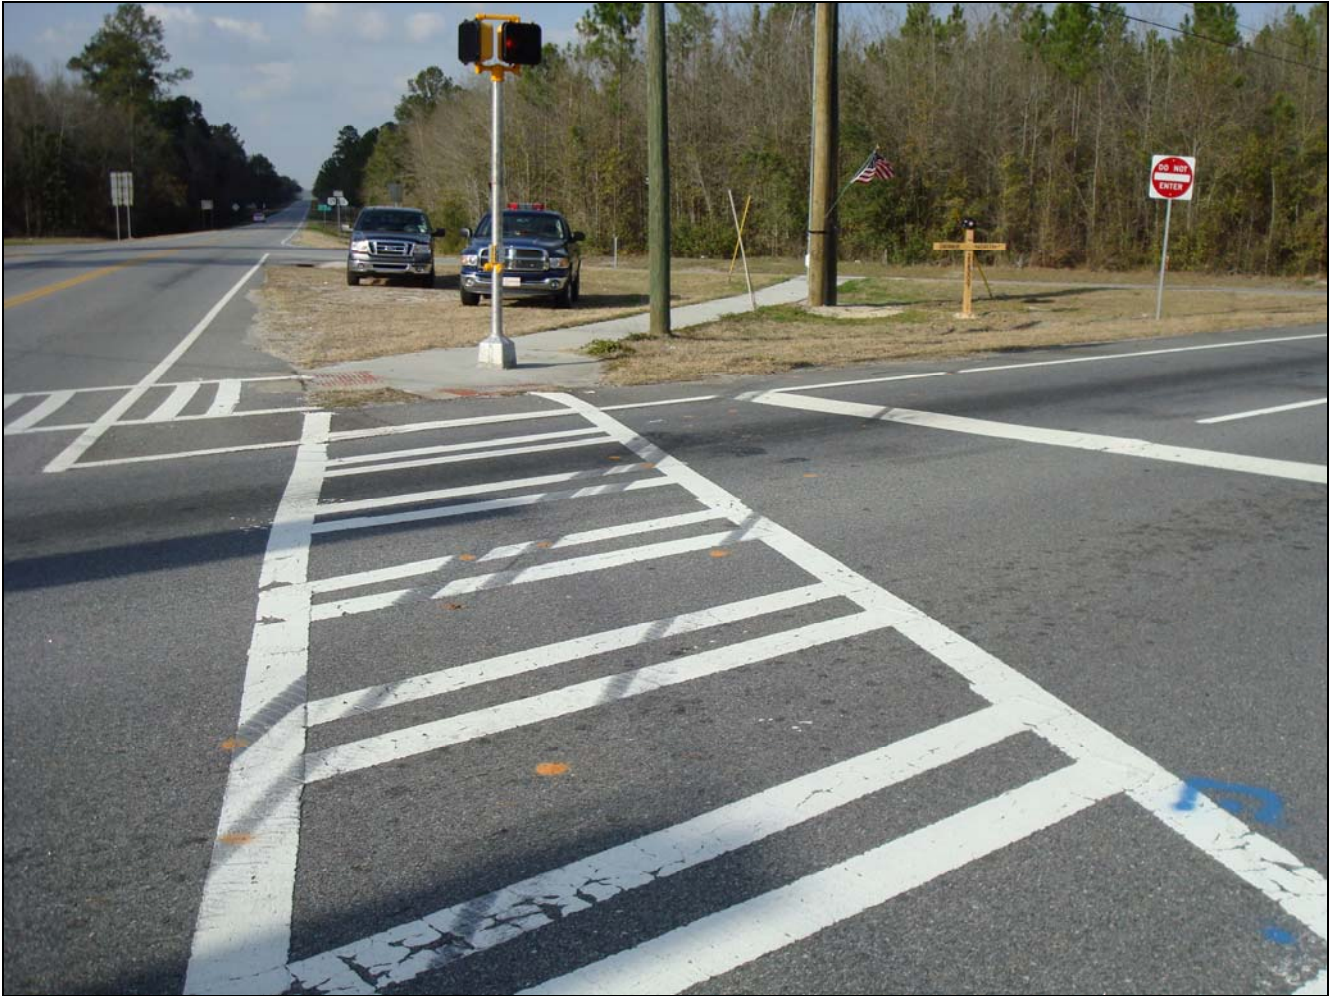
There were no apparent skid marks on the roadway at the approach to the first traffic light or the second intersection. Yaw marks (see Photo 4) at the second intersection indicate the vehicle was moving in a direction to the right of center in the intersection before overturning.

**Photo 4. Road markings just before rollover. Note “yaw” marks on roadway. Marks on the right are from the front tires and marks on the left are from the rear tires just prior to the rollover. Tire yaw marks occur when a vehicle slides sideways while still moving forward. In a true yaw, where the vehicle’s rear is attempting to pass the vehicle’s front, each rear tire tracks outside the corresponding front tire.<sup>13</sup>**

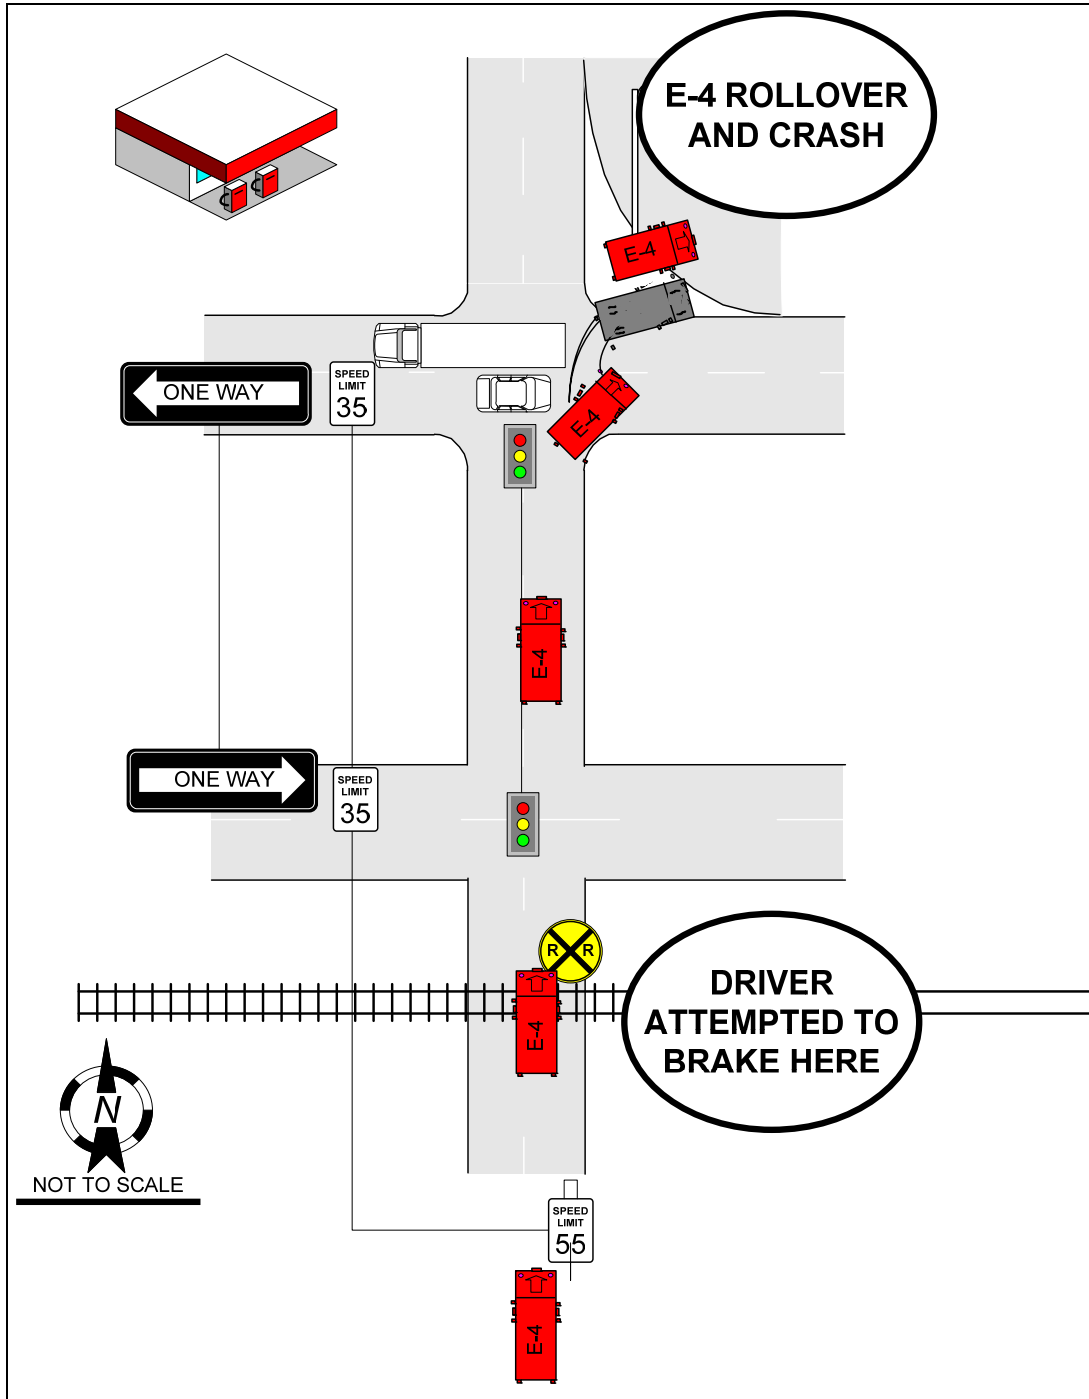
**Diagram. E-4's path of travel after driver realized he had no brakes at rail road crossing.**
