## **Career Fire Fighter Seriously Injured from Collapse of Bowstring Truss Roof –California**

On May 21, 2009, a 36-year-old male career fire fighter was seriously injured while operating in a non-designated collapse zone of a commercial structure when an overhang of a bowstring truss roof system collapsed and struck him. The first arriving company officer reported a working fire in a single story Type II warehouse. The officer looked under a steel roll-up door that was raised approximately three feet off of the ground and saw heavy fire towards the rear of the structure from floor to ceiling. Per department procedures, the first arriving companies went into a “Fast Attack” mode. Crews attempted but were unable to enter the structure because the steel roll-up door wasn’t functioning and the man door was heavily secured. The department’s Deputy Chief arrived on the scene 9 minutes after the initial crew and determined that the fire should be fought defensively, however, this command was not relayed over the radio or verified with all crews. A crew was operating a 2 ½-inch handline just outside the structure approximately 20 minutes after the first apparatus arrived when the overha

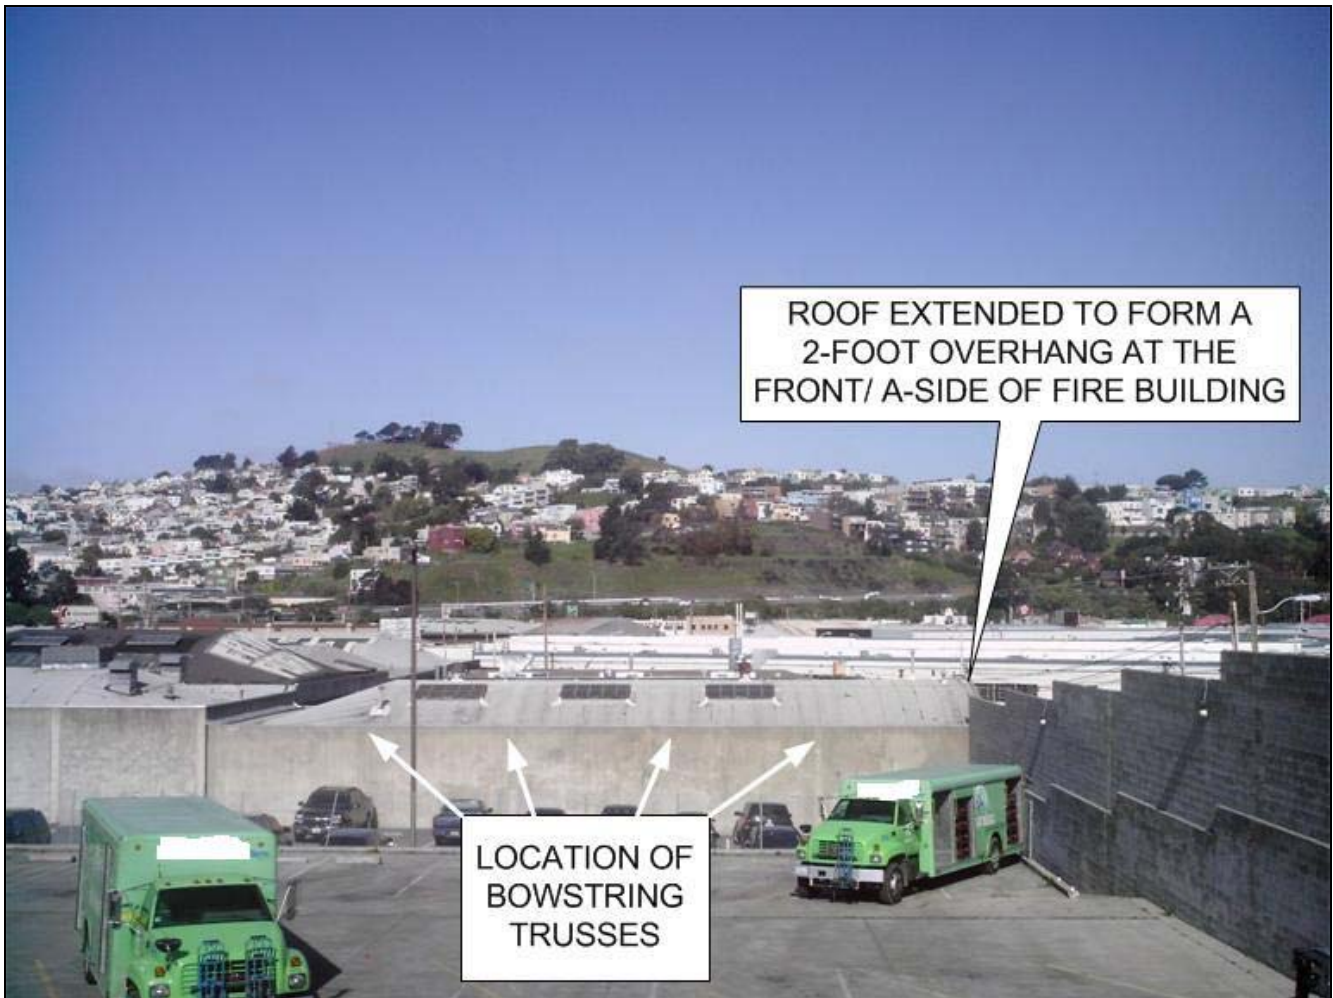
**Photo 1. Picture of structure from B-side parking lot exposure prior to fire.**  
*Photo courtesy of Alfredo Ruiz.*

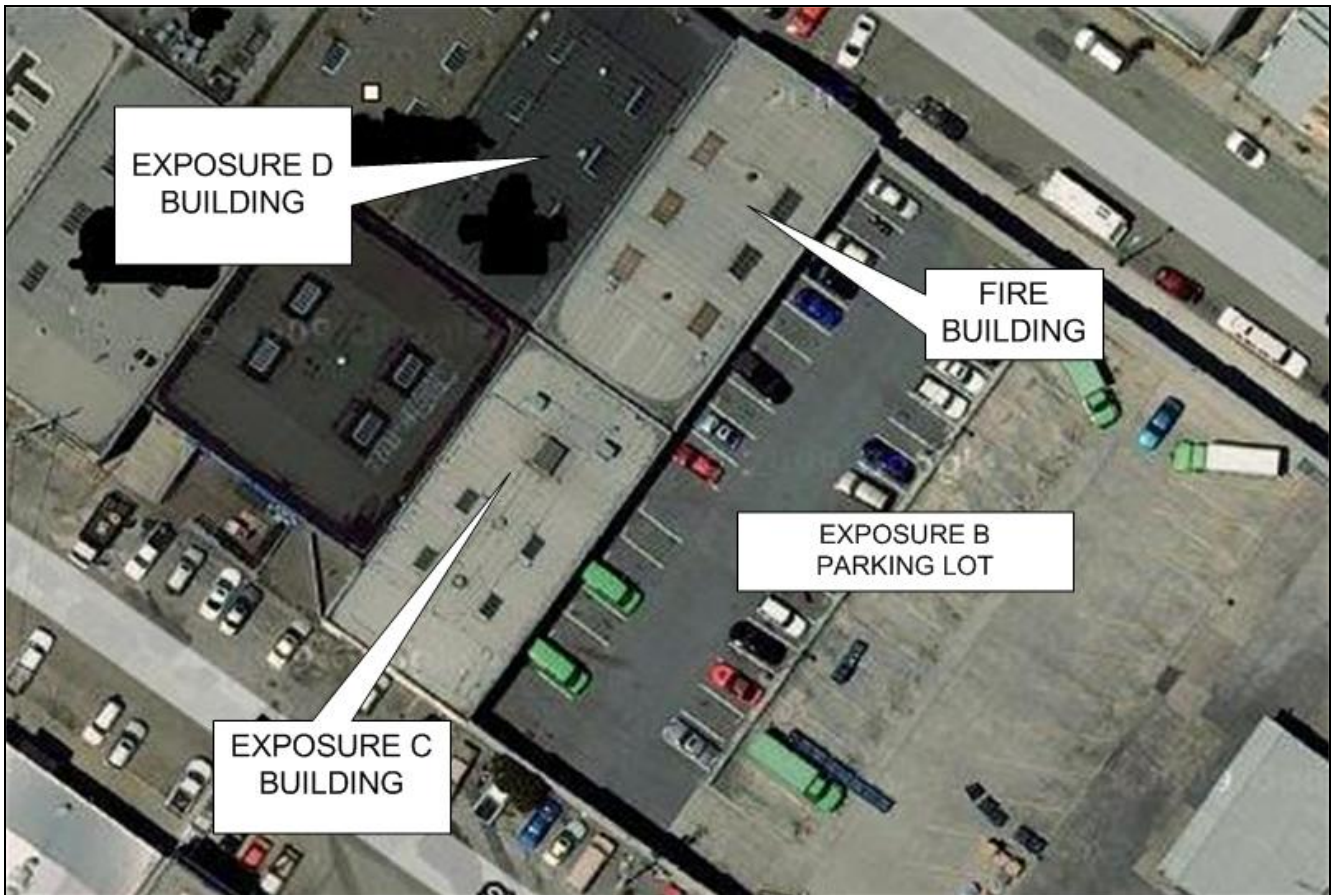
**Photo 2. Aerial photo of fire building and exposures.**  
*Adapted from Google Maps® satellite image.*

Structural stability to the heavy timber truss units was provided by 2-inch x 6-inch wood cross bracing in conjunction with the stability provided by the wood purlins and plywood deck roofing membrane. The structure contained six skylights that were 3 feet by 6 feet (see Figure 1, Photo 1, Photo 2, and Photo 3). The overall integrity and structural stability of this type of structural support and roofing system is contingent upon all components maintaining their connections and load bearing or load transferring capacity.

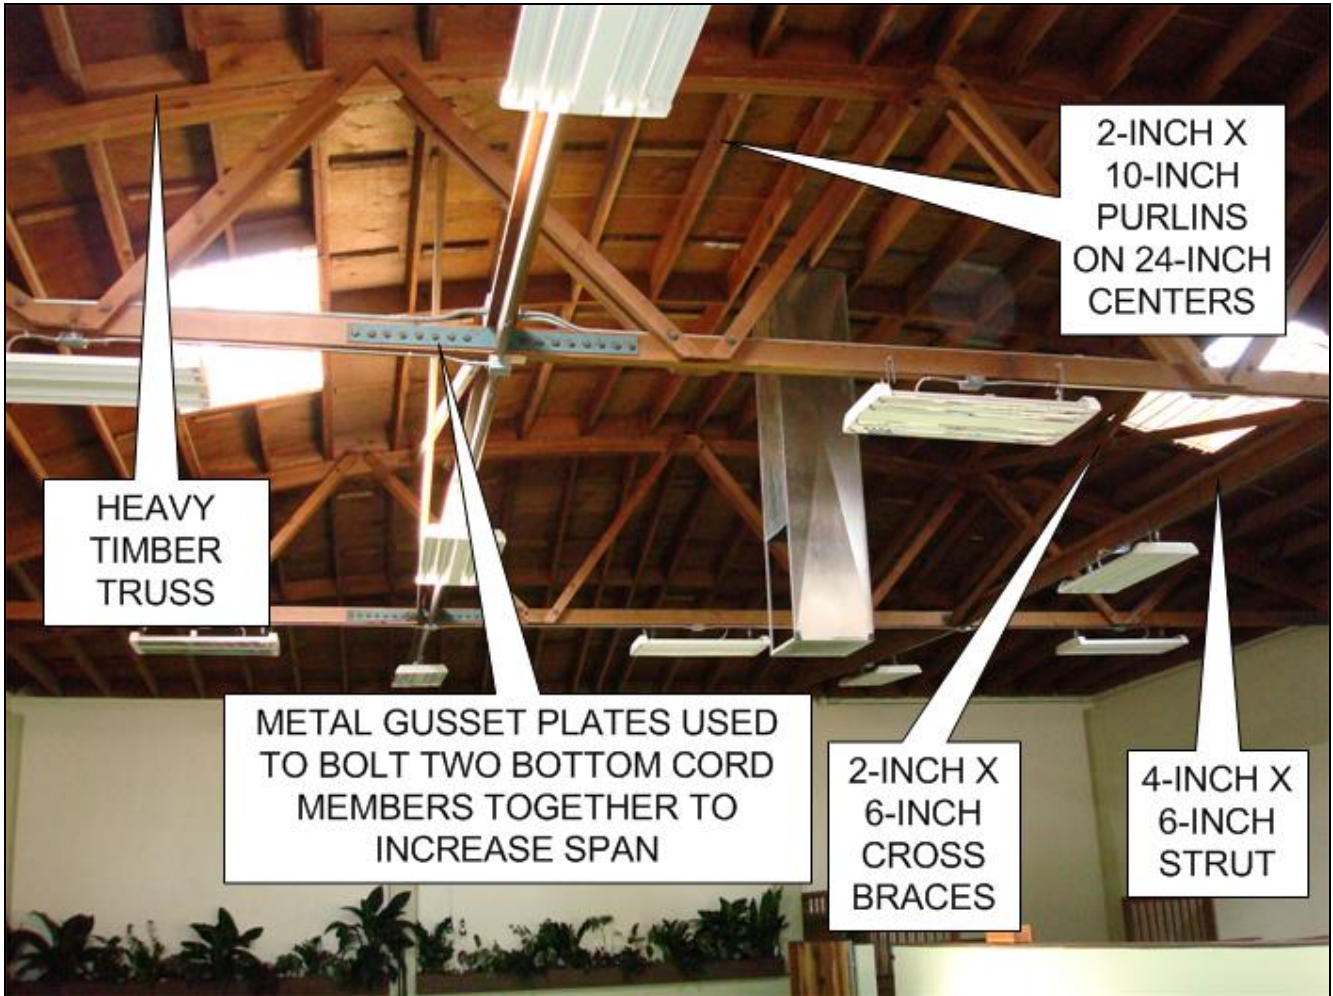
**Photo 3 . Exposure D building with similar bowstring roof construction.  
*NIOSH photo.***

Command and fire fighters need to recognize the dangers of operating near parapet walls or underneath overhanging awnings, porches, and other areas susceptible to collapse. Immediate safety precautions must be taken if factors indicate the potential for a building collapse. An external load, such as a parapet wall, steeple, overhanging porch, awning, sign, or large electrical service connections reacting on a wall weakened by fire conditions may cause a wall to collapse. Other factors include fuel loads, damage, renovation work, deterioration caused by the fire as well as pre-existing deterioration, support systems and truss construction.<sup>21-23</sup> Fire departments should not rely solely on time as a collapse predictor.<sup>23</sup> In this incident, the presence of the bowstring truss roof, the overhanging roof at the front of the structure, and full fire involvement should have been indicators of a collapse hazard. The bowstring truss roof that collapsed in this incident consisted of heavy timbers (Photo 3).

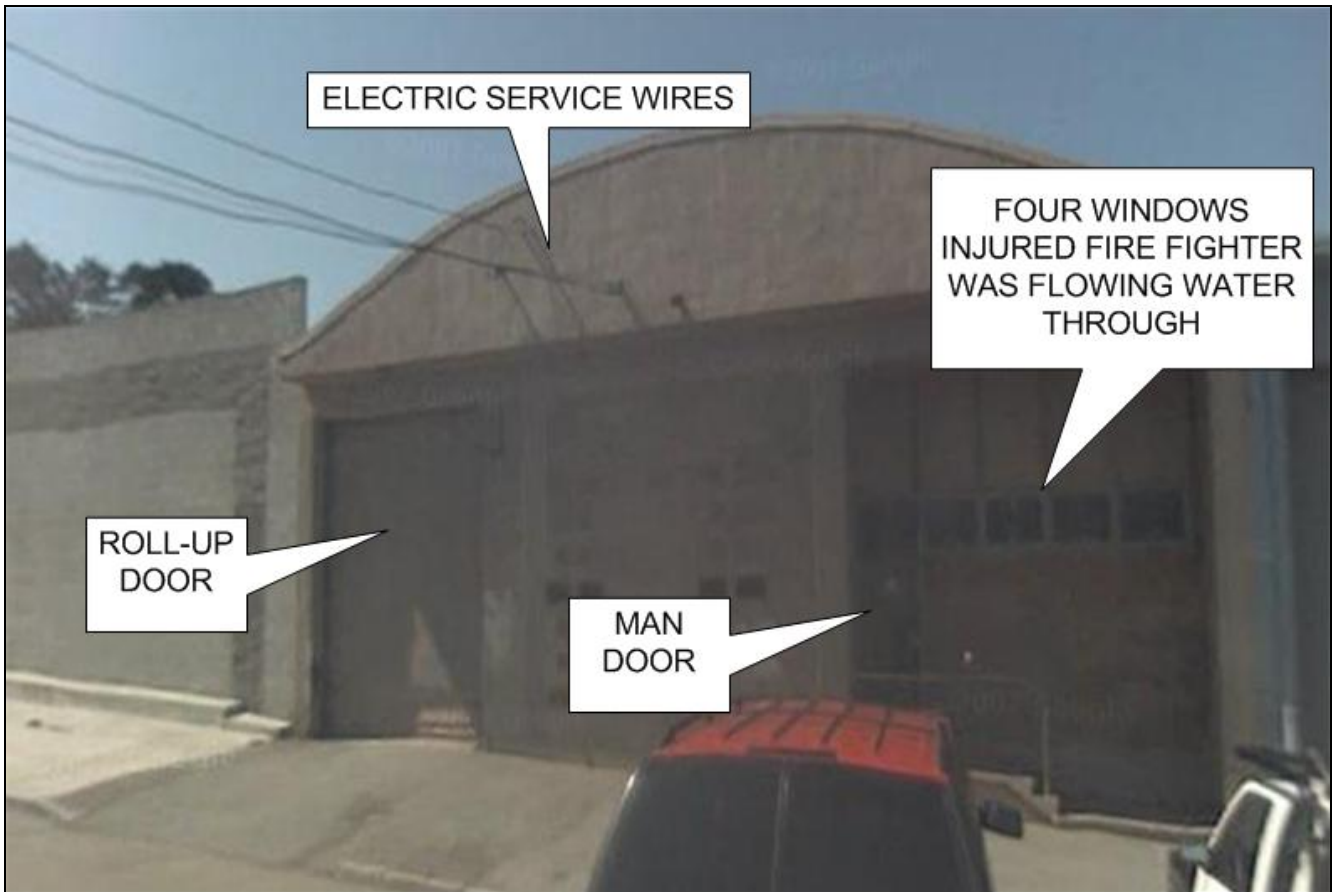
**Photo 4. A-Side of fire building.**  
*Adapted from Google Maps® satellite image.*

side wall (Photo 4). The E42 Lieutenant looked under the door and saw heavy fire towards the rear of the structure from floor to ceiling. The E42 Lieutenant and the fire fighter attempted to raise the door but could not due to the door being dislodged from its track. Note: *The door frame had been compromised by the fire and the tracks were not attached to the wall.* They immediately went to a man door to the right of the A-side. It was locked and had heavy security bars. The E42 Lieutenant called Battalion Chief 6 for a truck company to perform forcible entry.

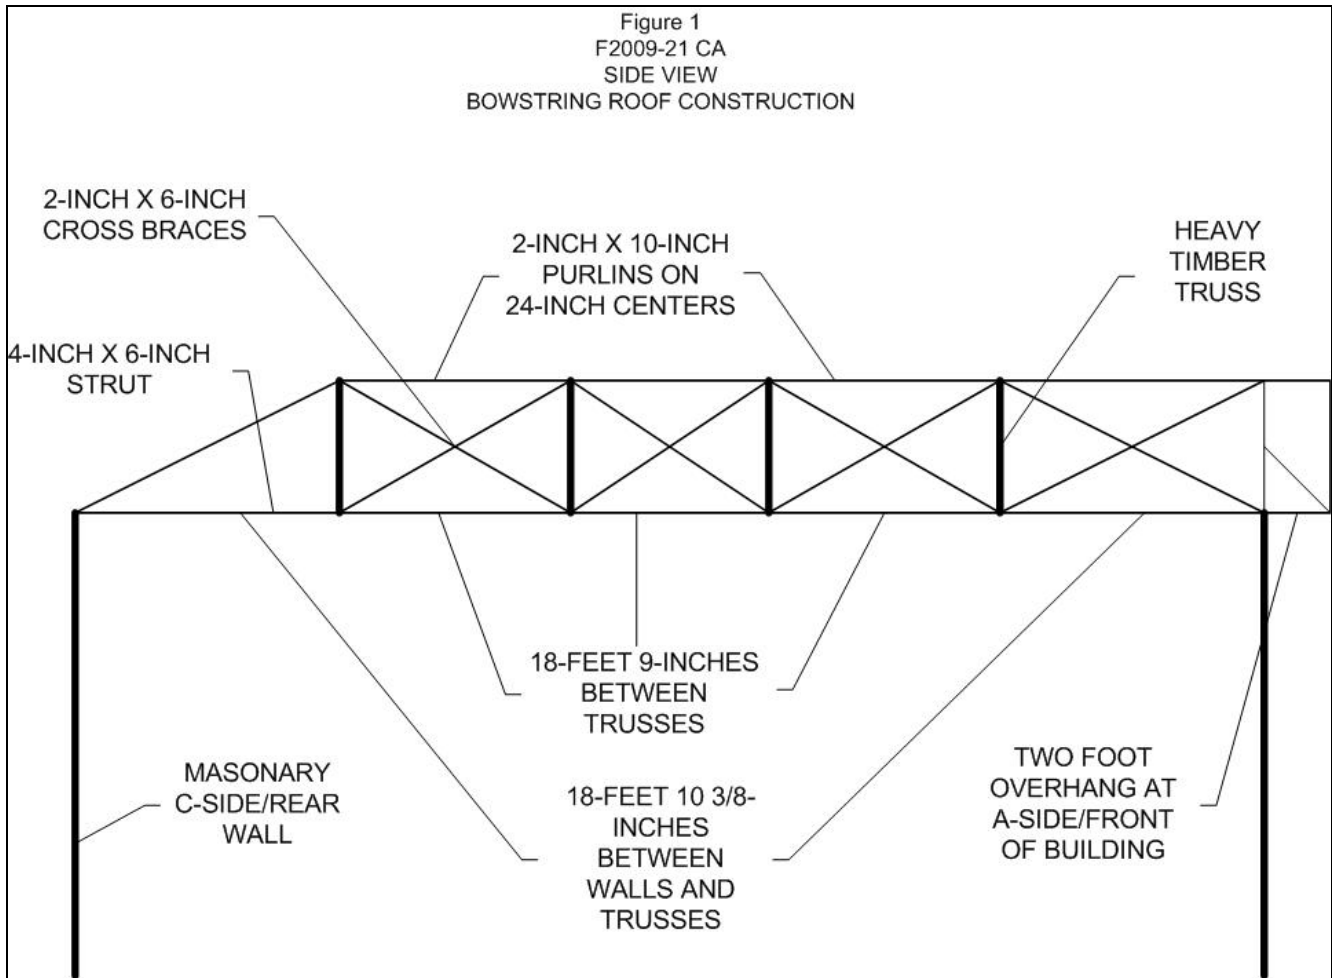
**Figure 1. Side view of building components.**

commercial and it operated as a warehouse. The building's structural system consisted of masonry block bearing walls with four heavy timber wood bowstring trusses for a roof system. The heavy timber wood trusses had a 50-foot clear span to the bearing walls and were located 19 feet 9 inches on center. The heavy timber wood truss assemblies were 48 feet 7 inches in depth and were constructed of 4-inch x 6-inch timber cords and webs connected with bolt fasteners with a metal splice plate and bolt configuration at the bottom chord span. Solid 2-inch x 10-inch wood purlins located on 24-inch centering spanned perpendicular to the truss assembly with a ¾-inch plywood roofing deck. The roofing system assembly was exposed and did not have a membrane or other passive fire protection features.

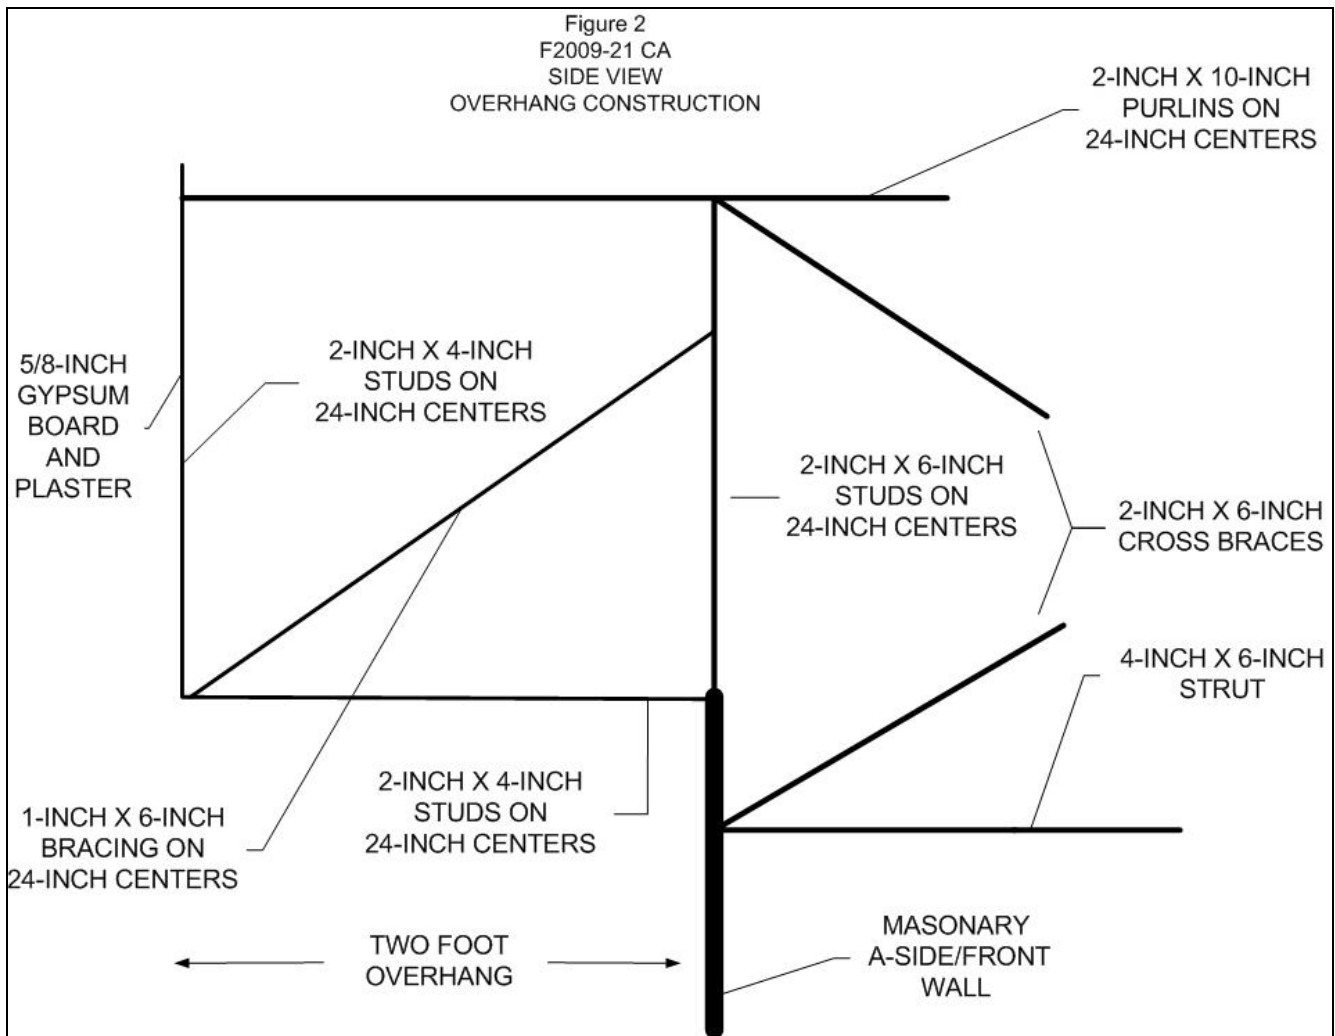
**Figure 2. Side view of overhang construction.**

The A-side was a non-load bearing wall that showed the traditional arched roof profile that is consistent with bowstring roof construction. The A-side wall also consisted of what appeared to be an overhanging or cantilevered façade that was covered by stucco (see Figure 2). The overhang was part of the original construction that tied back into the bowstring truss system. The fire building was integrated into a block of commercial occupancies so that only the A-side was accessible for interior fire fighting activities (see Photo 2 and Photo 4). The B-side exposure of the building was adjacent to a parking lot and was of masonry construction without any windows or doors. The C-side and D-side exposures were of similar size and construction and shared party walls between their respective sides. A pre-plan had not been completed for this structure.
